# Nancy Creek Stream and Water Quality Improvement Project

*Sandy Springs, GA*

**Catherine Mercier-Baggett, AICP**

**Geoff Smith, PE**

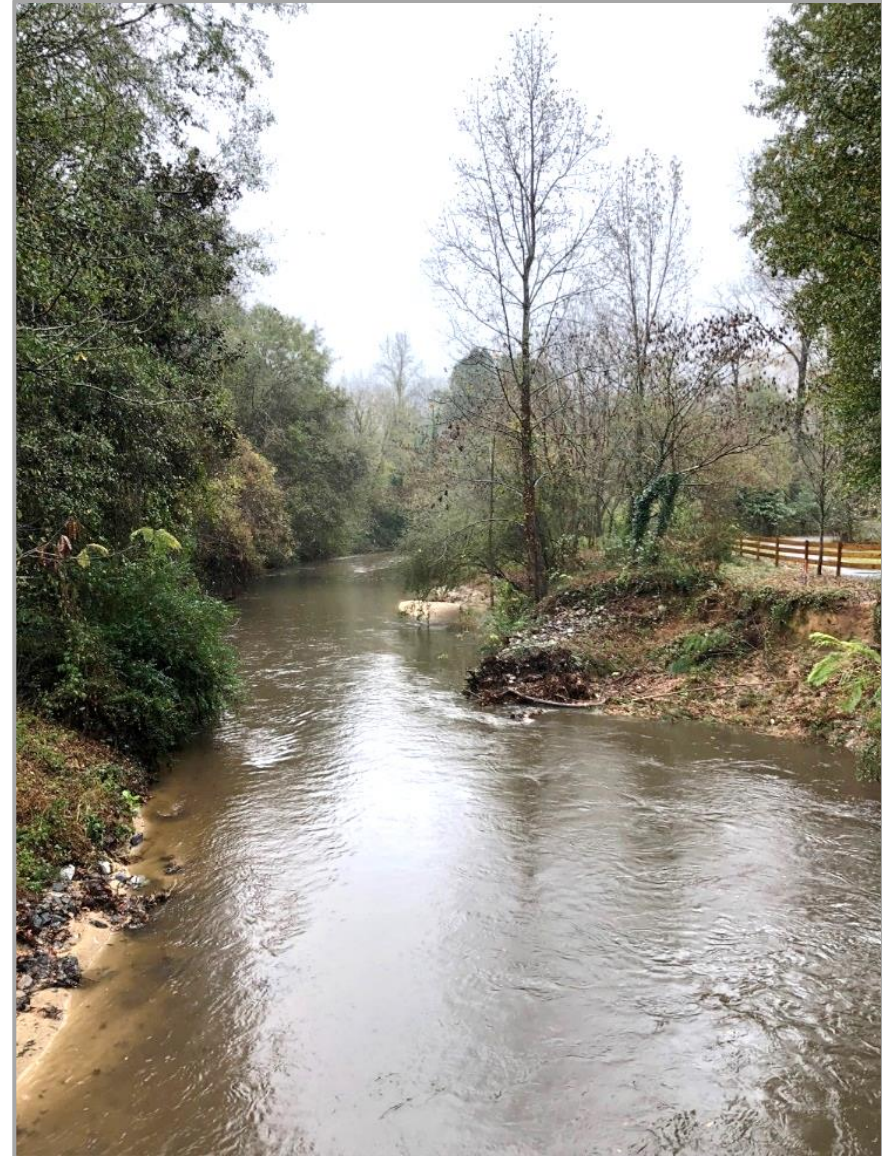
- Typical urban waterway: High peak flows, degraded
- Eroding the edge of the park
- Top of bank 12' above OHWM

- Fecal coliform
- Fish biota impacted

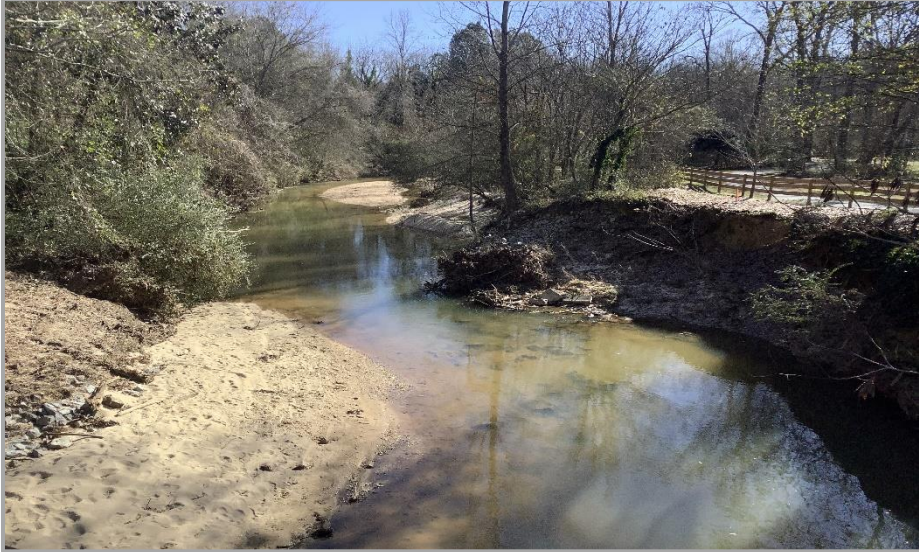
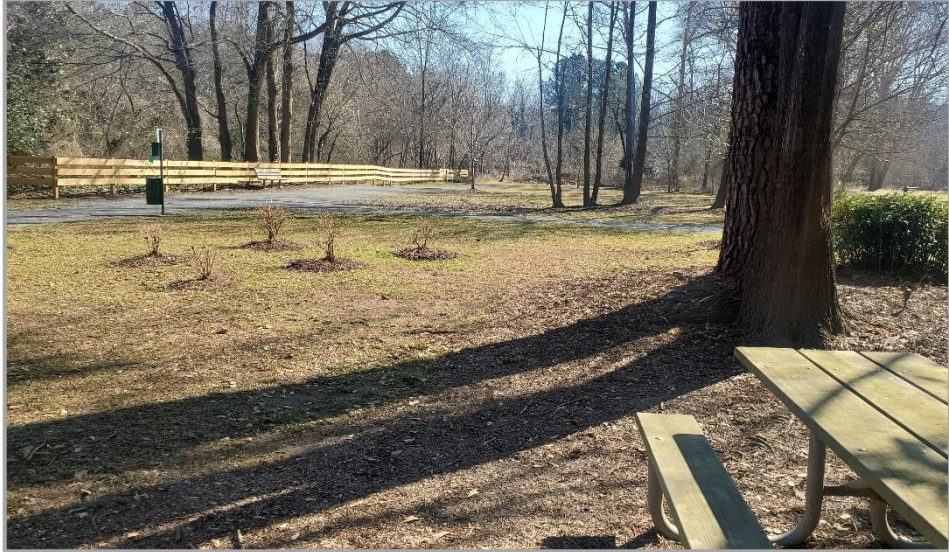
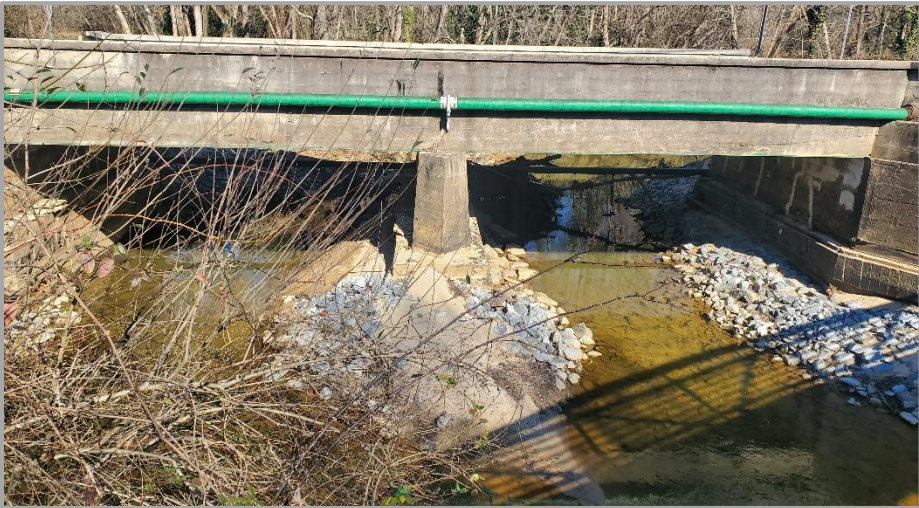
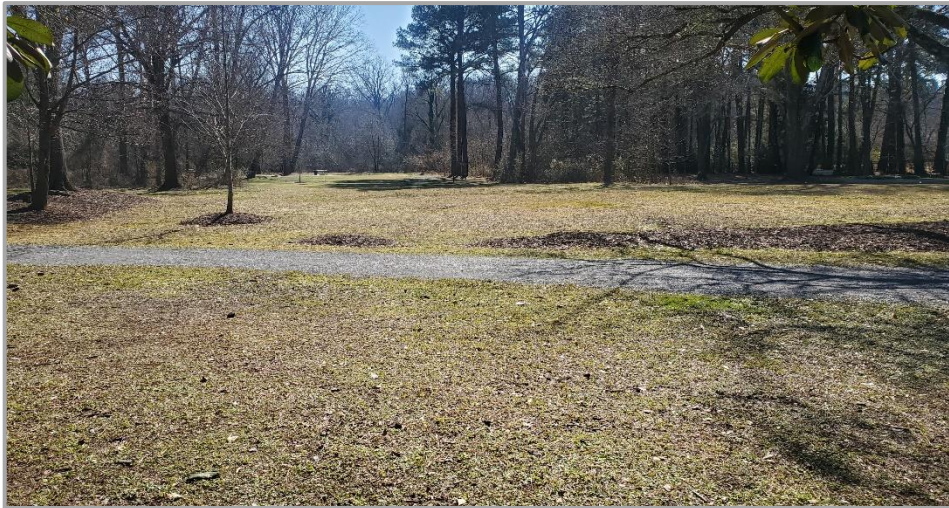
# Design Considerations → How bad does it get?

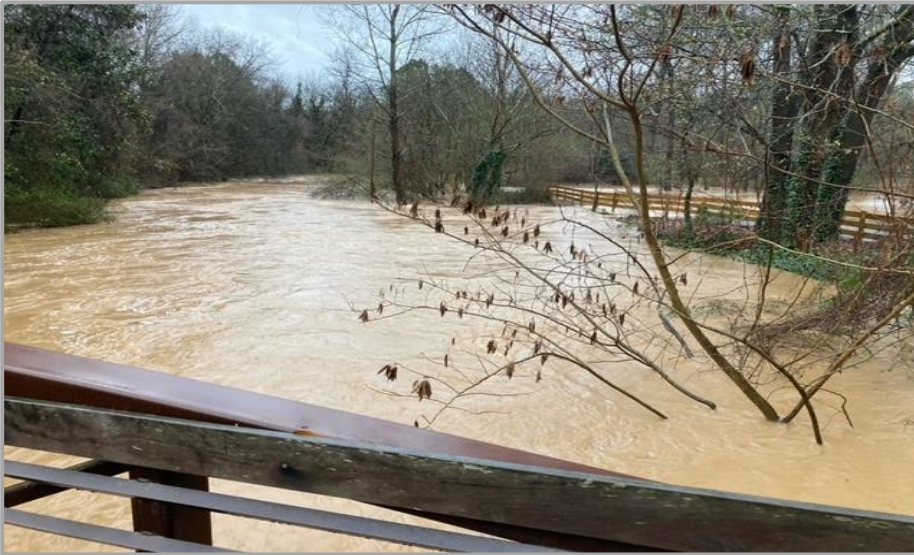
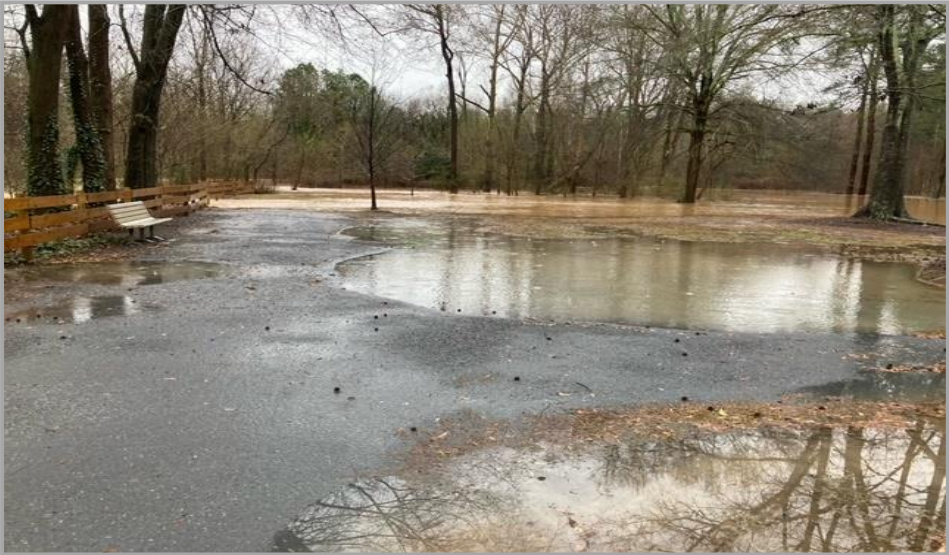
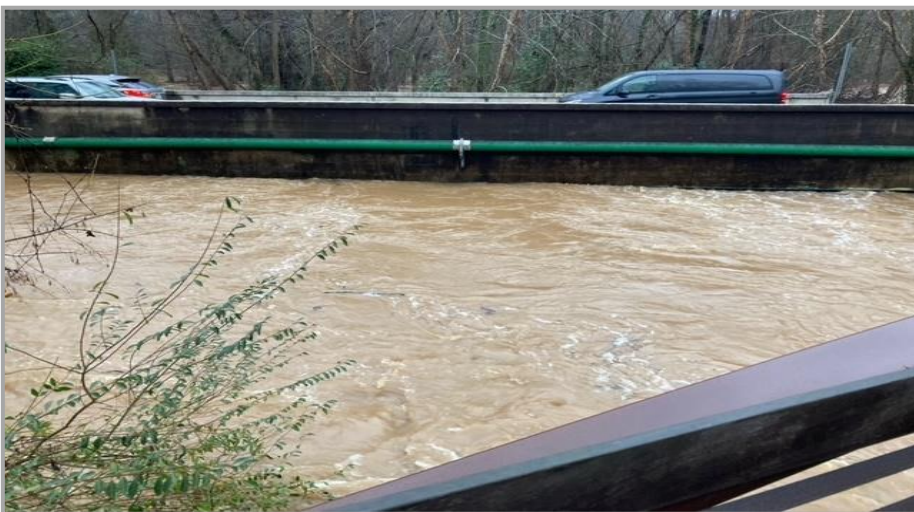
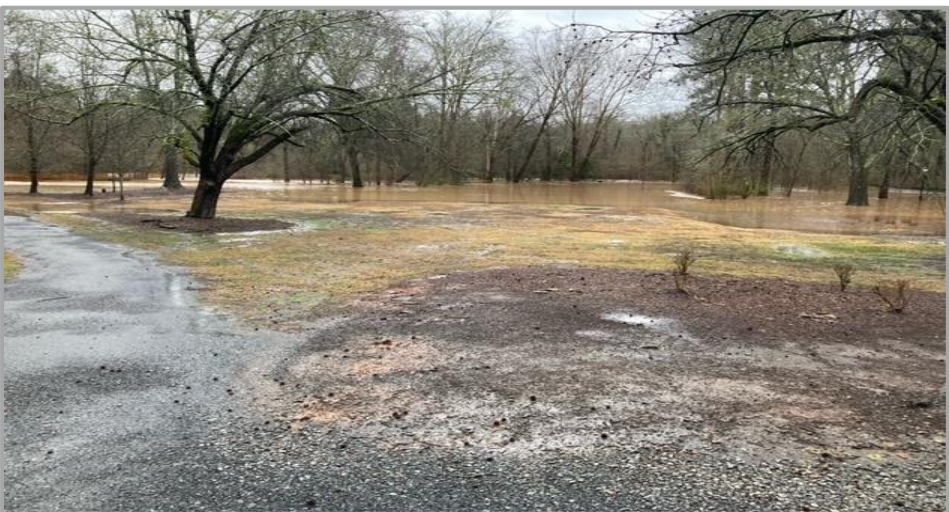
→ After 4" of rain in 24-hrs  
(between 2-yr and 5-yr recurrence interval)

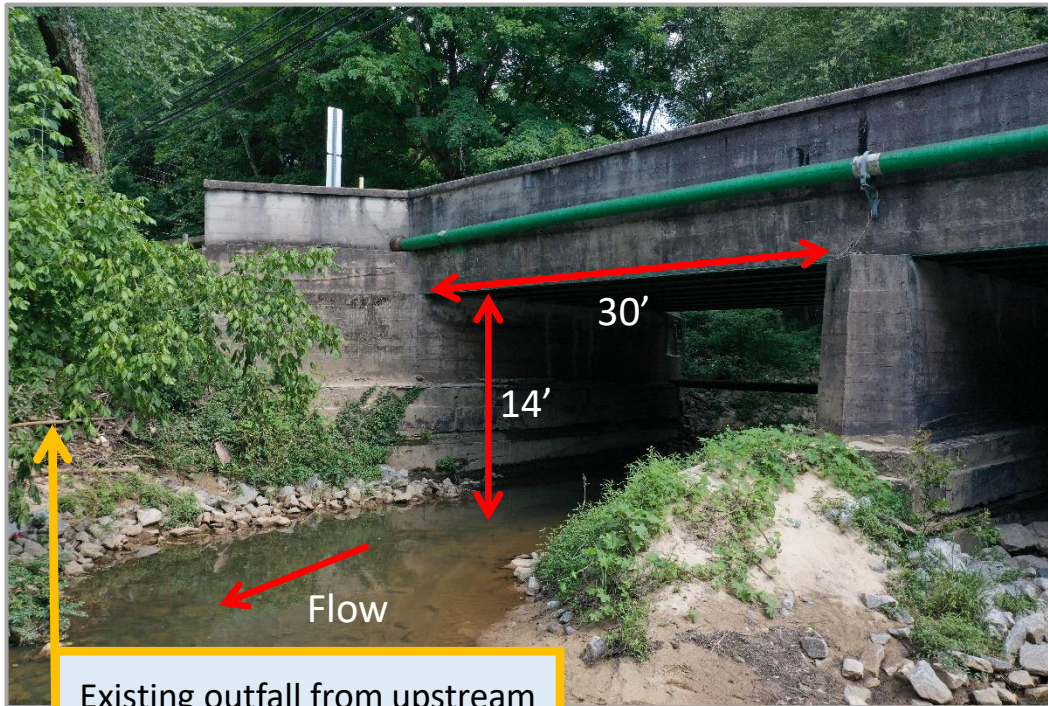
- Windsor Parkway Bridge
- Bridge skew ~ 30 degrees into Park
- Majority of base flow along right bank

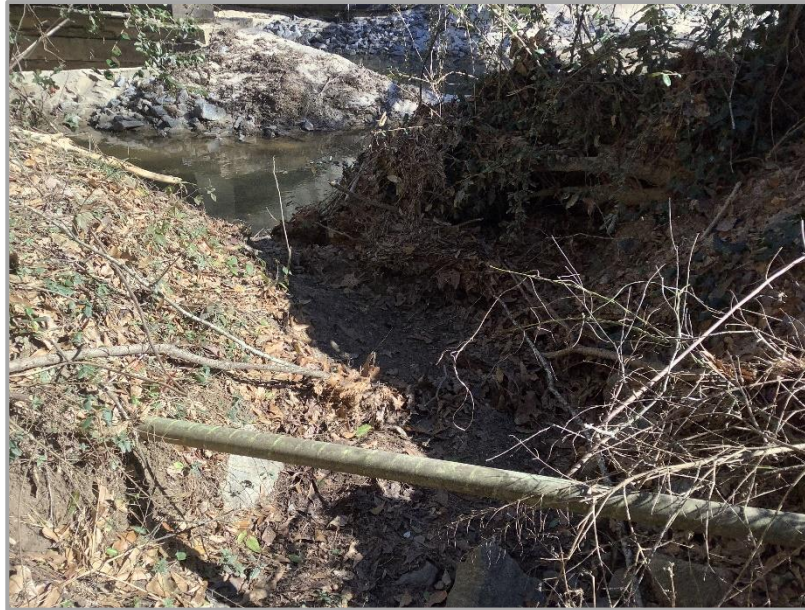
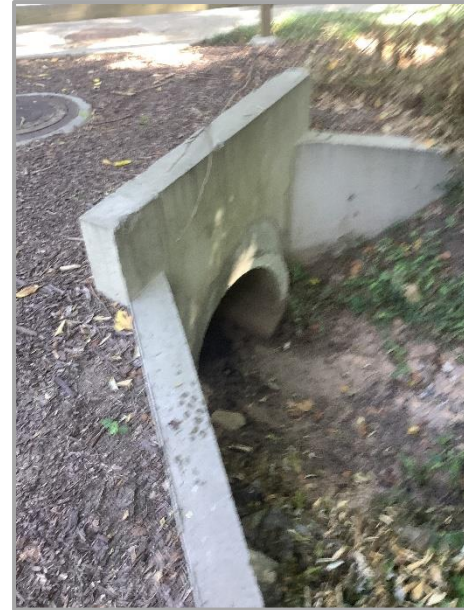
## EXISTING UTILITIES

- Water
- Electric
- Gas
- Stormwater

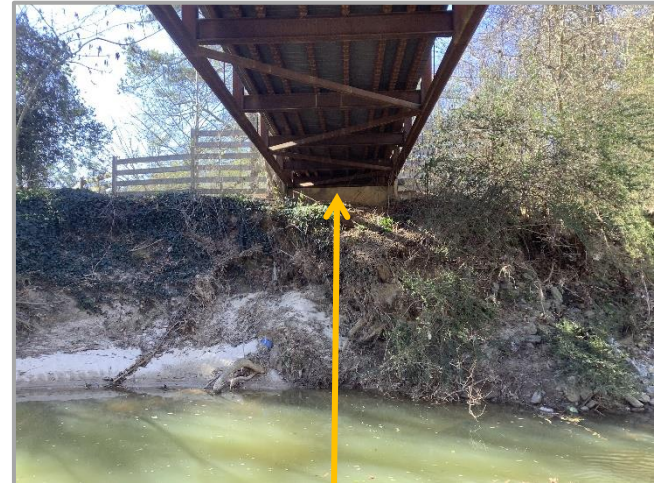
Bridge foundation scour

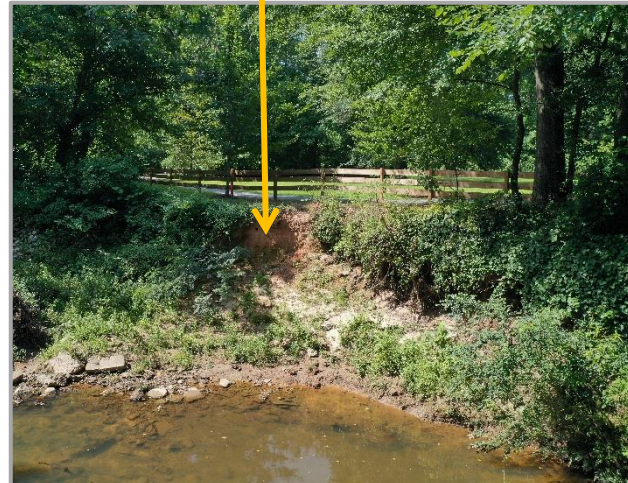
Bank erosion undermining fence (previously moved)

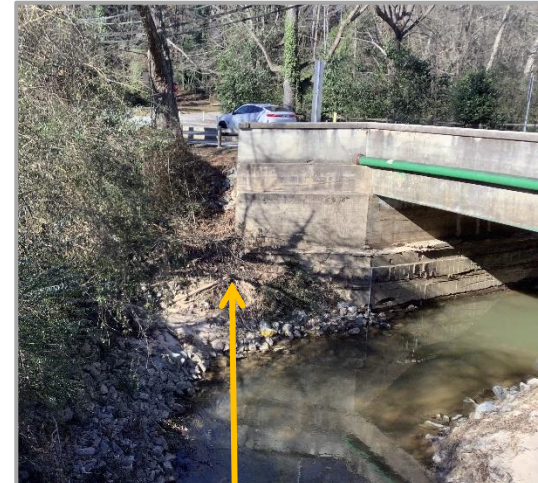
Historic scour issues and roadway runoff

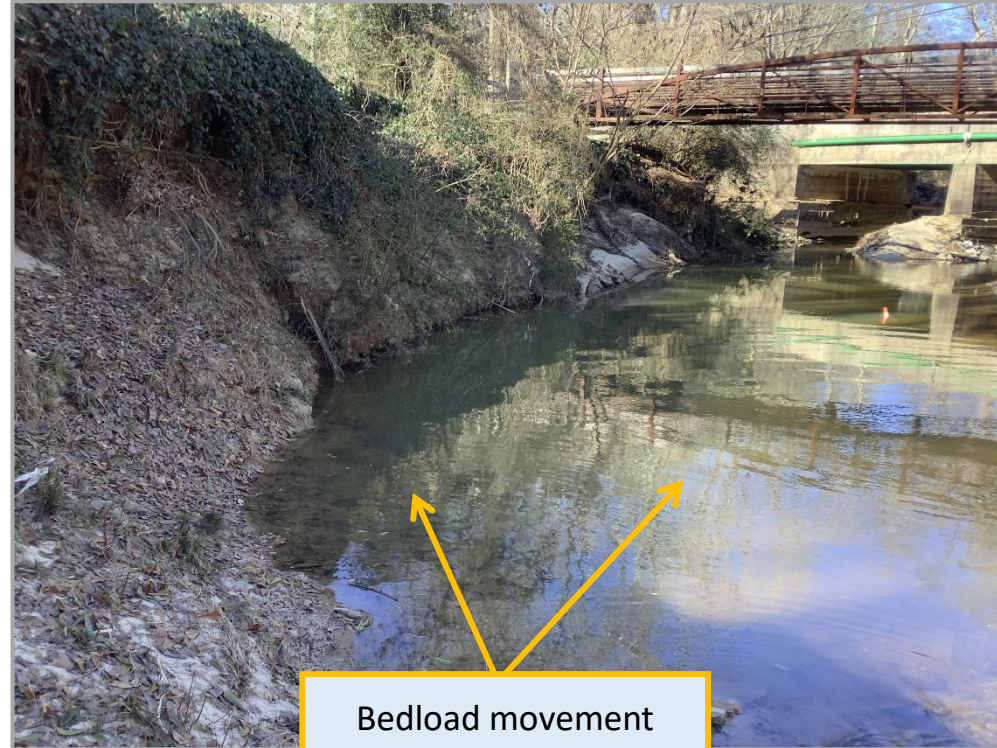
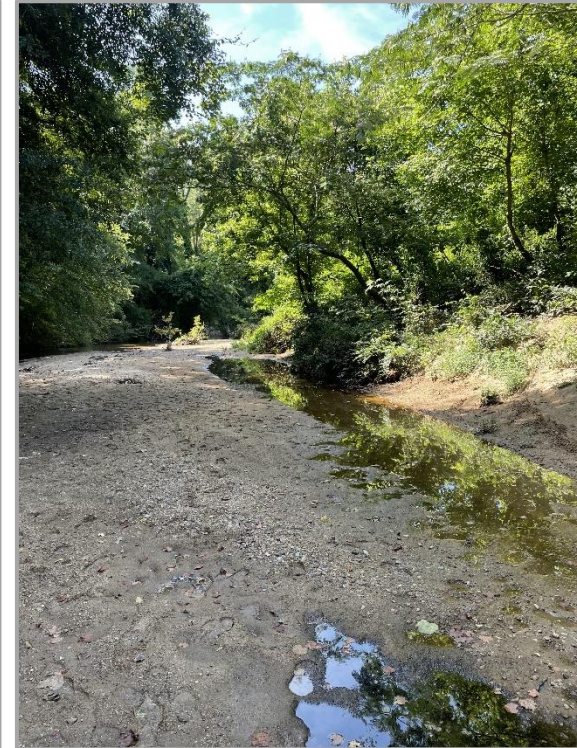
- Sand bed system
- Highly mobile bedload
- High velocity entering the park through right side of bridge abutment
- Downstream depositional bars
- Thalweg highly transient

Bedload movement shifted thalweg during course of the assessment and design process

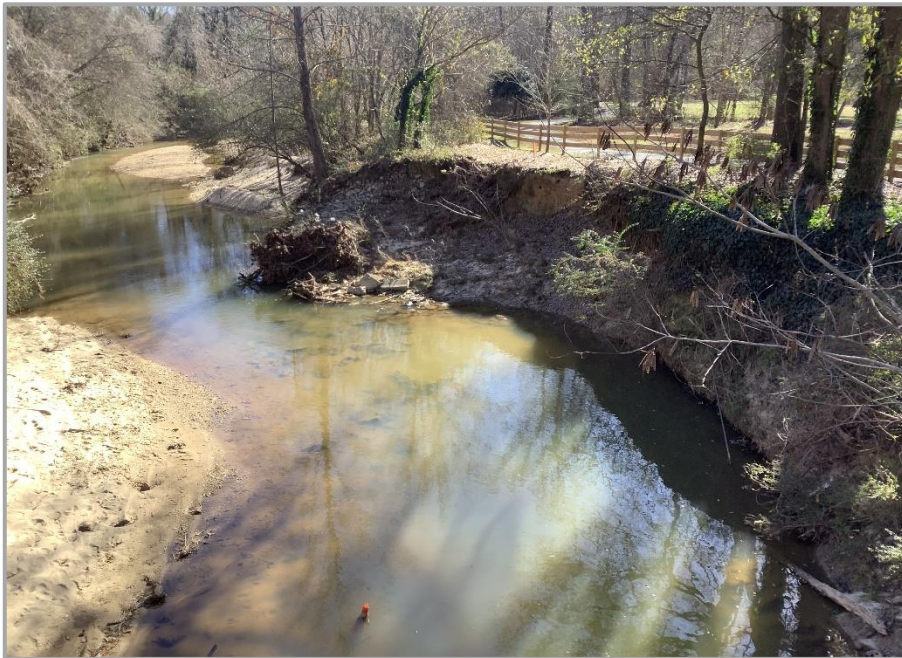
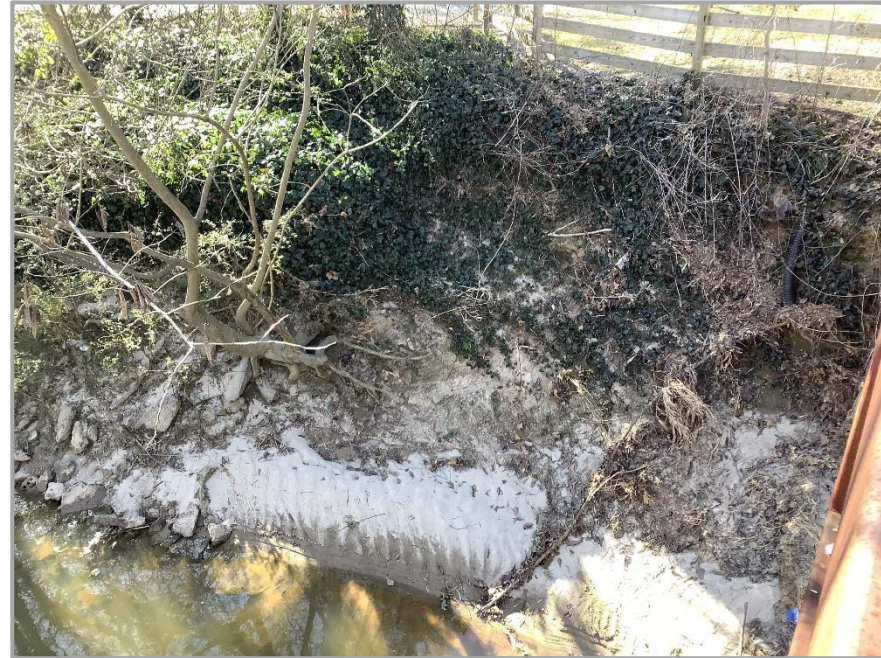
- Vertical along right bank for approximately 200' (height ~ 12')
- High velocity and shear stress on upstream section along right bank in excess of 1.0 lb/sf from bridge to just past pedestrian overpass
- Vegetation rooting depth inadequate to maintain stable banks

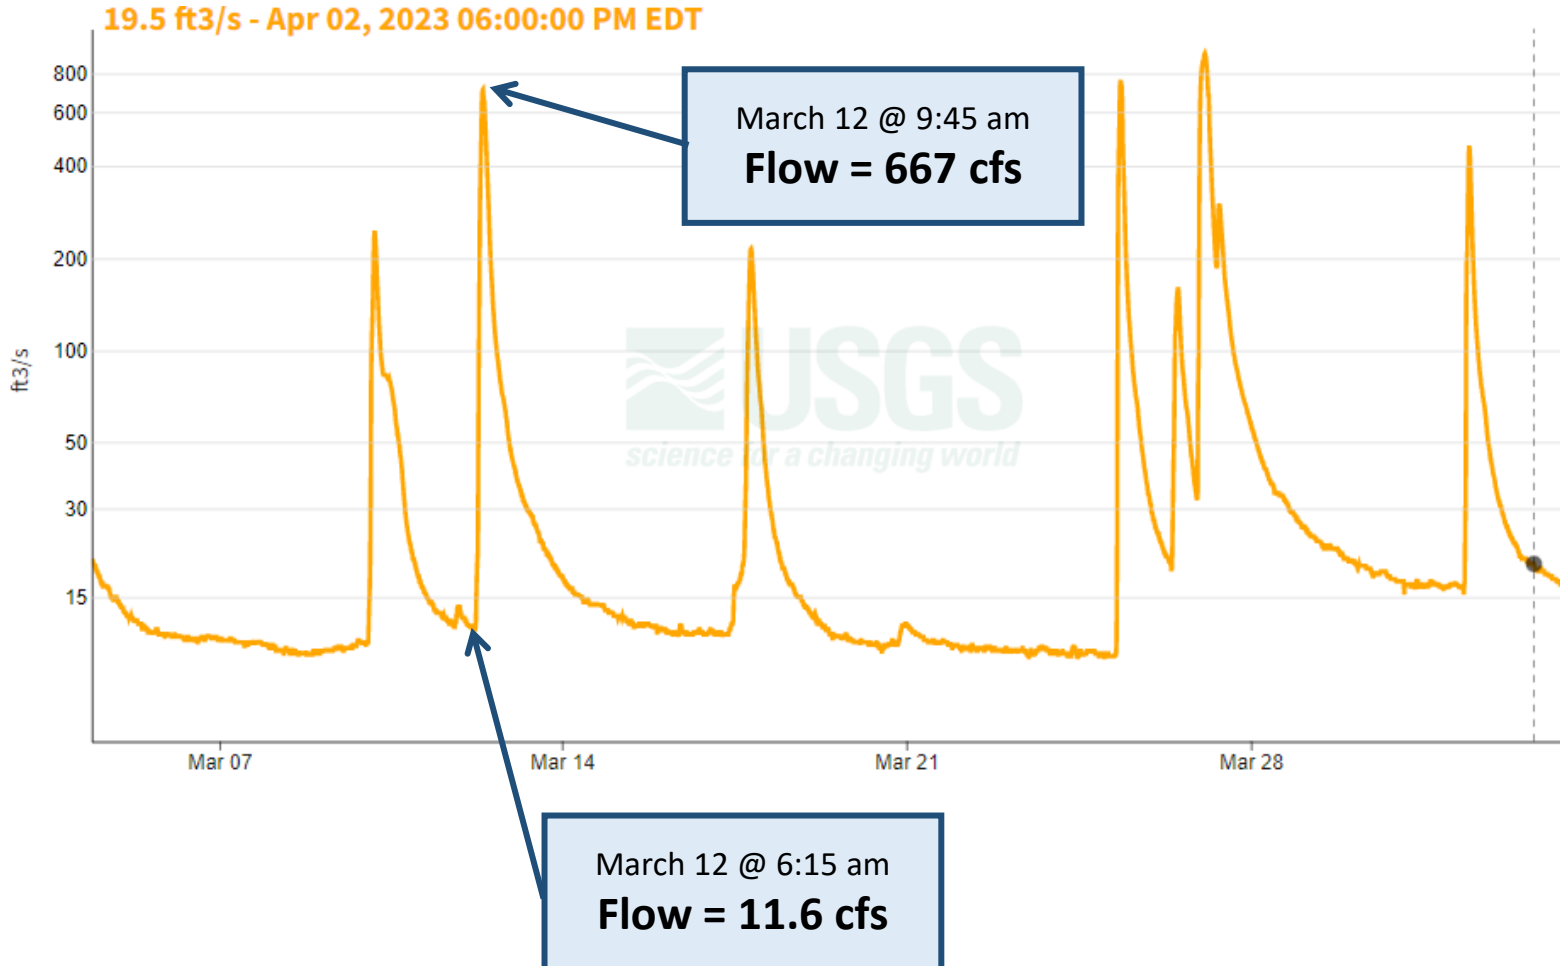
## USGS Gauge 02336240 @ Johnson Ferry Road (Brookhaven, Ga)

- 1.35 mi upstream of park
- Increase of 3.1 cfs /min (this was only a 1.2" storm event!)
- Extremely flashy system

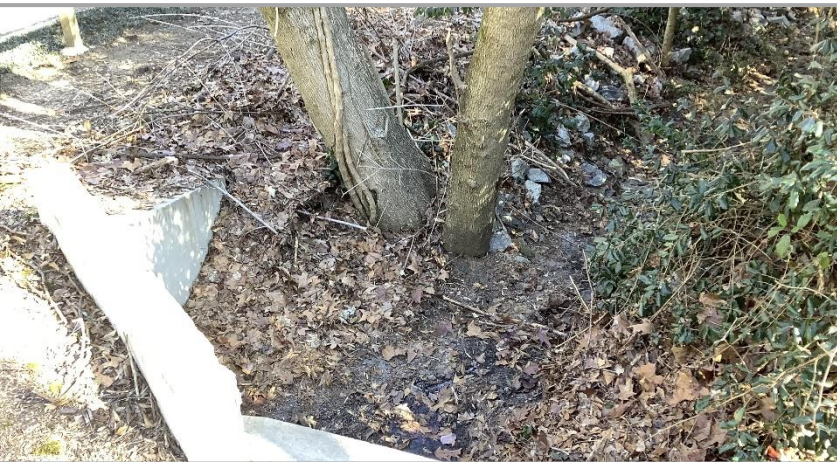
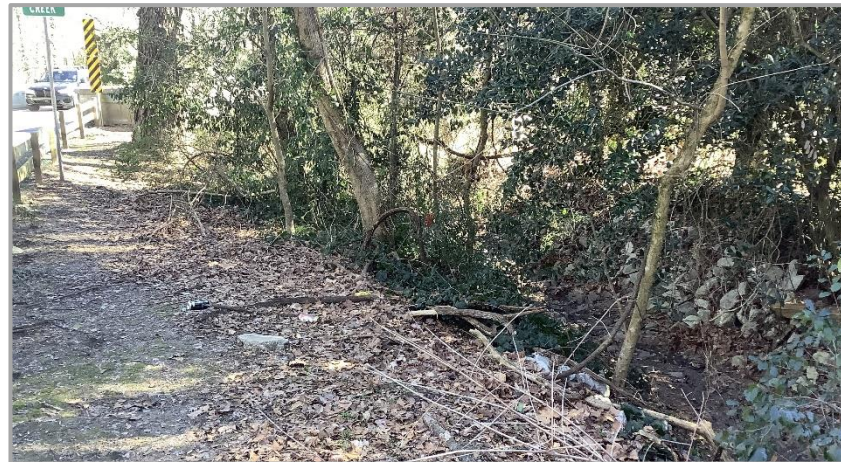
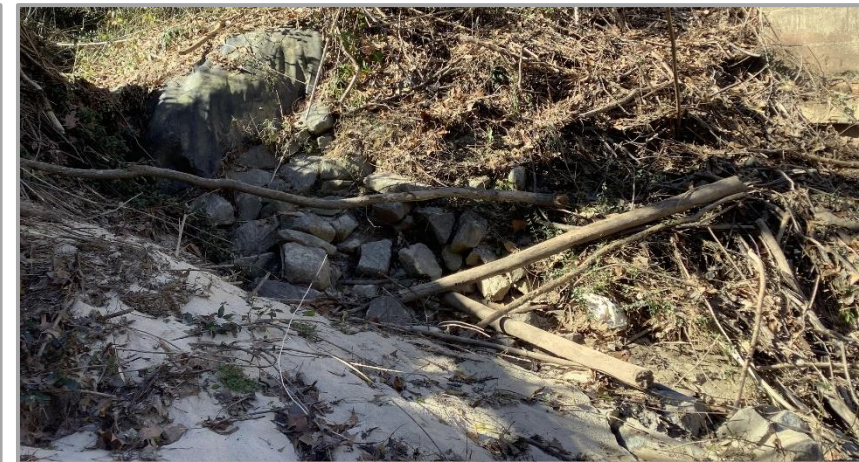
- Regenerative stormwater conveyance (RCS) required as part of the 319 Grant
- Location was conceptual
- Viability Assessment
- Constraints:
  - Existing path
  - Windsor Parkway
  - Existing vegetation

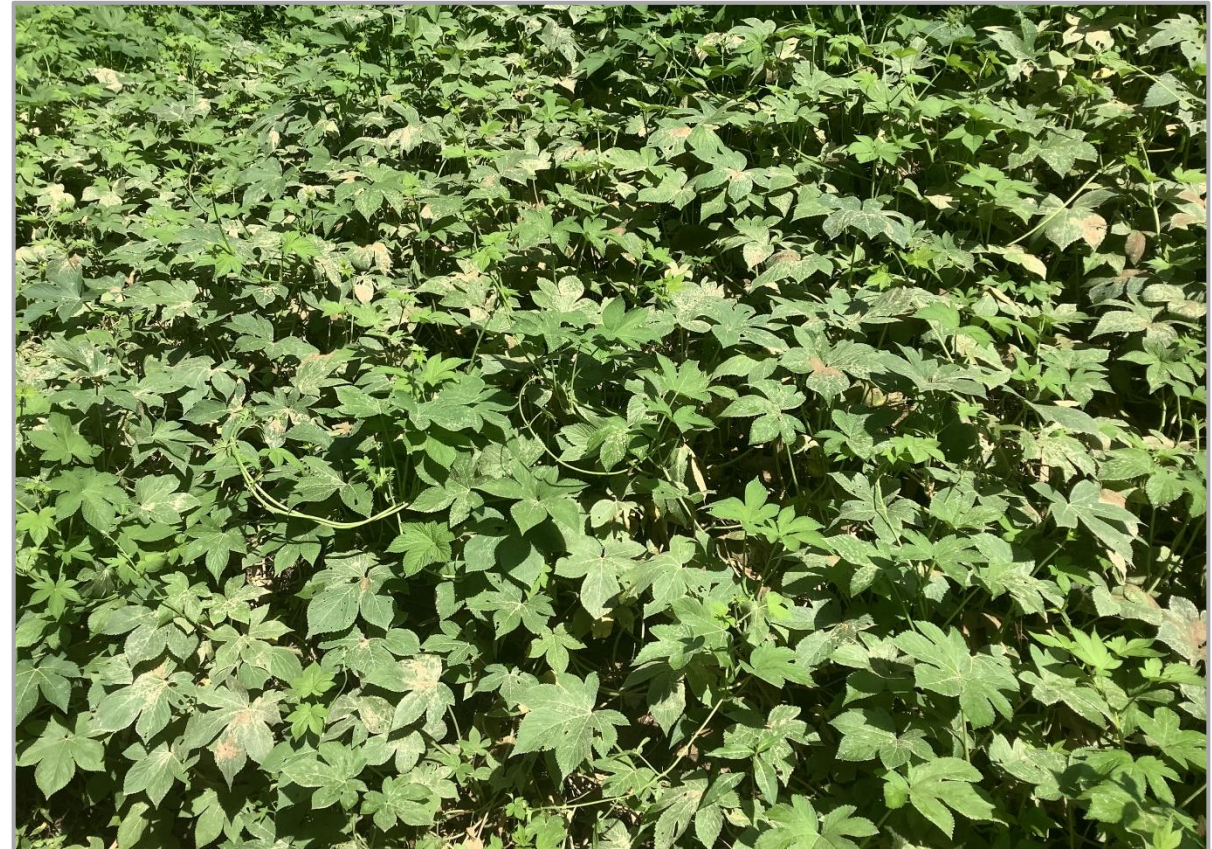
Several Invasive Species Identified along the stream bank through the park:

- Japanese Hops (*Humulus Japonicus*)
- Japanese Honeysuckle (*Lonicera japonica*)
- Mimosa (*Albizia julibrissin*)
- Tree of Heaven (*Ailanthus altissima*)
- Japanese Knotweed (*Reynoutria japonica*)
- Chinese Privet (*Ligustrum sinense*)

Developed Invasive control plan for the City to treat prior to construction

Contractor to implement treatment:

- Prior to construction
- Post-construction prior to planting

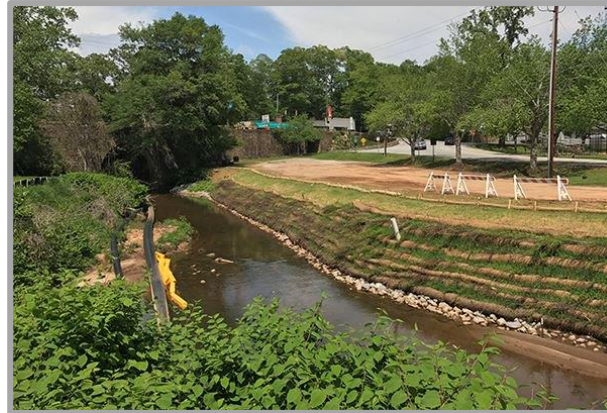
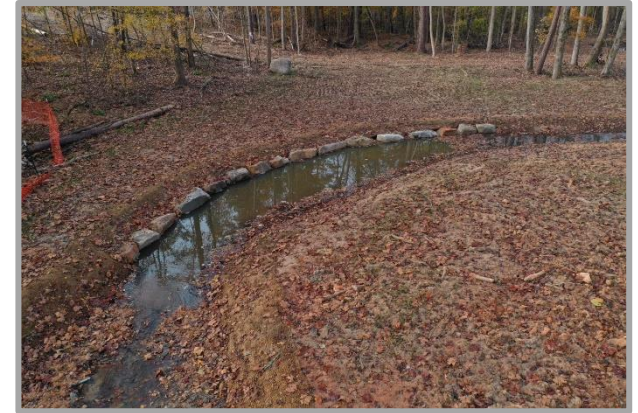
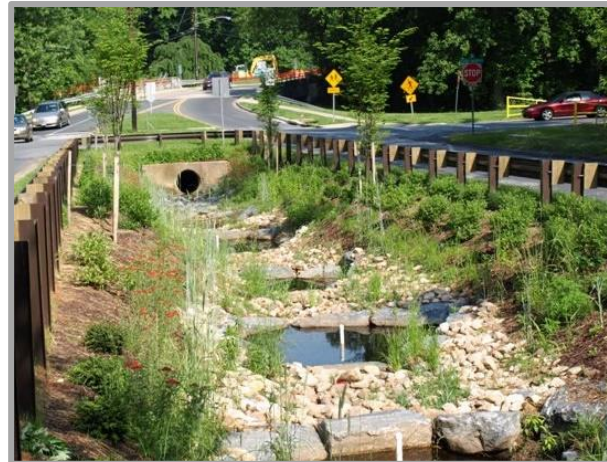
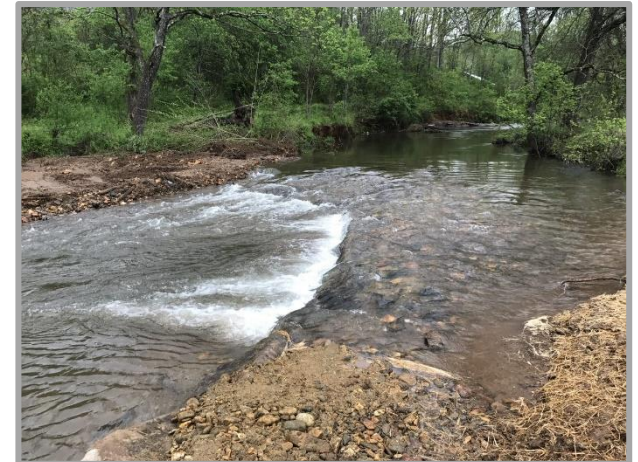
# Design Approach

Natural restoration design techniques

- Boulder toes
- Geolifts
- Rock vanes

RSC (water quality treatment)

Native vegetation and pervious materials throughout the site

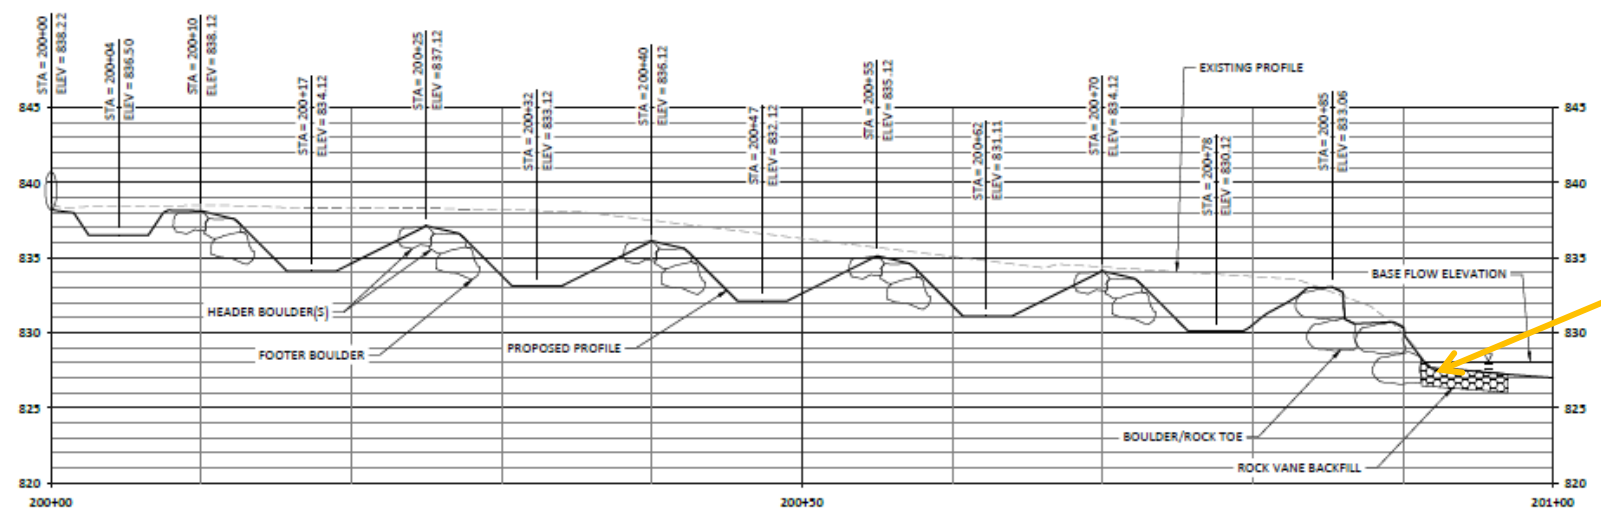
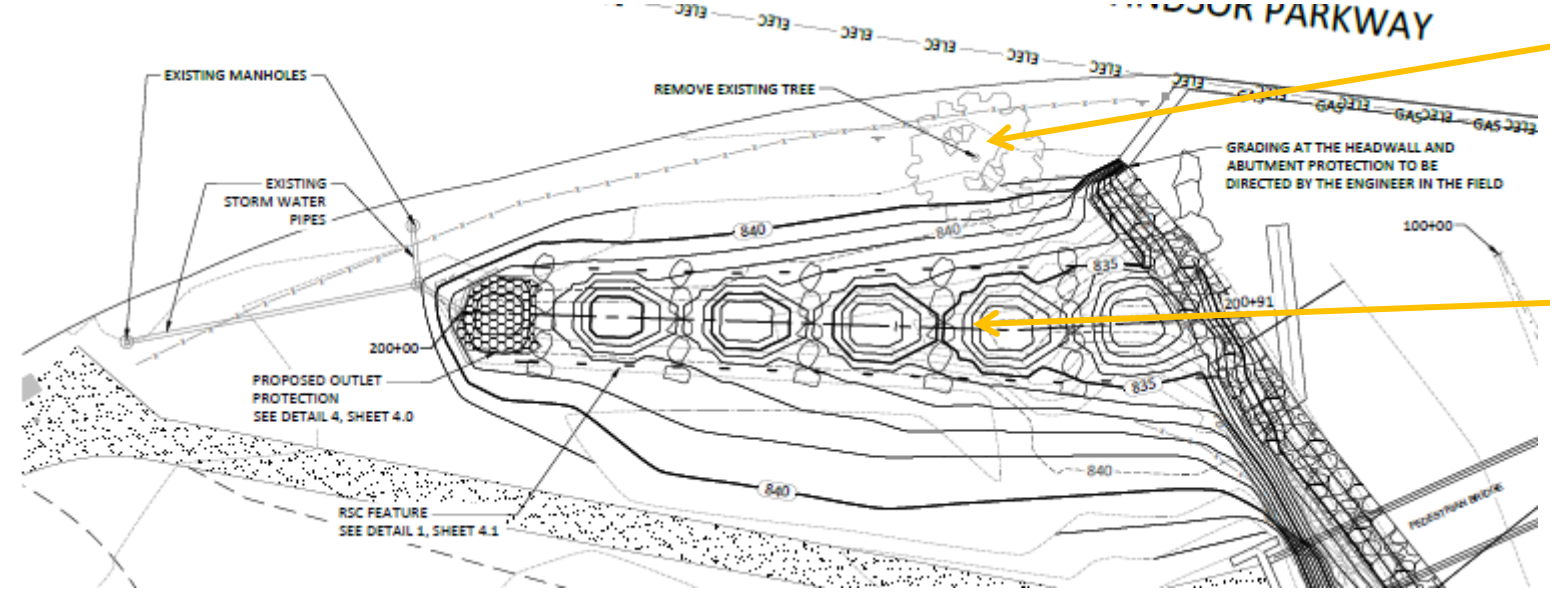
# Design Iteration: Final 60% → RSC Design

Create splash pad with rock vane backfill

Not feasible to keep the tree

Reduce the amount of rock in the RSC

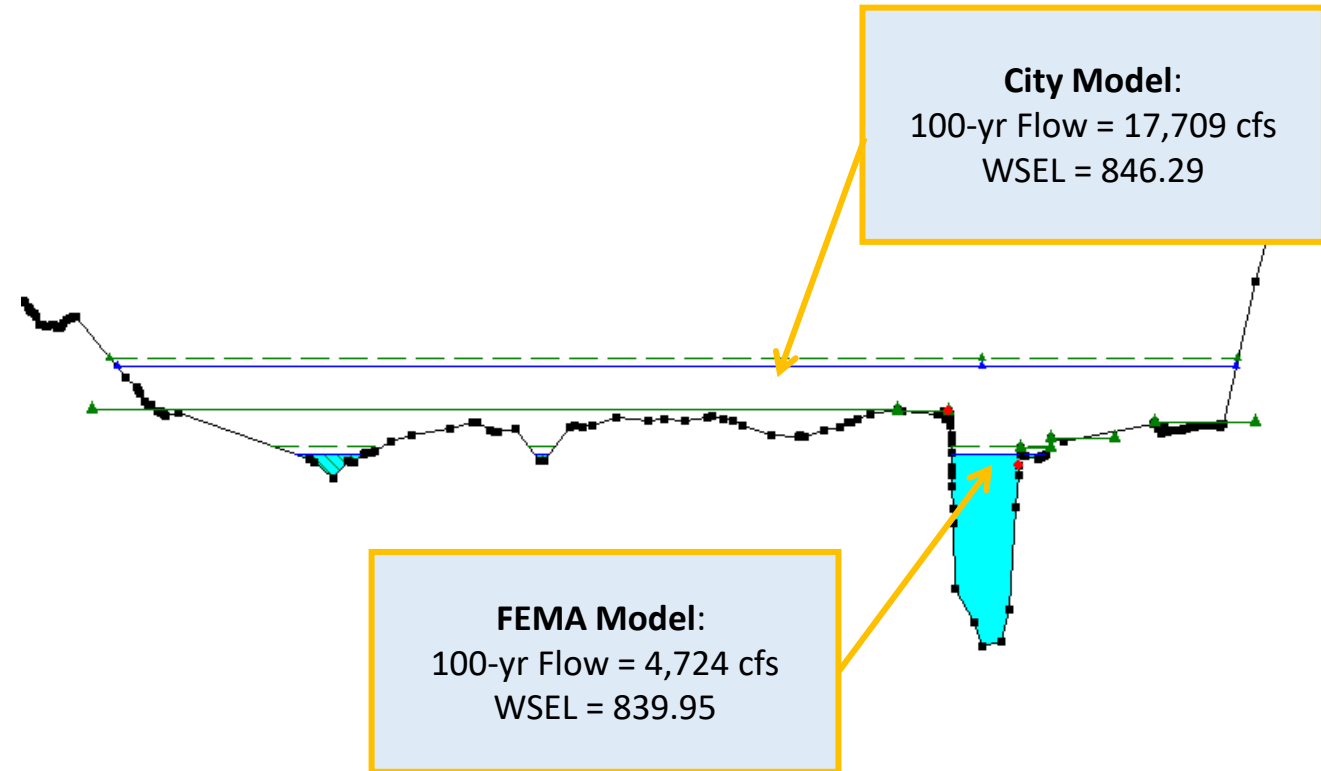
Two separate flood models for the site:

- FEMA FIS
- City Flood Study

Major Variability in discharge and elevations

- (City more conservative)

Model required to meet both for no-rise conditions

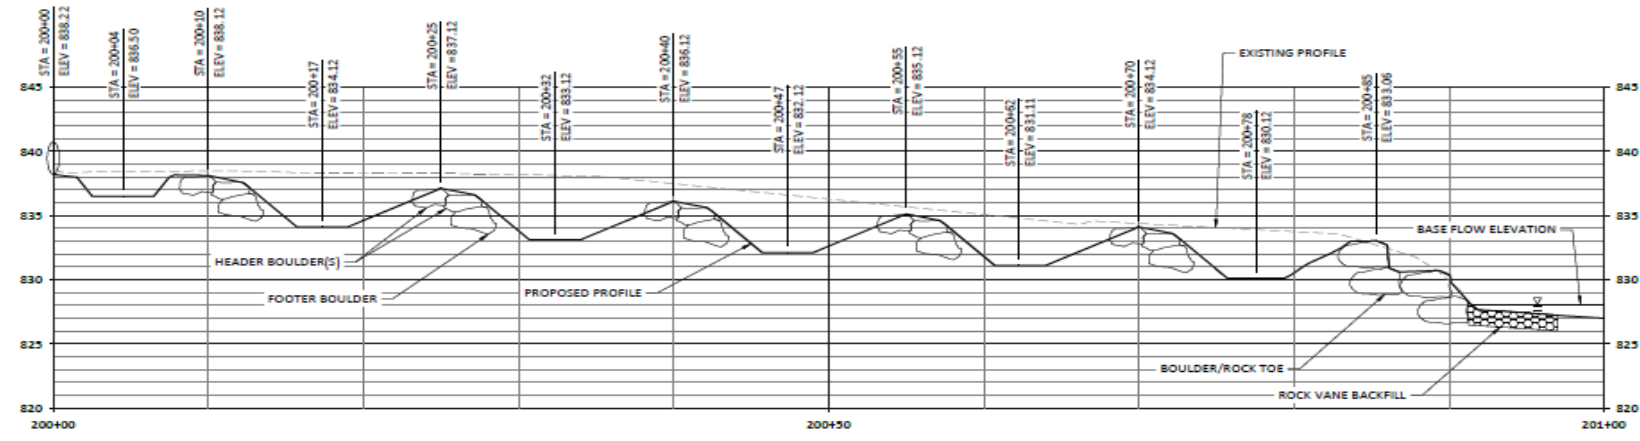
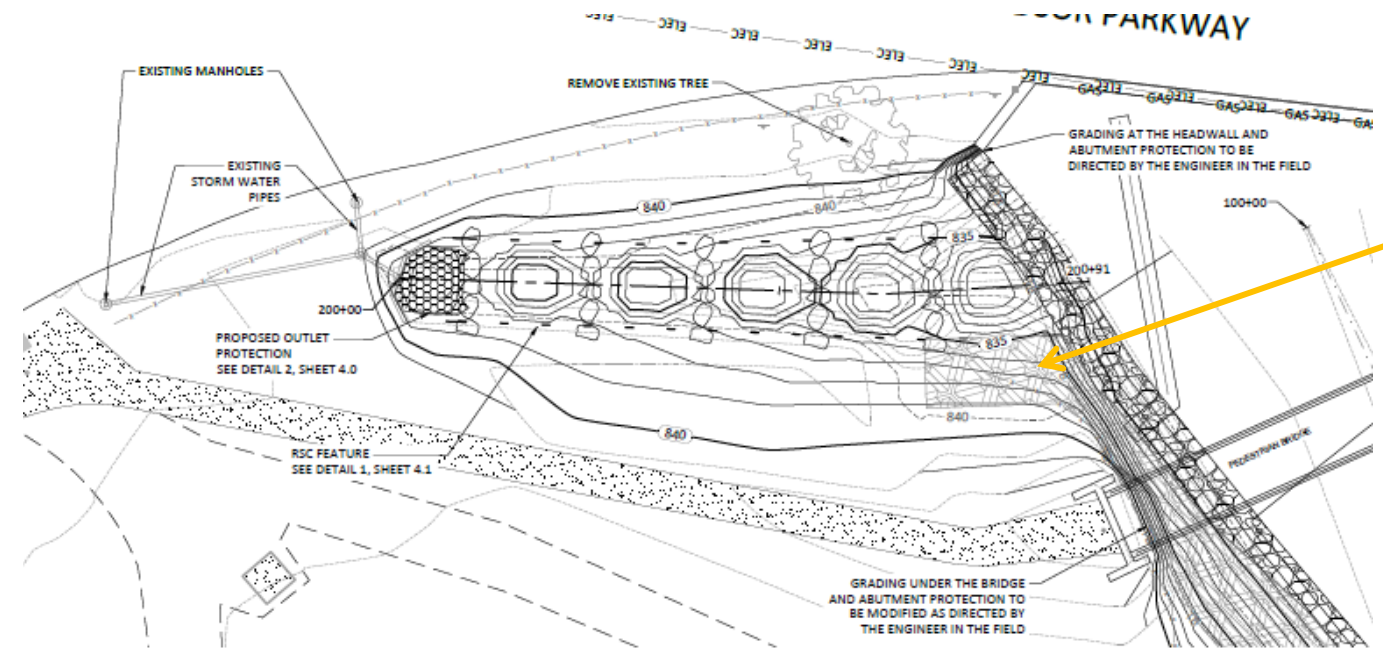
# Design Iteration: 90% → RSC Design

Hydraulic modeling to address bank shear
