Greening Kentucky's Signature Industry: Bioretention Treatment of Runoff at the Kentucky Horse Park

Southeast Stormwater Association Annual Conference

Friday, October 16, 2015 Chattanooga, TN

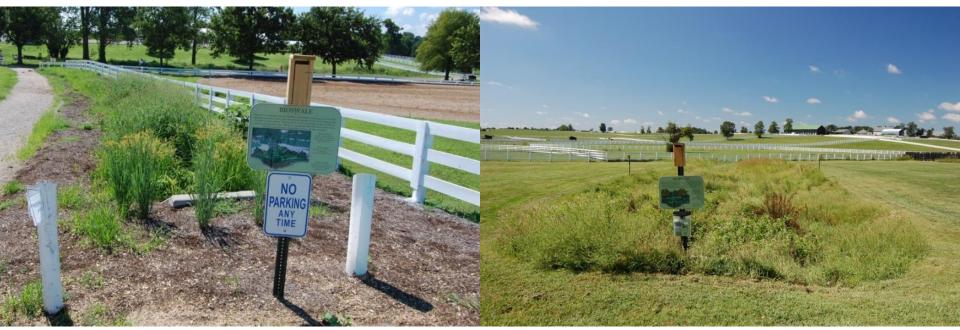
Headcut repaired with rocked bioswale

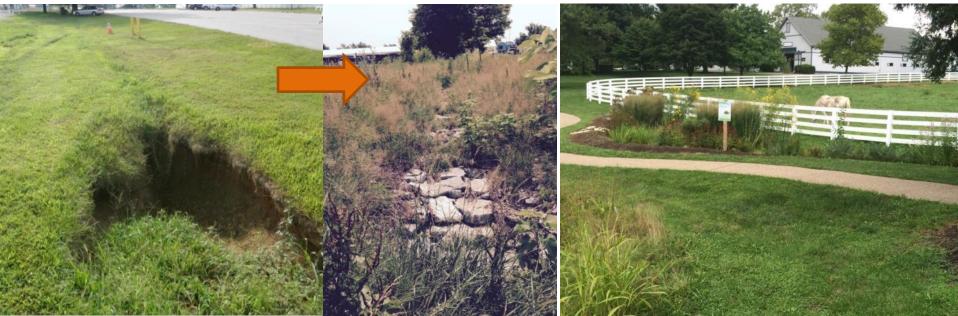
Rain Gardens

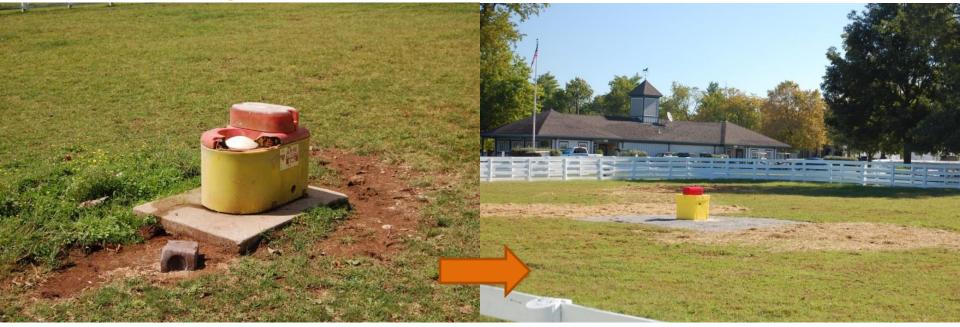
Repaired watering stations

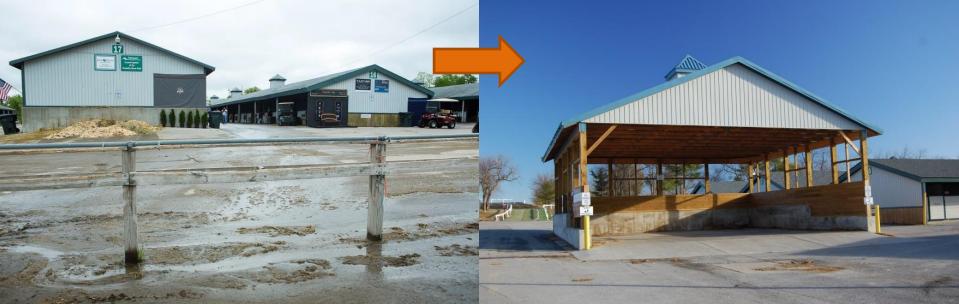
Covered Muck Storage Shed

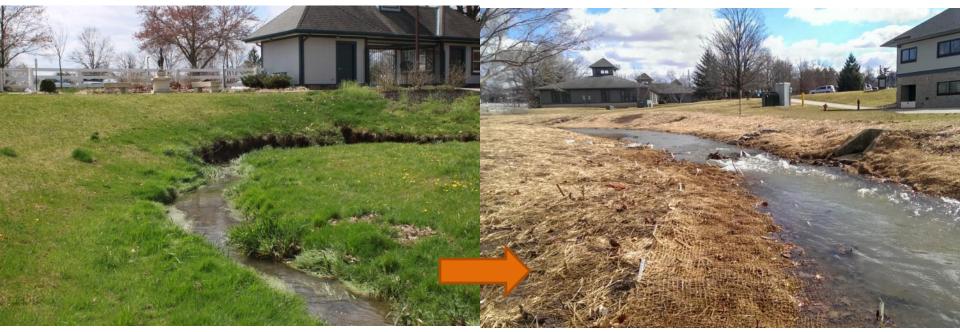
Streambank Stabilization

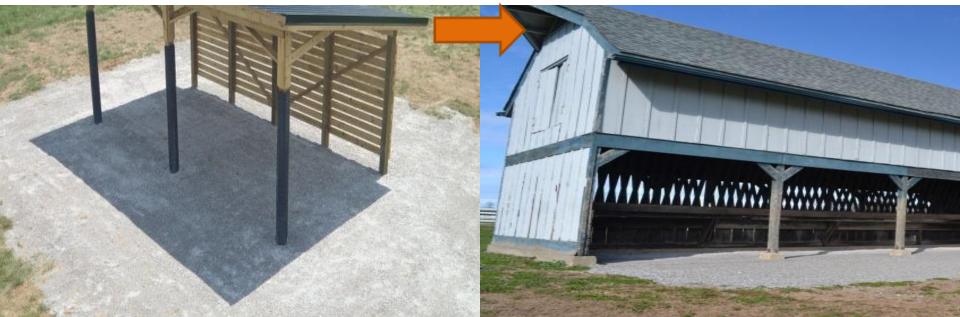
DGA Pads for Heavy Use Areas

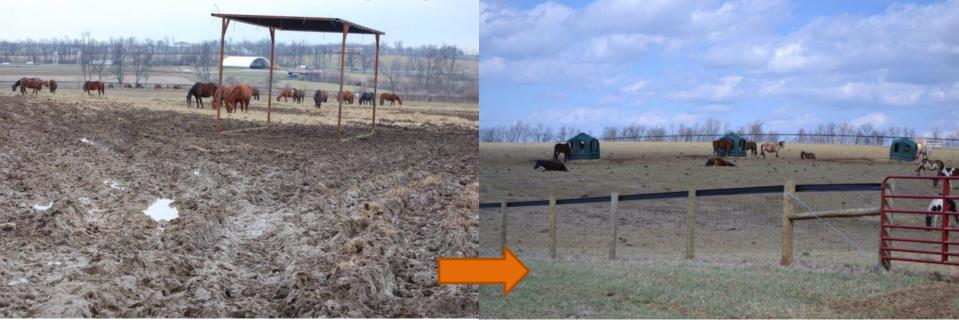
Straw huts (in lieu of spreading on ground)

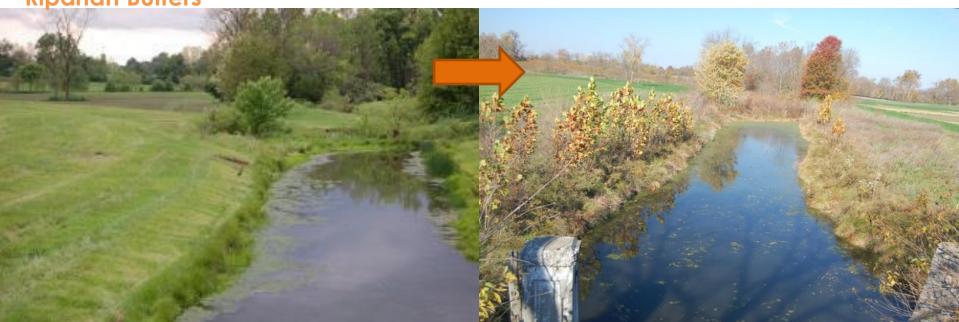
Riparian Buffers

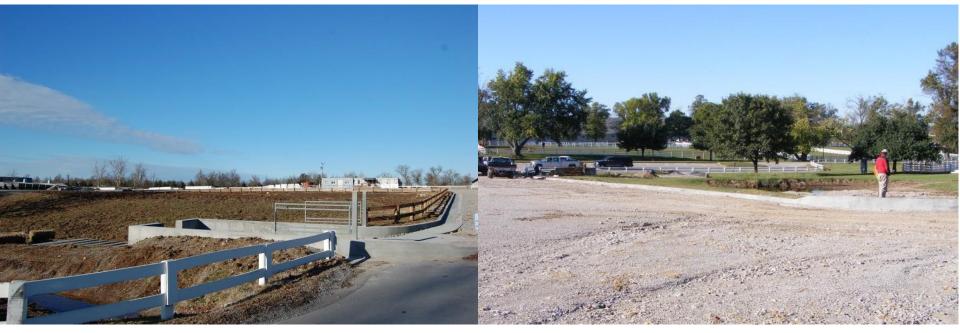
Curbing around gravel lot/concrete forebay for gravel collection/cleanout

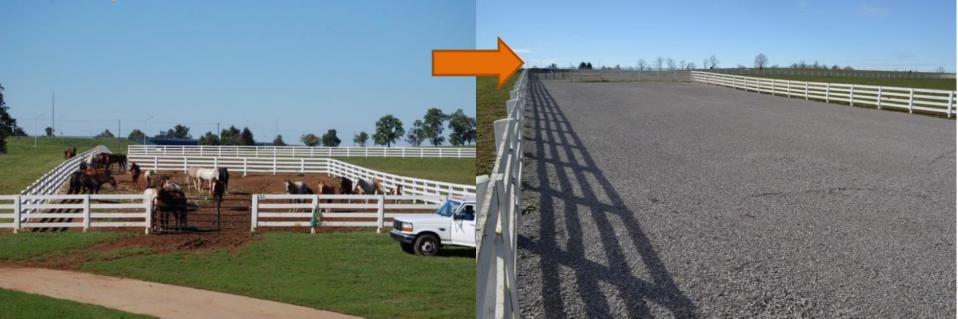
DGA Dry Lot

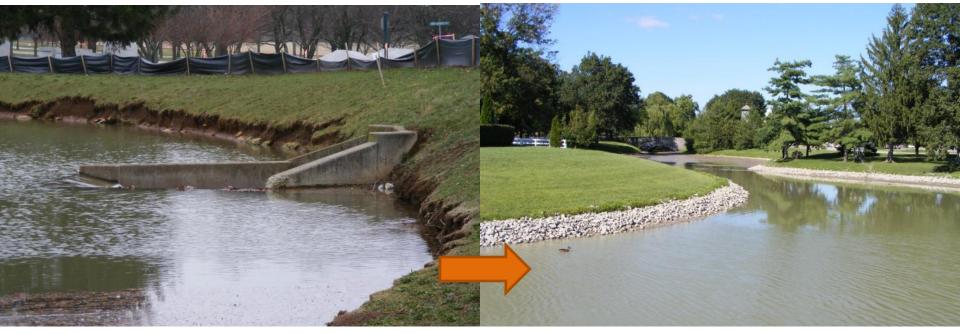
Pond bank stabilization

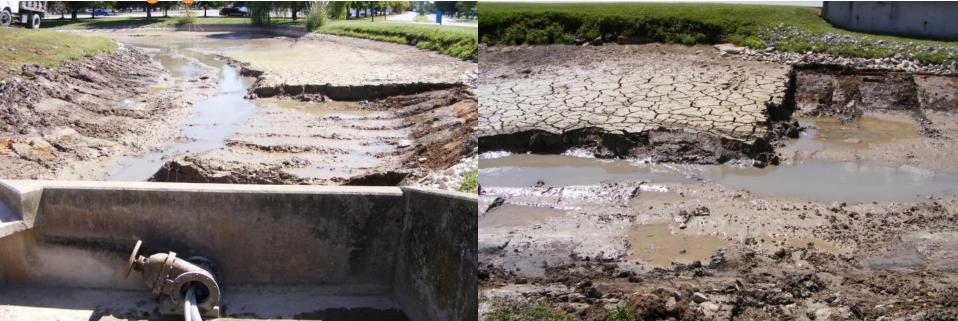
Pond dredging

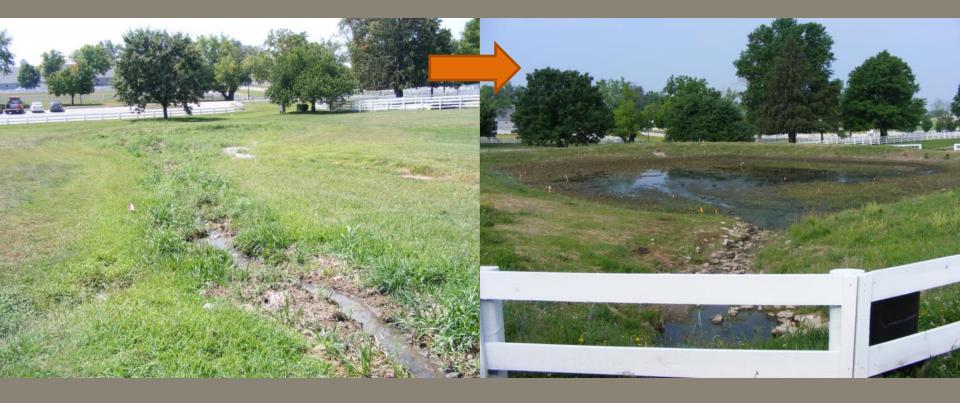
Bioretention Basin Plan View(Not to Scale)

4. Compacted Clay at Upper End of Basin with Elongated Overland Flow Path to Promote Sunlight Exposure/UV Treatment

5. Runoff Infiltrates into the Amended Soil/Filter. A Stop-Log Structure Controls the Groundwater Level in the Basin. Runoff is Collected with 6" Perforated HDPE Underdrain Pipes. Basin is Designed to Drain in <48 hours.

6. Excess Ponding (>1.5' deep) is Controlled by the Principal Spillway, and the 20' Wide Emergency Spillway.

3. Native Limestone Forebay to Collect Muck/Sediment

-1. Barn Outfall (18" CPP): Drainage Area = 6.4 acres Impervious Area = 4.3 acres, 67% Water Quality Volume = 0.59 acre-feet 100-yr, 24-hr Runoff Vol. = 2.3 acre-feet Basin Volume = 0.46 acre-feet

Compacted Clay Embankment w/ 8' Crest

-New Concrete Curbing to Prevent Erosion into Basin

Repaired Headcut with Native Limestone Channel
