Long Indian Creek Watershed Improvement Plan

If a dog poops in the forest does it still contaminate your watershed?

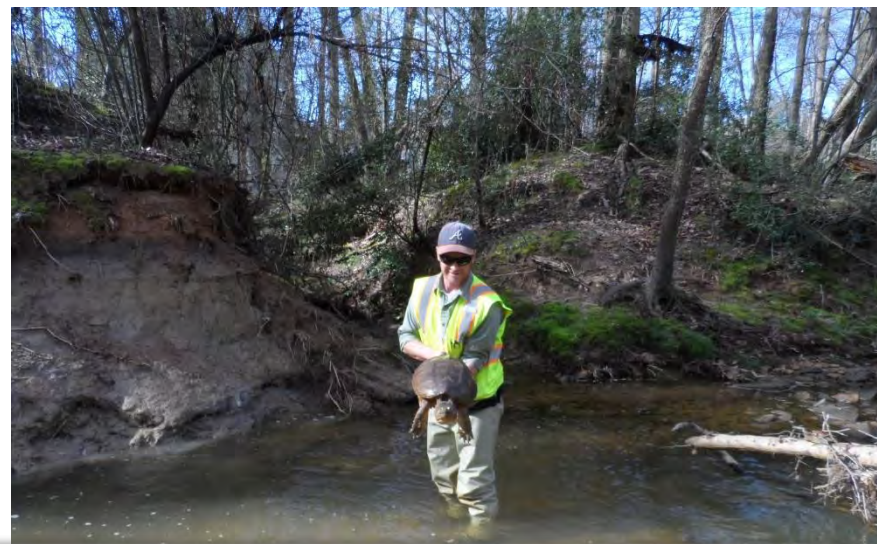
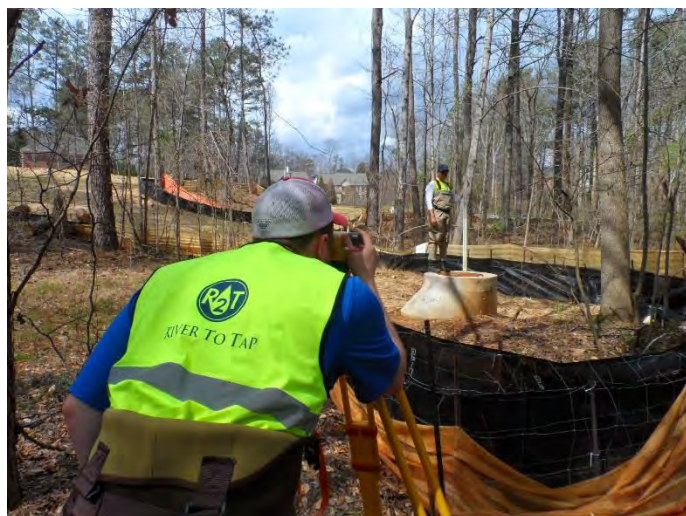
- Assess stream conditions
 - Habitat and Stability
 - Cross Section and Bank Height
 - Estimate Bankfull Width
 - Bank Erosion Hazard Index
 - Riparian Buffer Conditions

1538603
LONG INDIAN CREEK
Worksheet 21. Summary of bank erosion hazard index (BEHI) SITE 1
3/14/2016 LEFT BANK

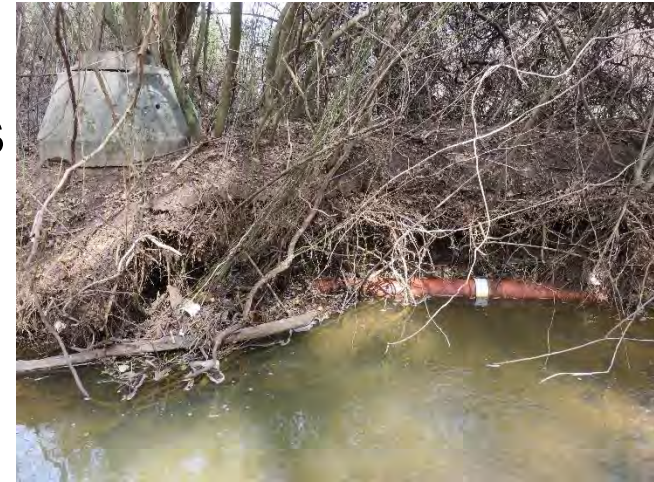
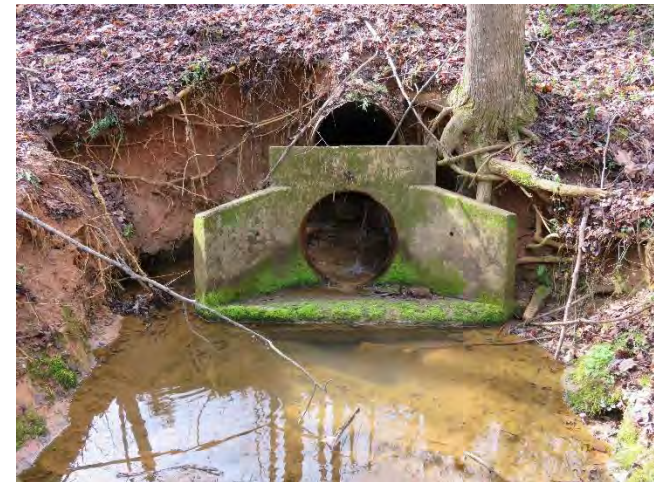
Data Collection: Stream Walks

- Identify Problem Areas/Opportunities
 - Potential Pollution Sources
 - SSOs, Illicit Discharges
 - Areas accessible to domestic animals
 - Debris Jams and compromised infrastructure
 - Outfalls causing significant erosion
 - Incision or Aggradation
- BMP, System Investigations
 - Size, Material, Shape, Condition, Invert
 - Maintenance Concerns and Potential for Retrofit

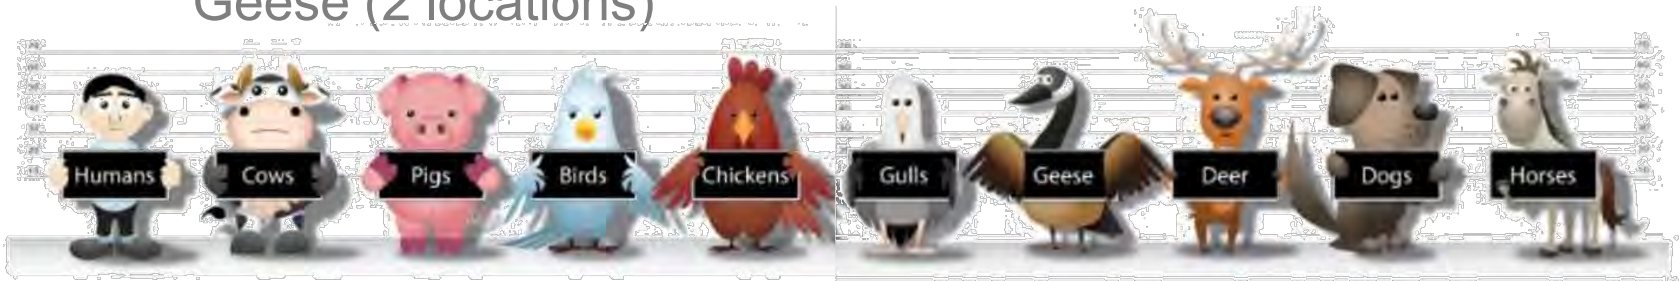
- Bacterial Source Tracking (BST)

- Tested for: Human, Dog, Bird, Ruminant (3 locations), and Geese (2 locations)

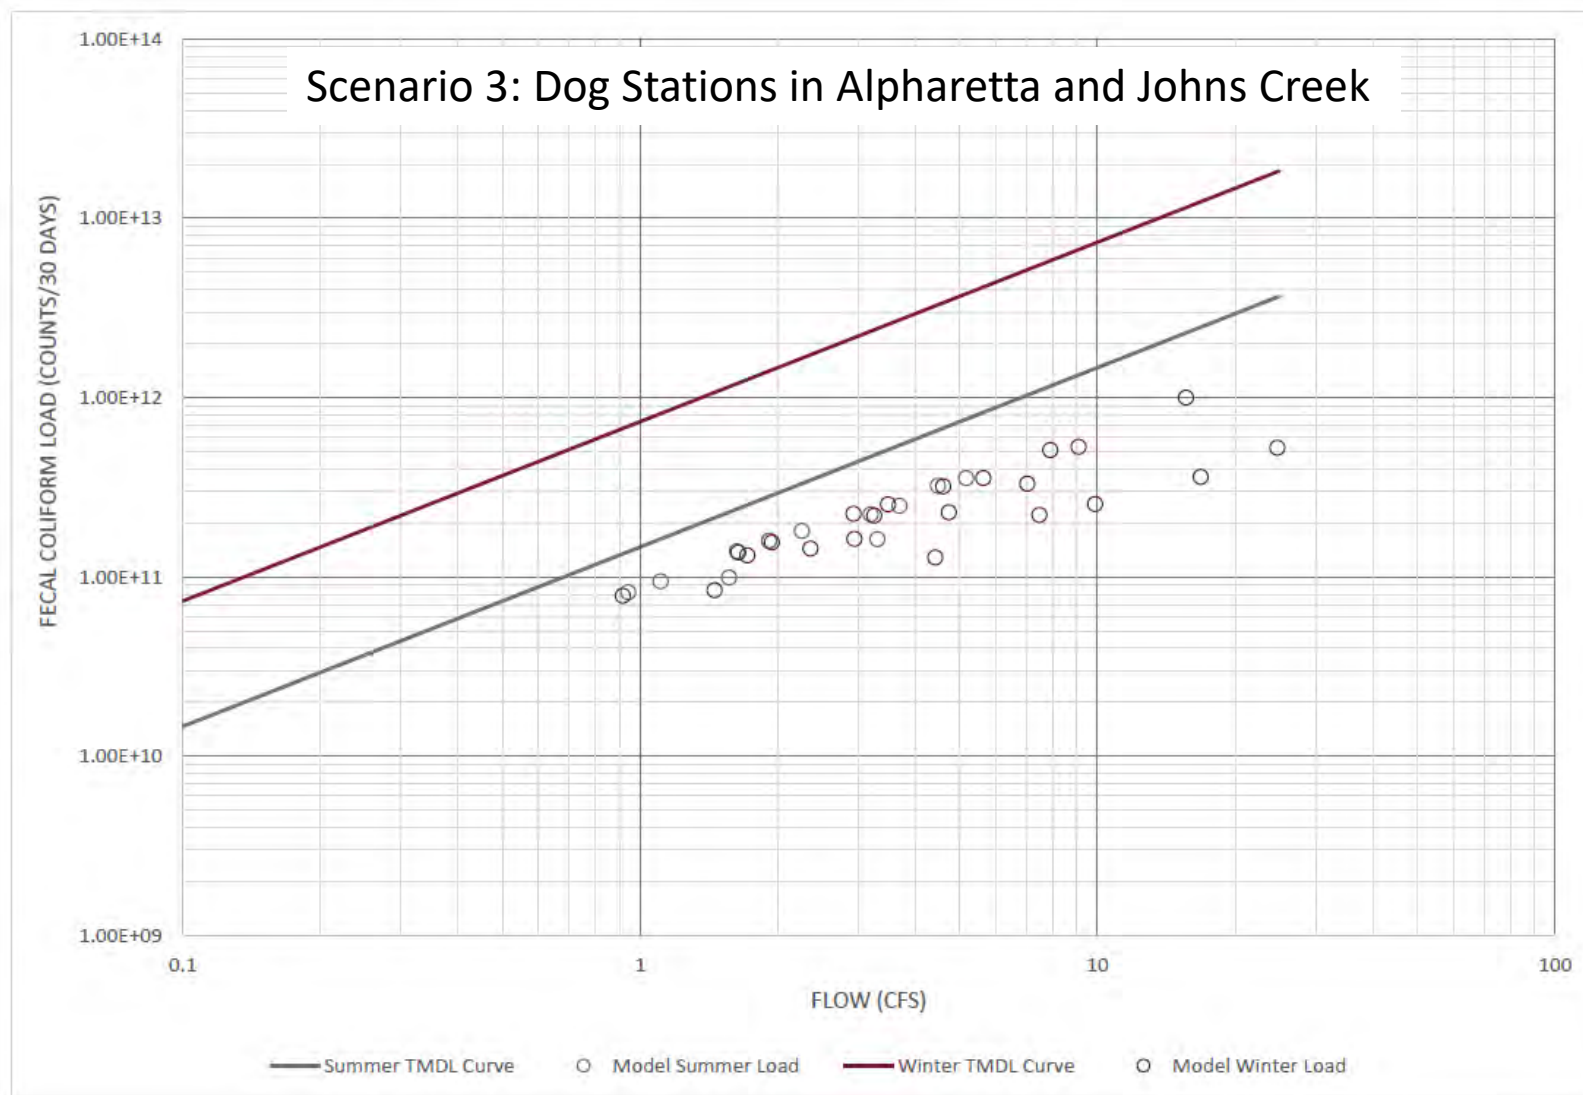
- City of Alpharetta wanted to meet the TMDL requirement while minimizing project costs
 - Limit investments in structural solutions due to cost and land availability concerns
- Explore feasibility of dog waste stations to meet TMDL goals
 - Modeled pollutant loading for three (3) scenarios:
 - Scenario 1: Existing Conditions
 - Scenario 2: Dog Waste Stations Installed only in the City of Alpharetta
 - Scenario 3: Dog Waste Stations Installed in the City of Alpharetta and the City of Johns Creek
 - Estimated a 60% reduction in fecal loads where dog waste stations are installed

Landcover Type	Washoff Coefficient
Lawn with Dog Stations	1600
Impervious with Dog Stations	400
