# The Ripple Effects of Collaborative Stream Restoration

## Brushy Creek

# Brushy Creek Stream Restoration

BMP Demonstration Project

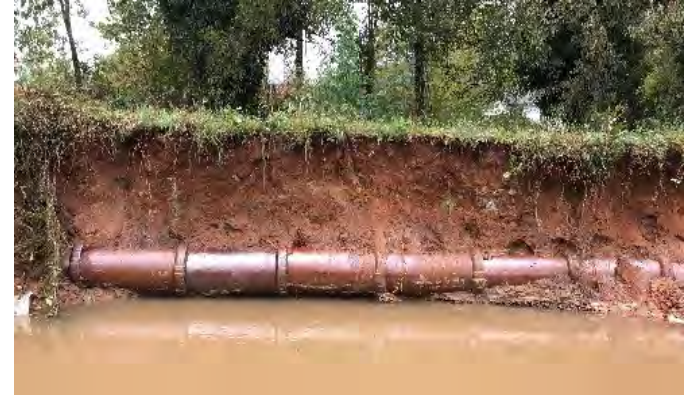
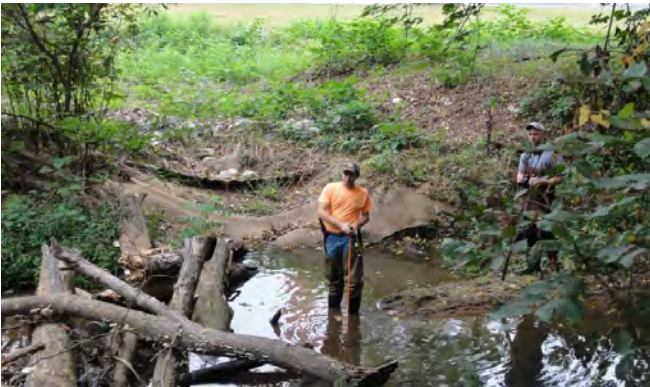
# Why Brushy Creek? The Issues

- Degrading stream banks
- Exposed sewer lines
- Older development in watershed
- Confined stream corridor
- In-stream debris and trash
- Multiple stakeholders – 5R Participants

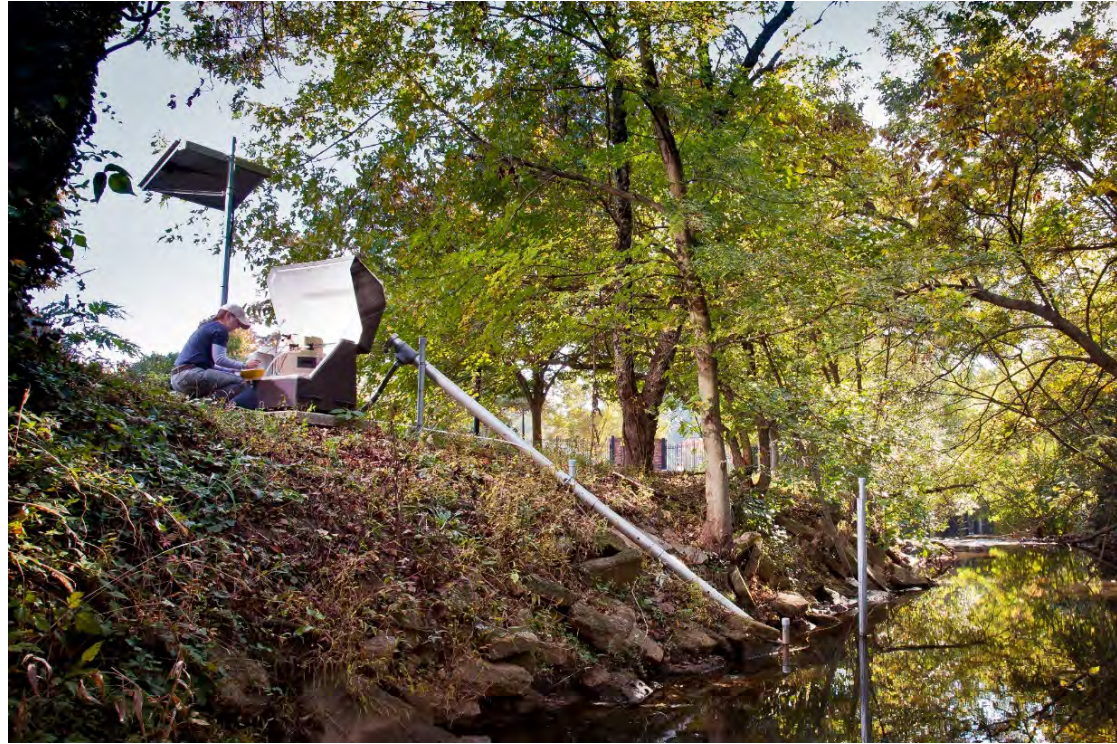
# Greenville County Monitoring Station

- Real-time water quality and gaging station installed in 2012
- Nearly 2 million individual data points collected
- More than 300 samples collected
- Enable County to evaluate the direct water quality benefits within the stream reach as a result of implementing this project

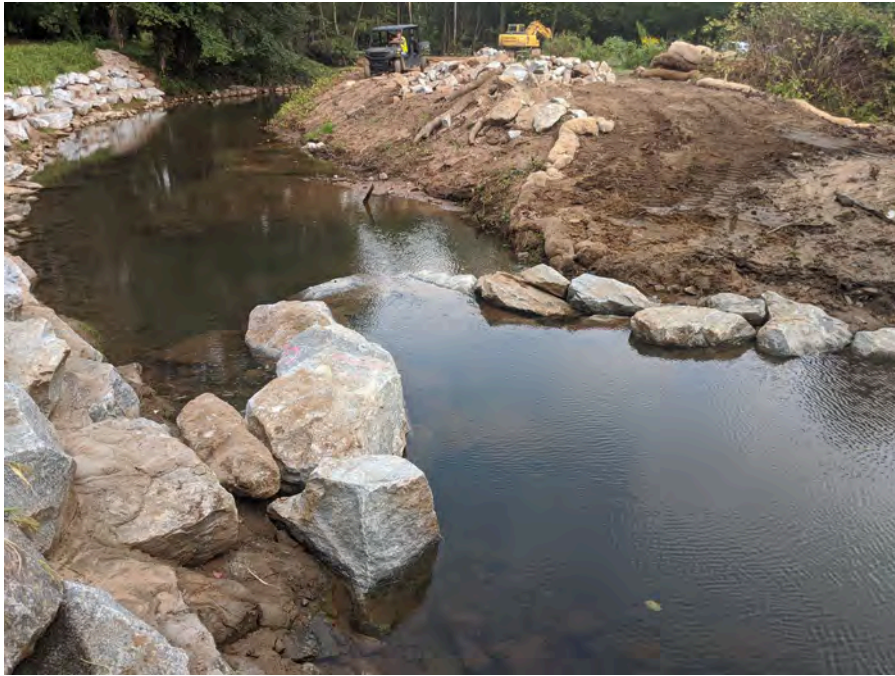
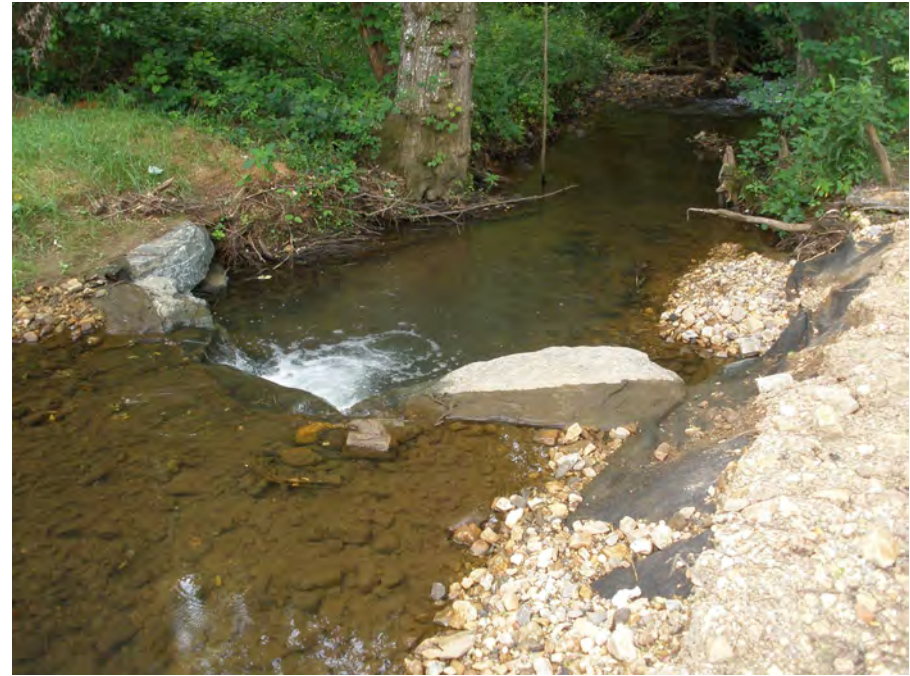
# Grade/Velocity Control: *Cross Vane*

Downstream

Upstream

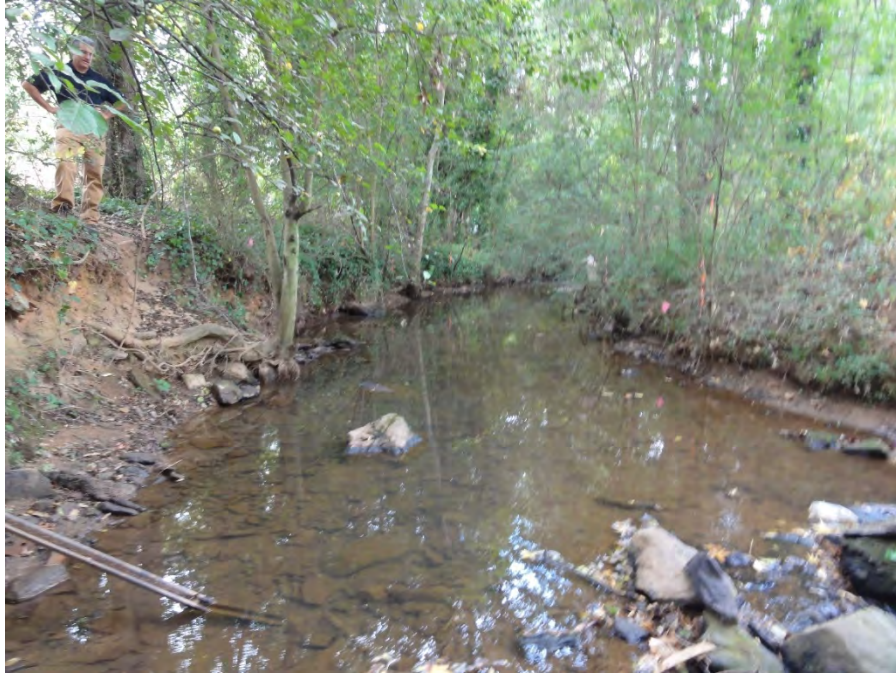
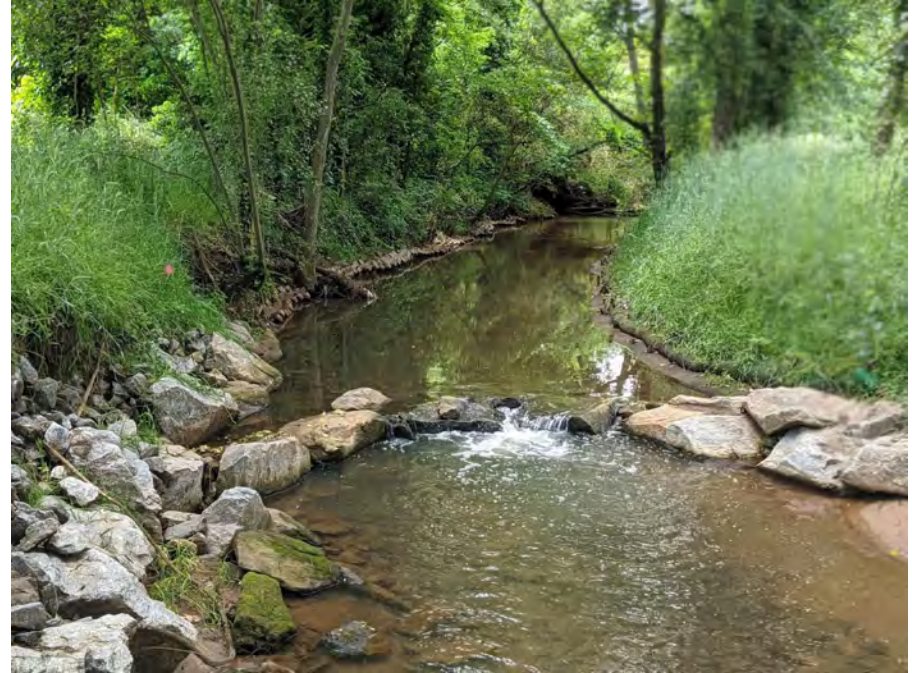
# Grade/Velocity Control: *Cross Vane*

Before

After

- Expect significant oversight for these critical applications.

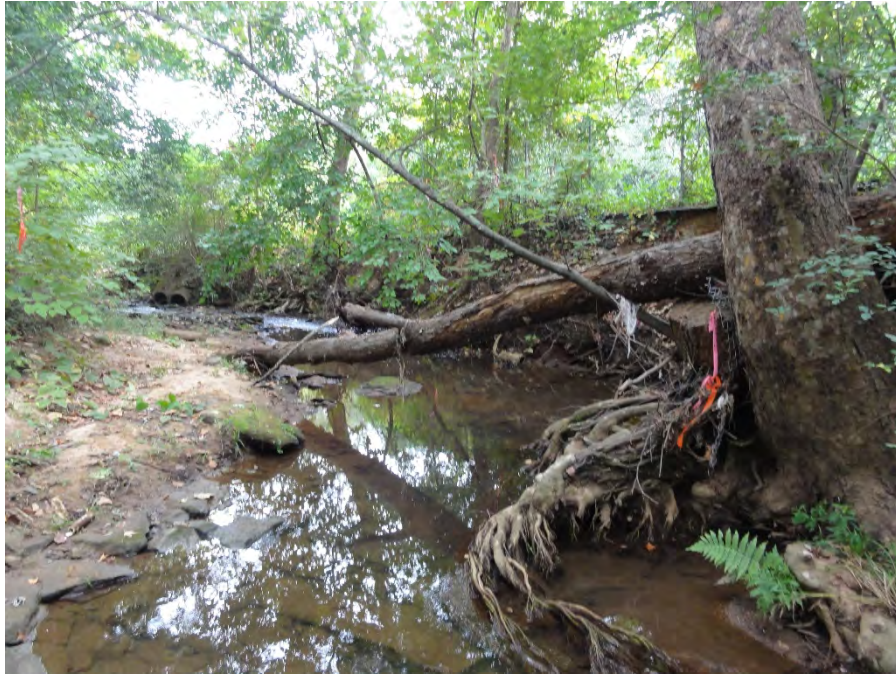
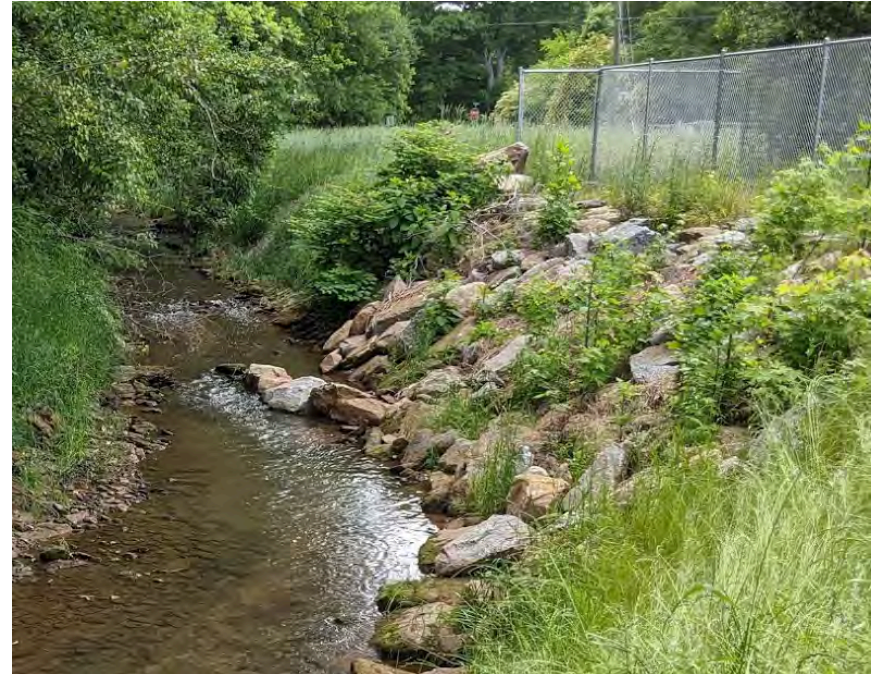
# Grade/Velocity Control: *Single Arm Vane*

Before

After

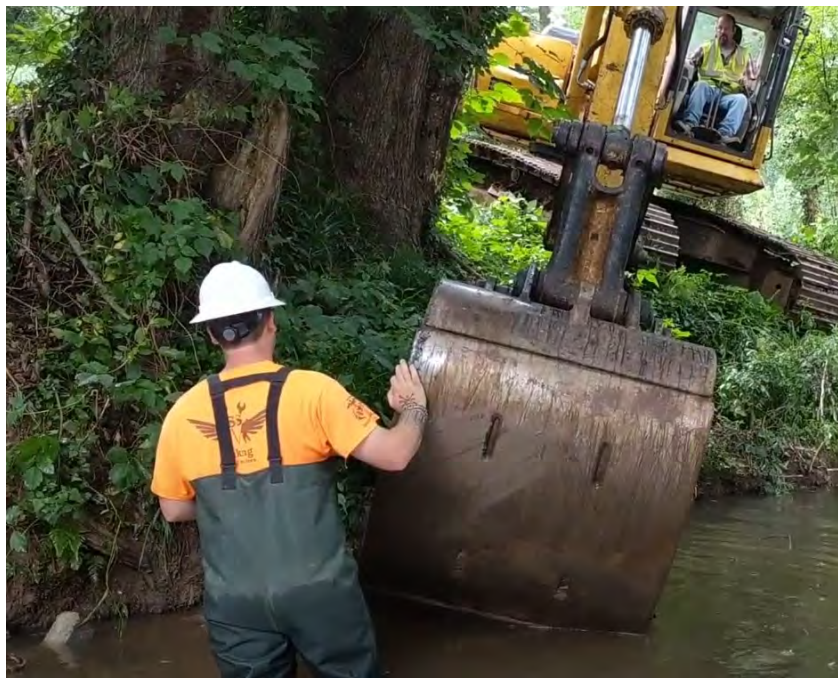
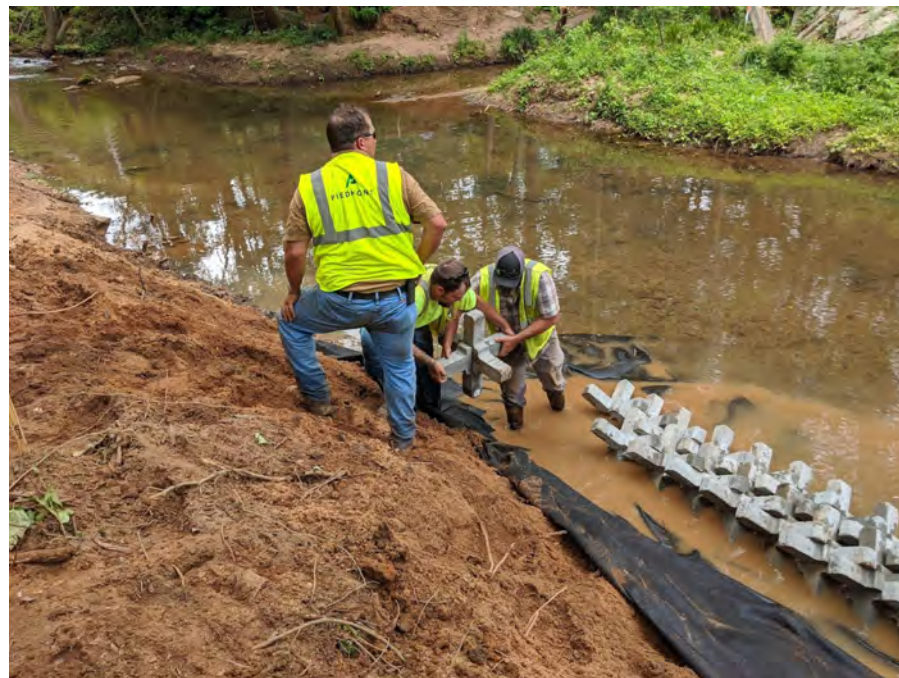
# Toe Protection: *Boulder Toe and Concrete Jacks*

Boulder Toe

Jacks

- In open areas, contractor preferred boulder toe, but recognized the benefit of concrete jacks in tight spaces.

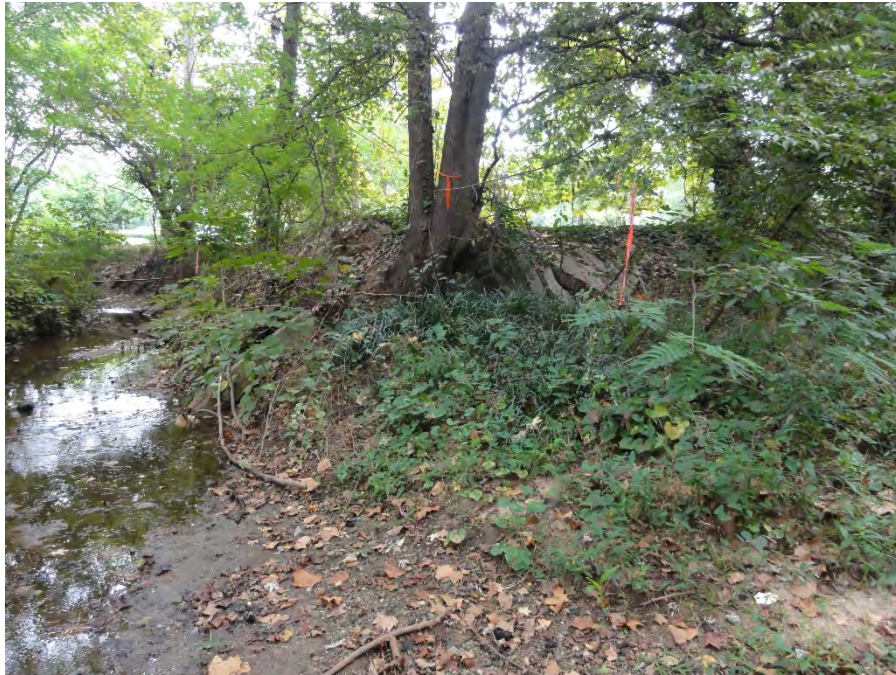
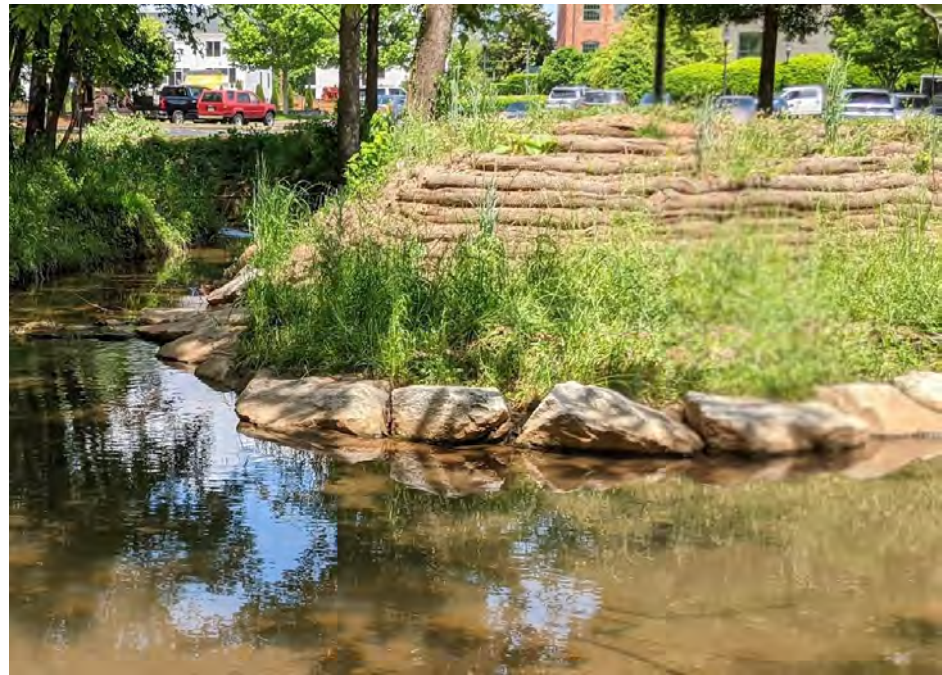
# Toe Protection: *Boulder Toe*

Before

After

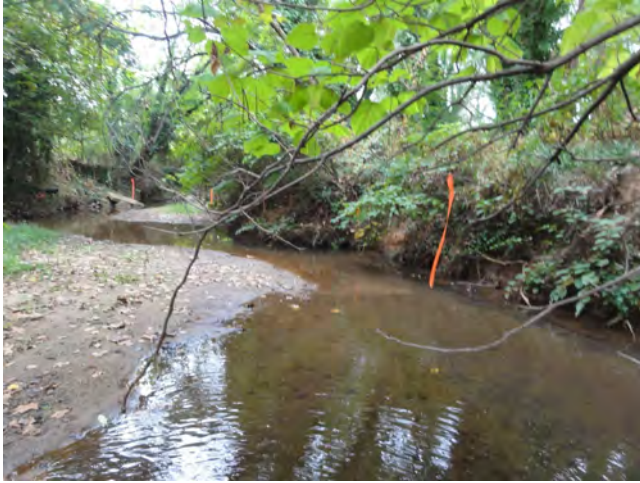
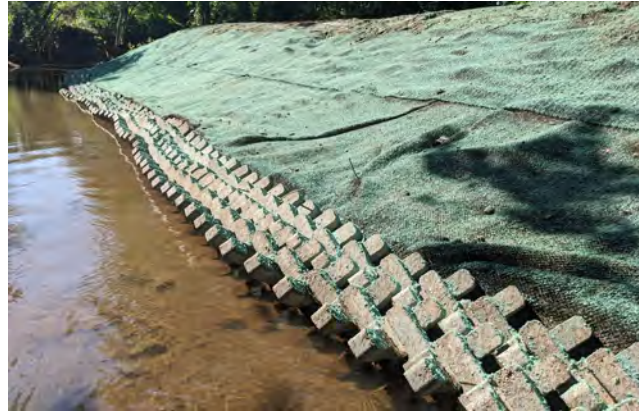
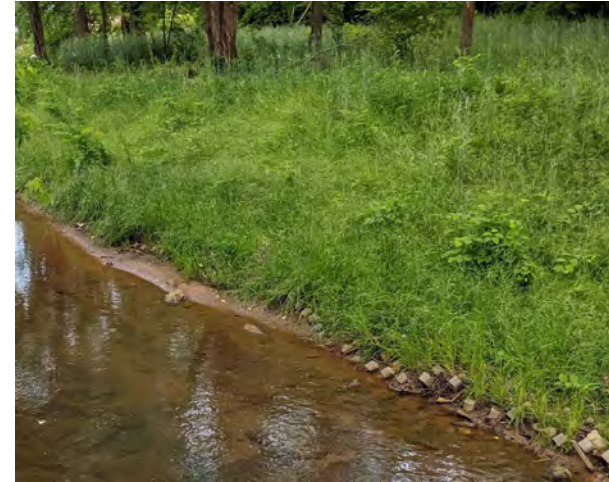
# Toe Protection: *Concrete Jacks*

Before

During

After

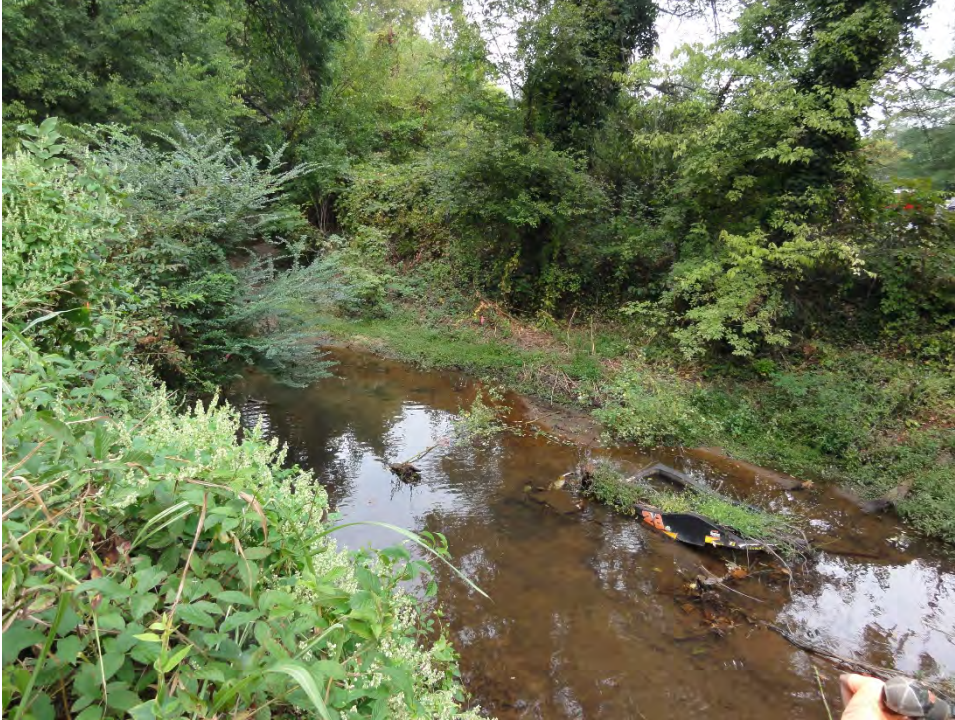
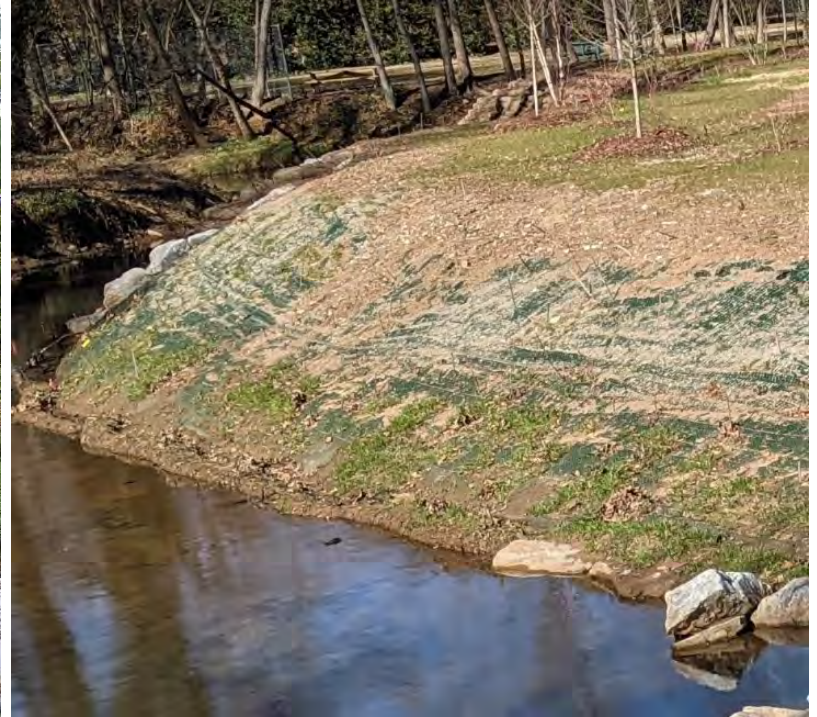
# Toe Protection: *Coir Logs*

Before

After

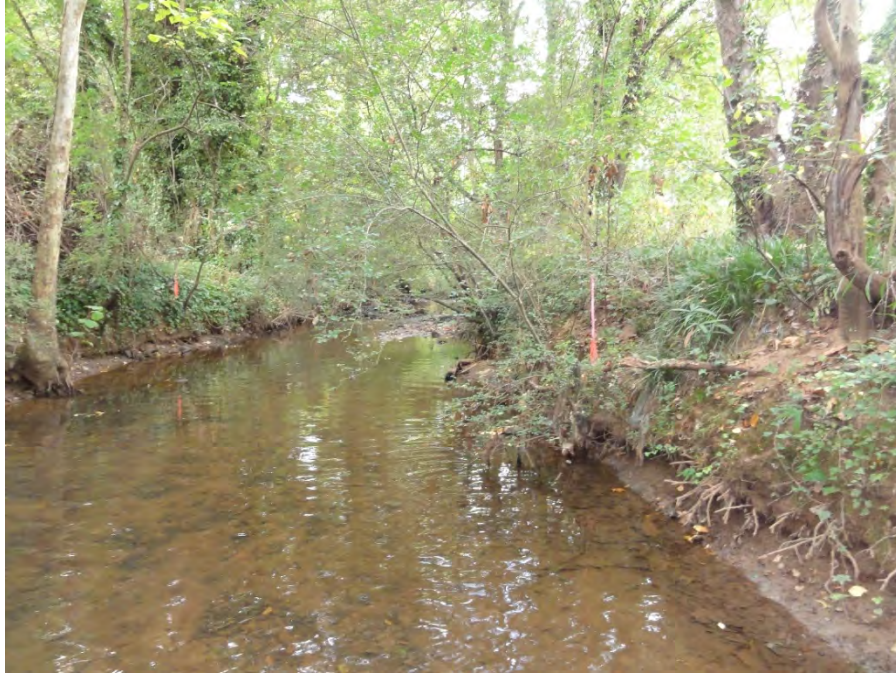
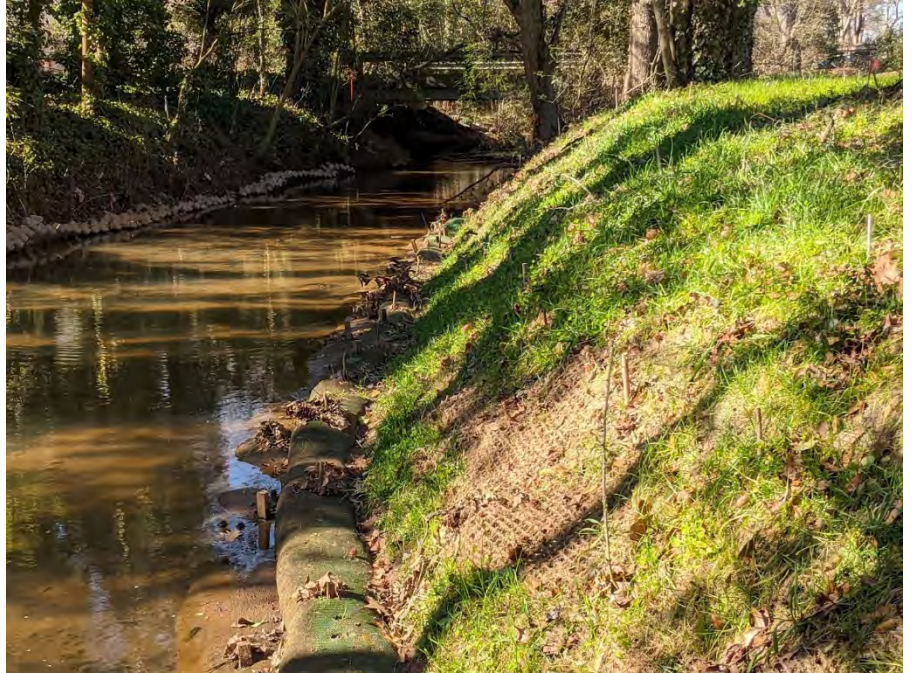
# Toe Protection: *Compost Sock*

Before

After

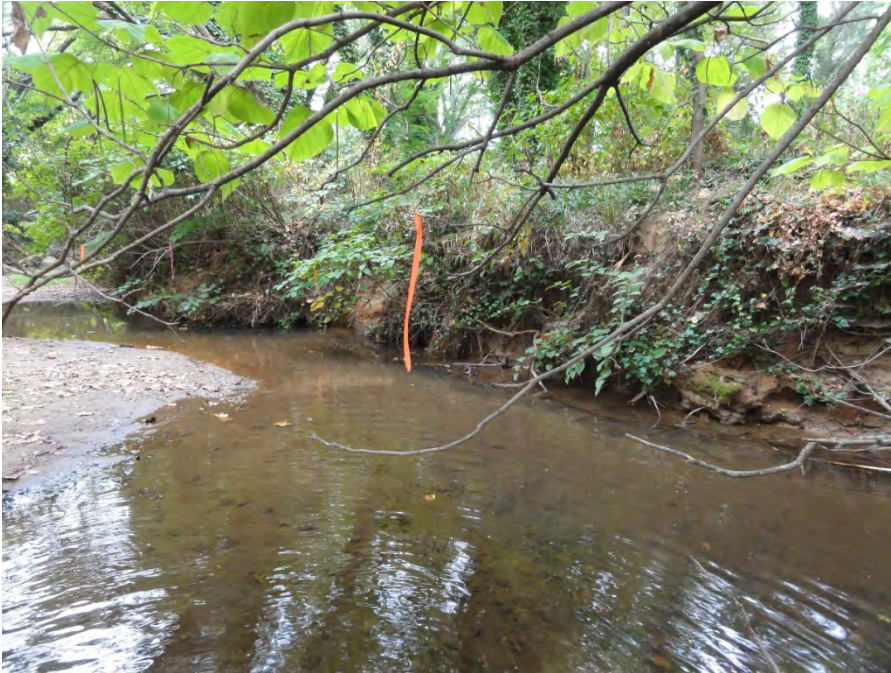
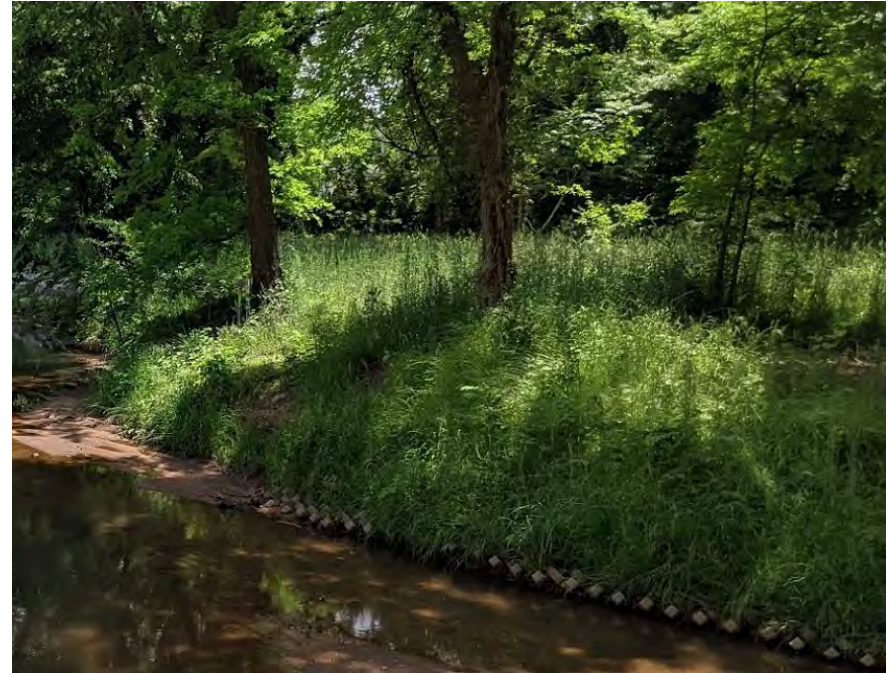
# Bank Stabilization: 3-D TRM

Before

After

- Blankets and TRMs were by in large preferred
- The 3-D nonwoven TRM resulted in the most immediate aesthetic appeal.
- Contractor did not mind soil lift installation, but it was time consuming and costly.

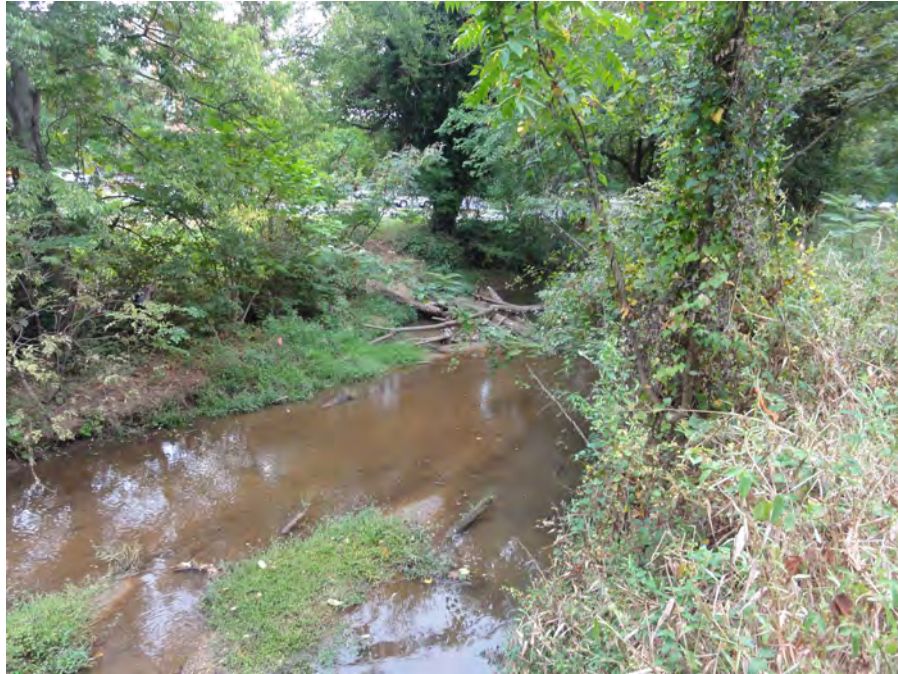
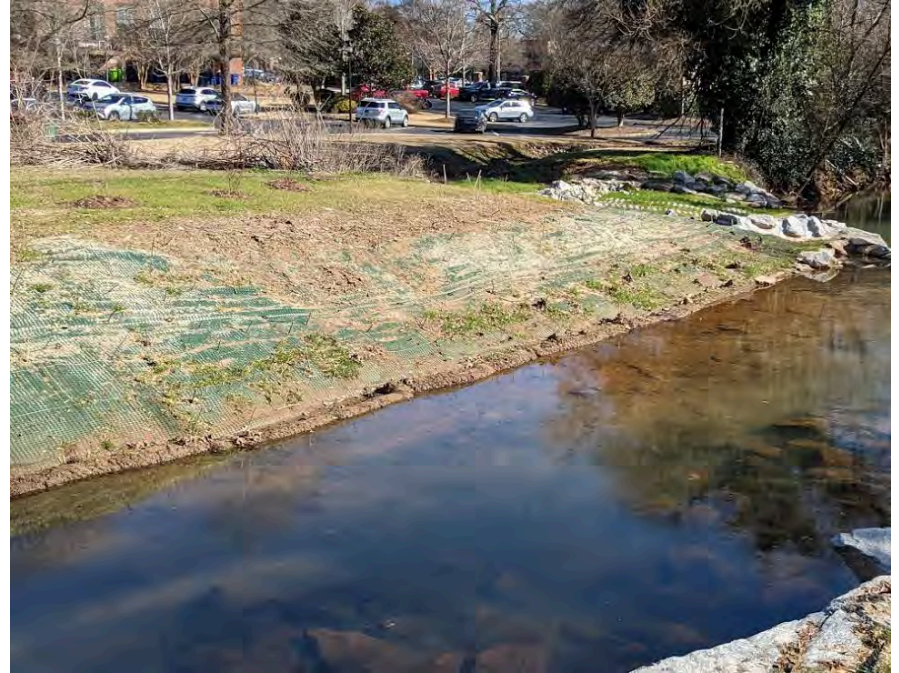
# Bank Stabilization: 3-D TRM

Before

After

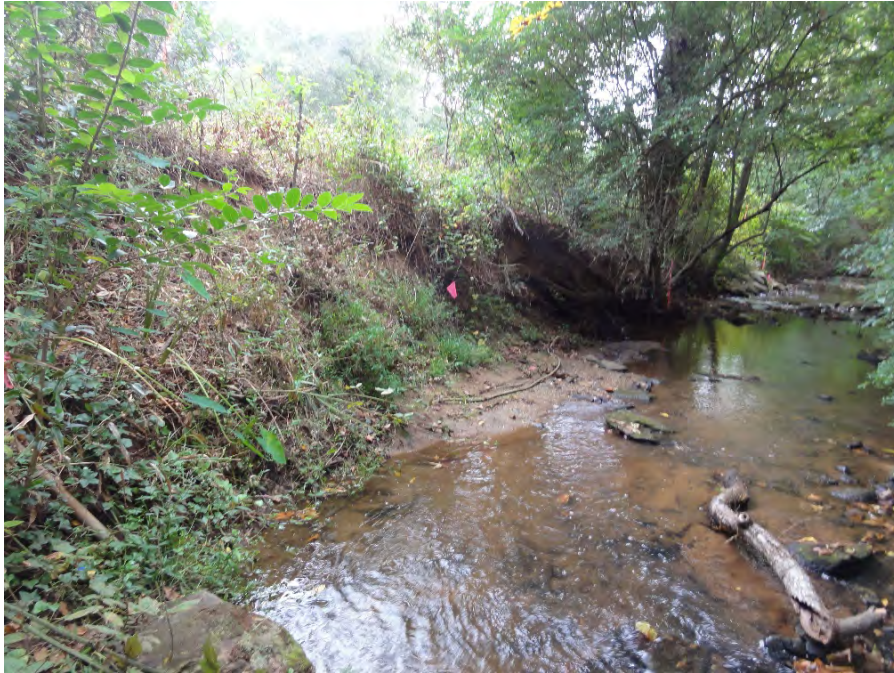
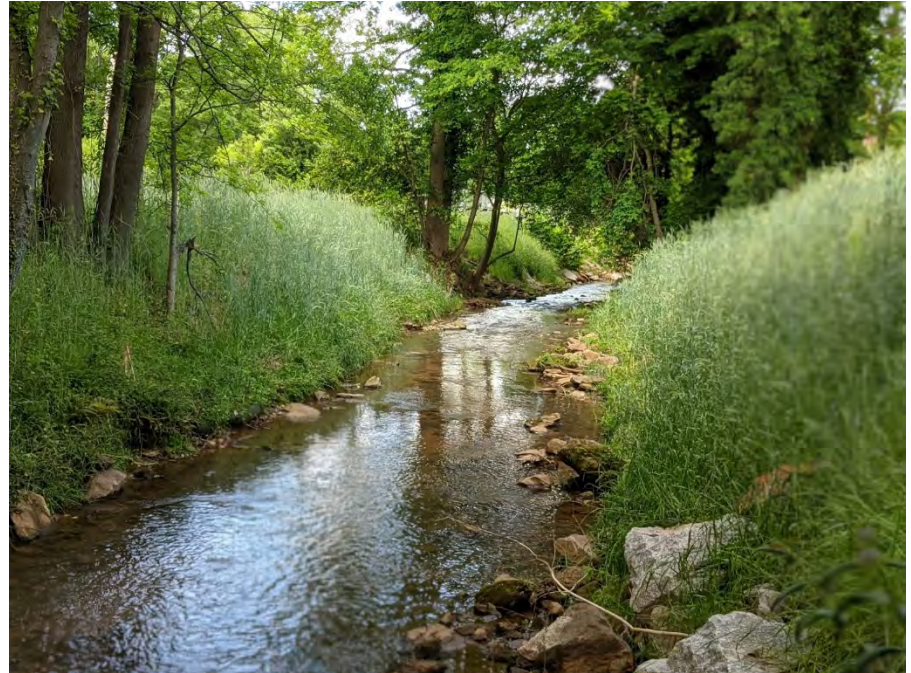
# Bank Stabilization: *Coconut/Straw TRM*

Before

After

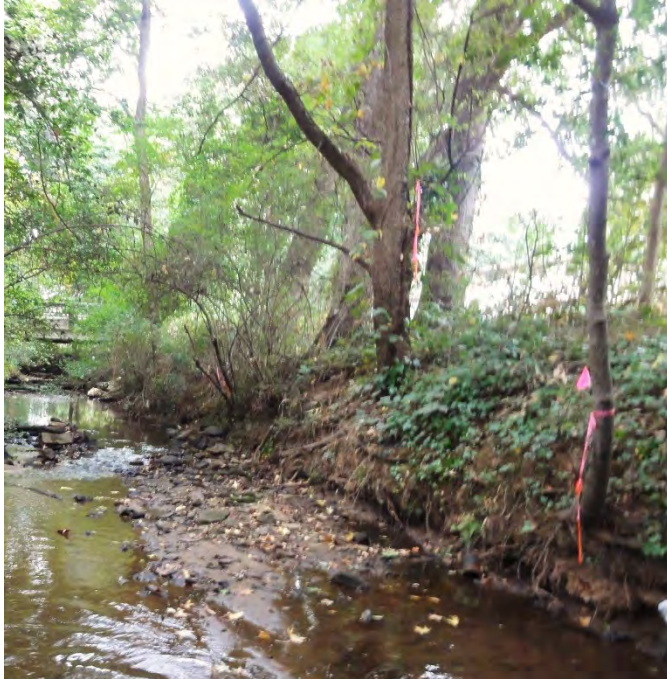
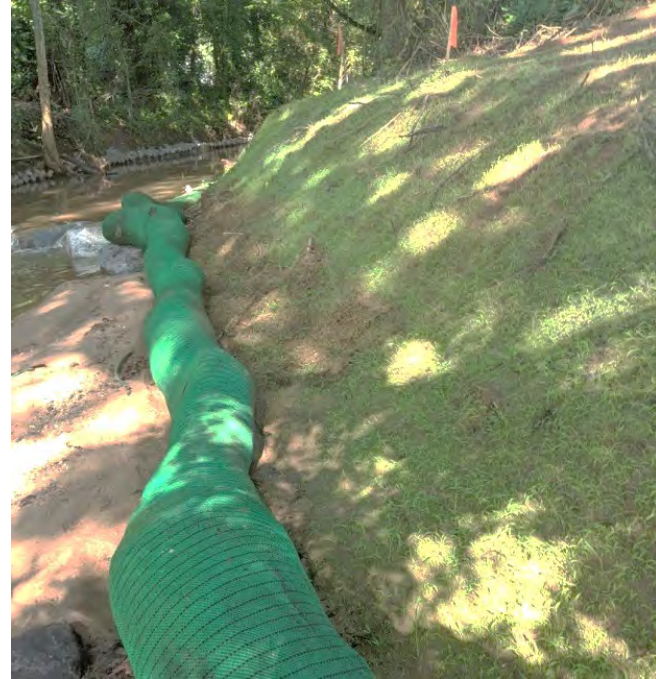
# Bank Stabilization: Coconut / Coir /Jute Matting

Before

After

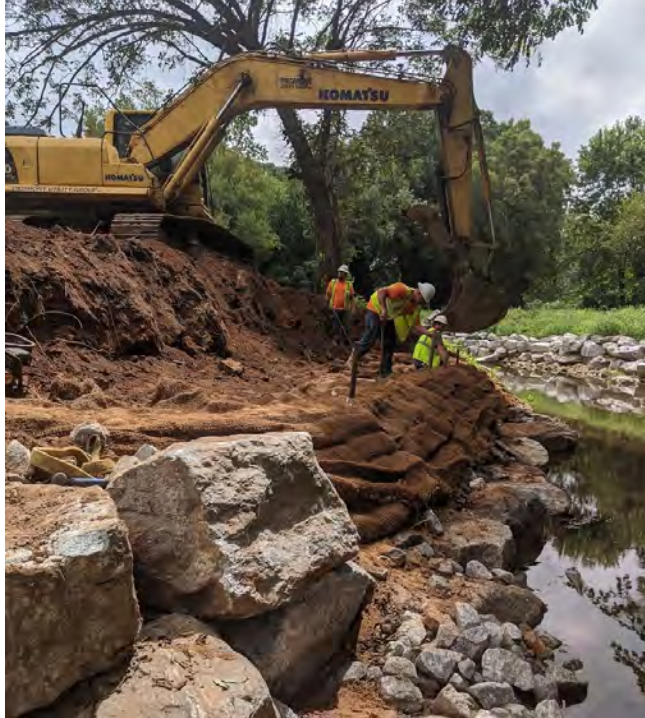
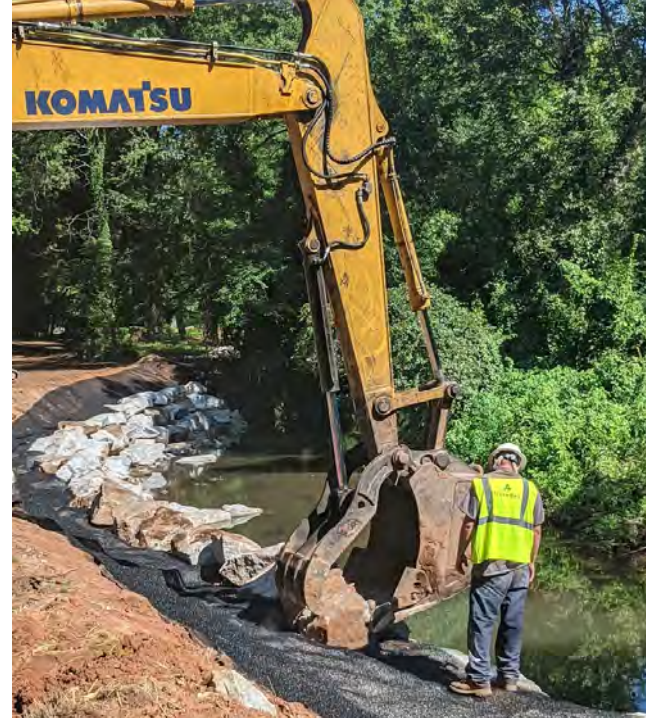
# Bank Stabilization: *Boulder Wall and Soil Lifts*

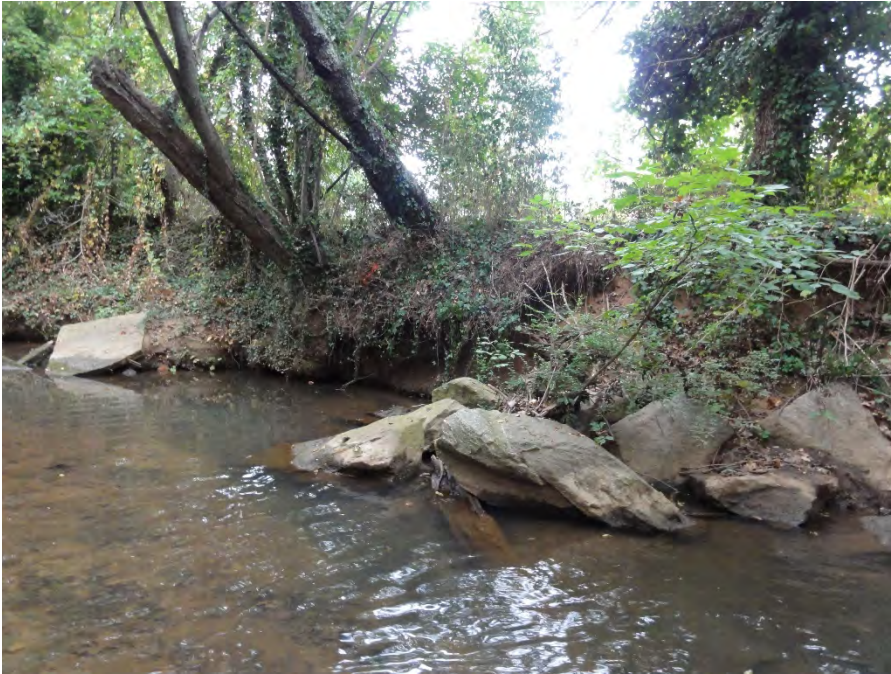
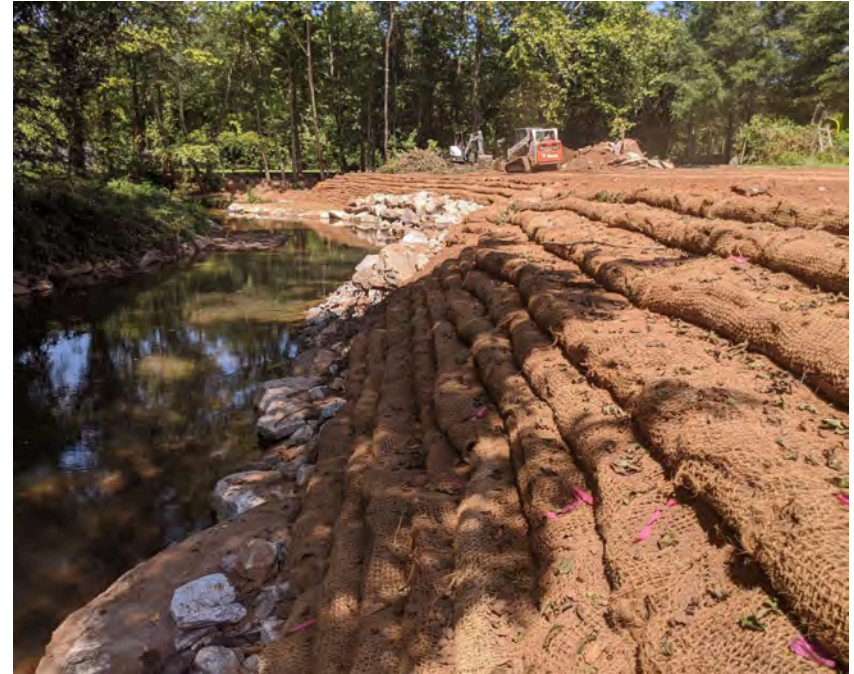
# Bank Stabilization: *Soil Lifts*

Before

After

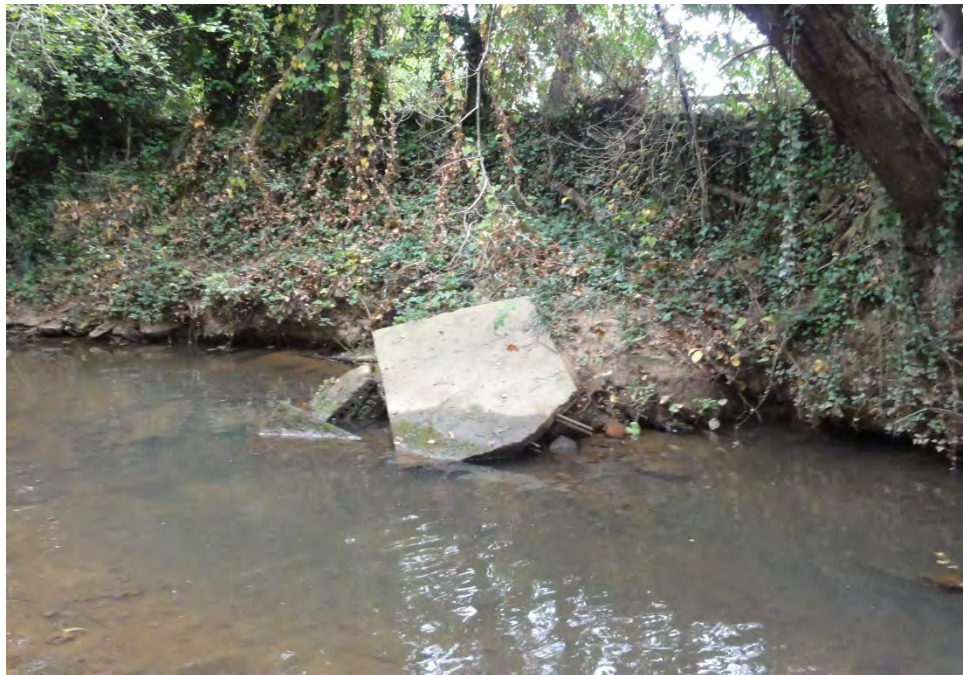
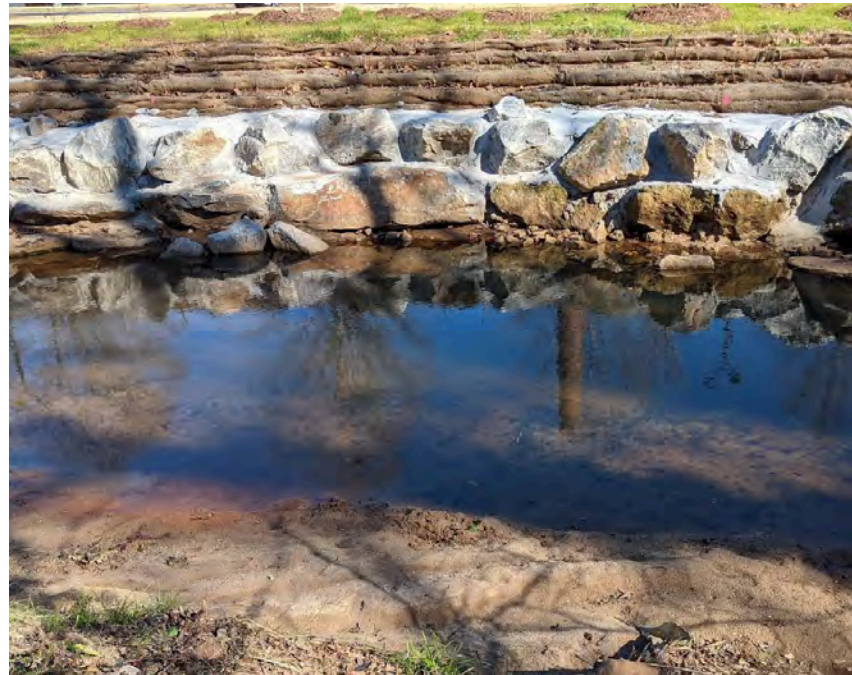
# Hard Armoring: *Boulder Wall*

Before

After

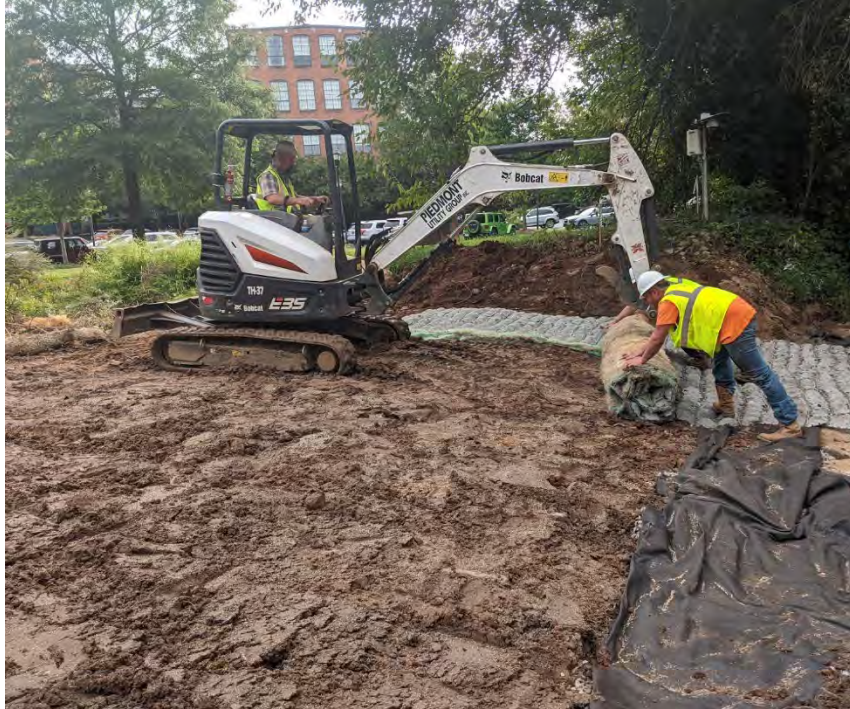
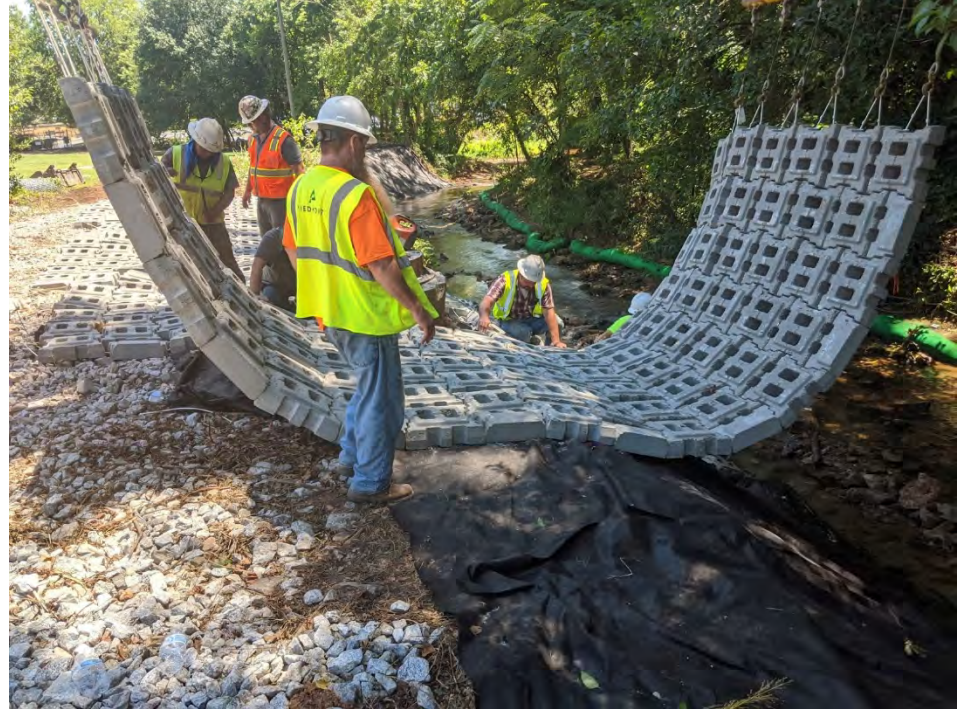
# Hard Armoring: *Flexamat* and Shoreblock

- Concrete mattresses are difficult to install along curves.
- Vegetated block mats are a great compromise for installation, strength, and aesthetics.

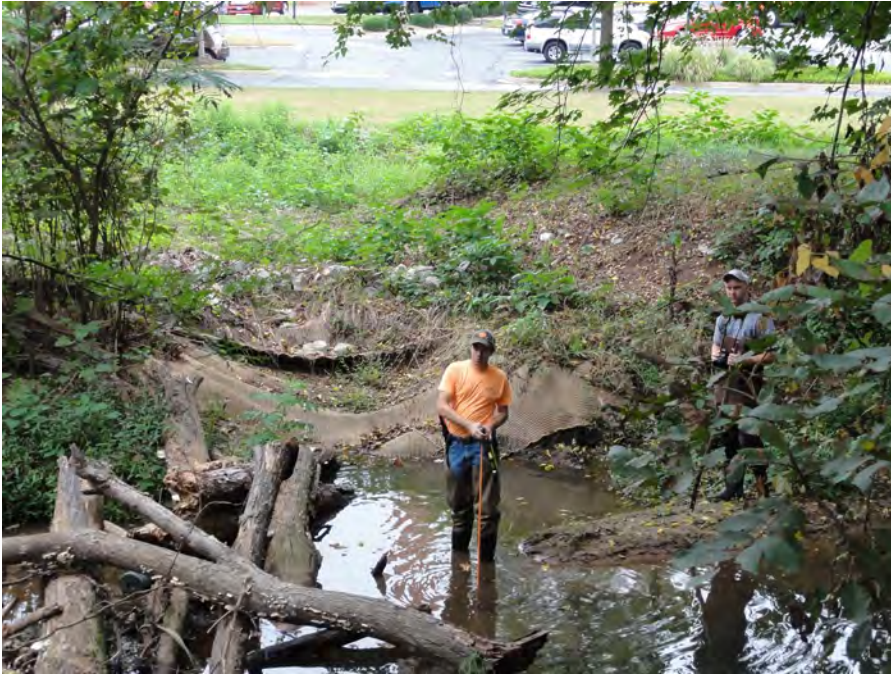
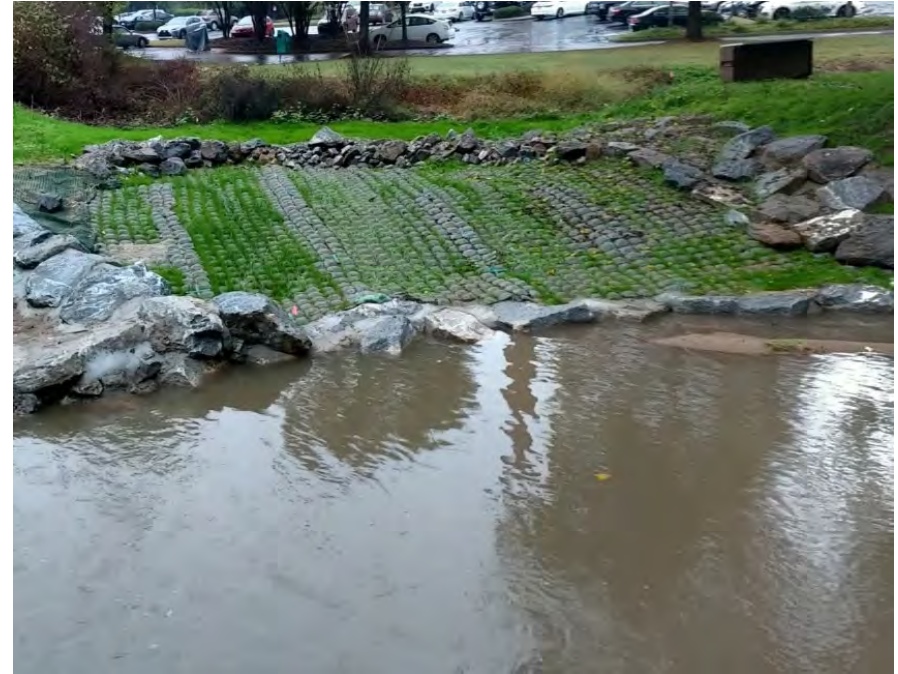
# Hard Armoring: *Vegetated Concrete Block Mat* (*Flexamat*)

Before

After

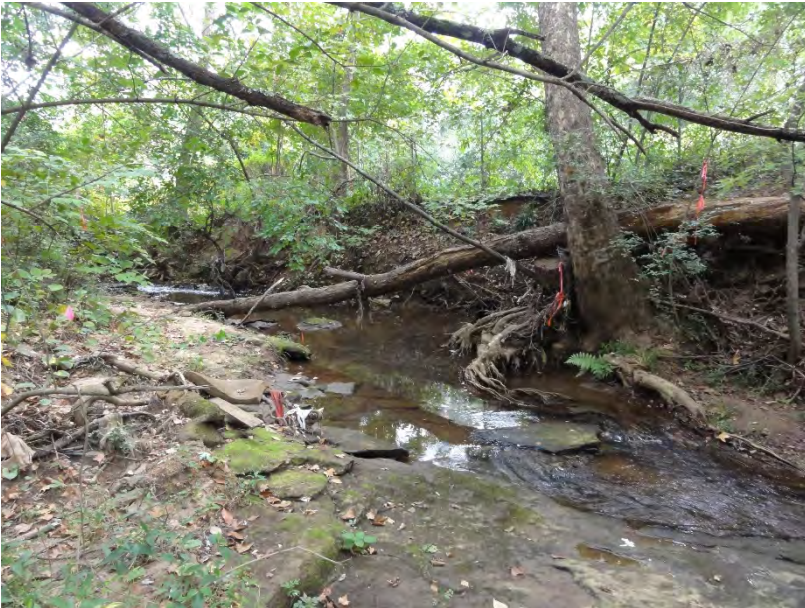
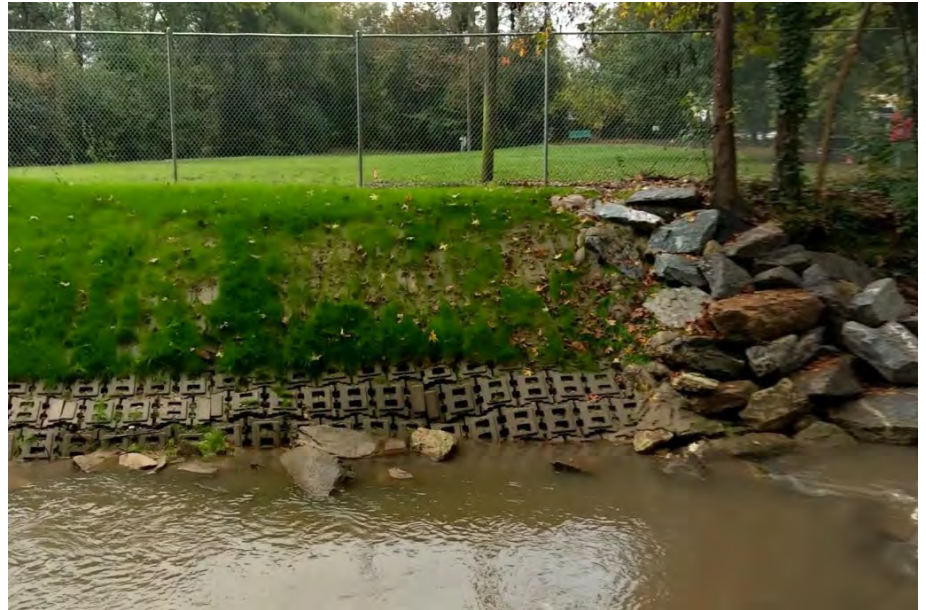
# Hard Armoring: *Tied Concrete Block Mattress* (Shoreblock)

Before

After
