# The Ripple Effects of Collaborative Stream Restoration

## Brushy Creek

# Brushy Creek Stream Restoration

BMP Demonstration Project

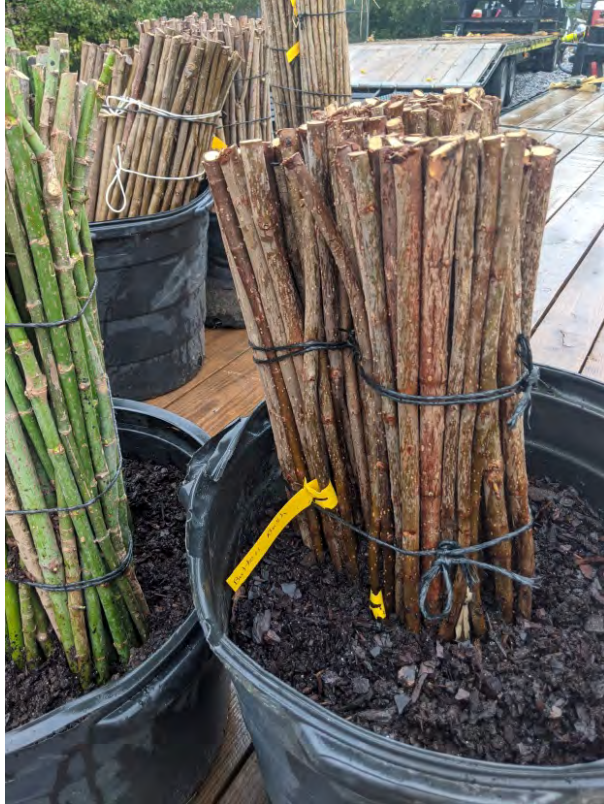
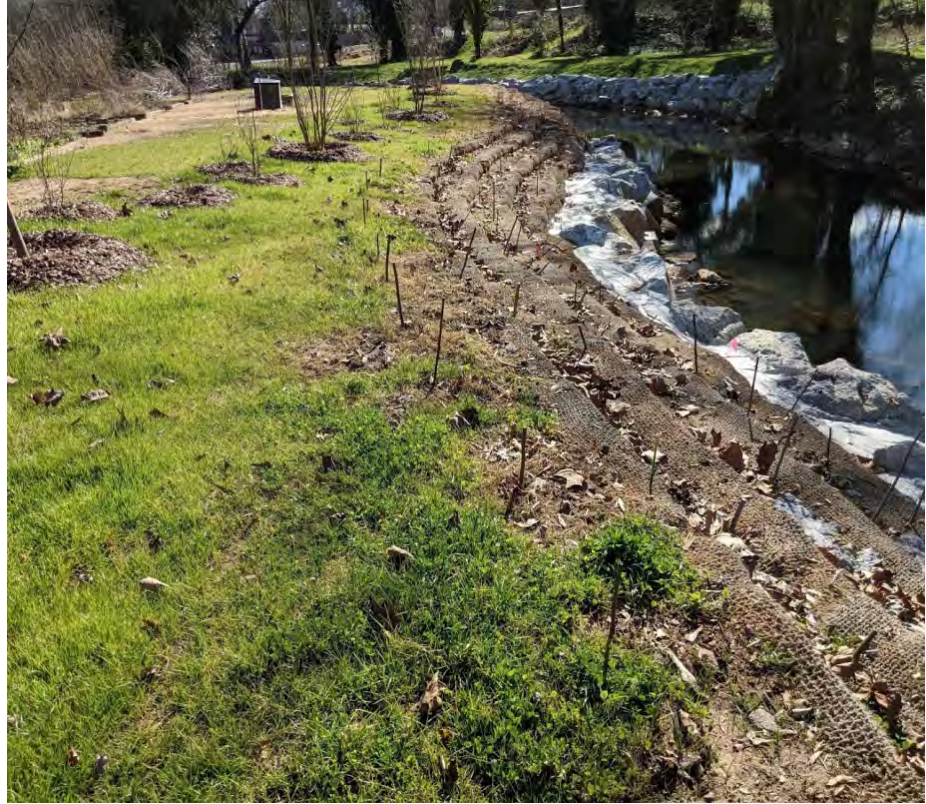
# Vegetation: *Live Stakes and Plantings*

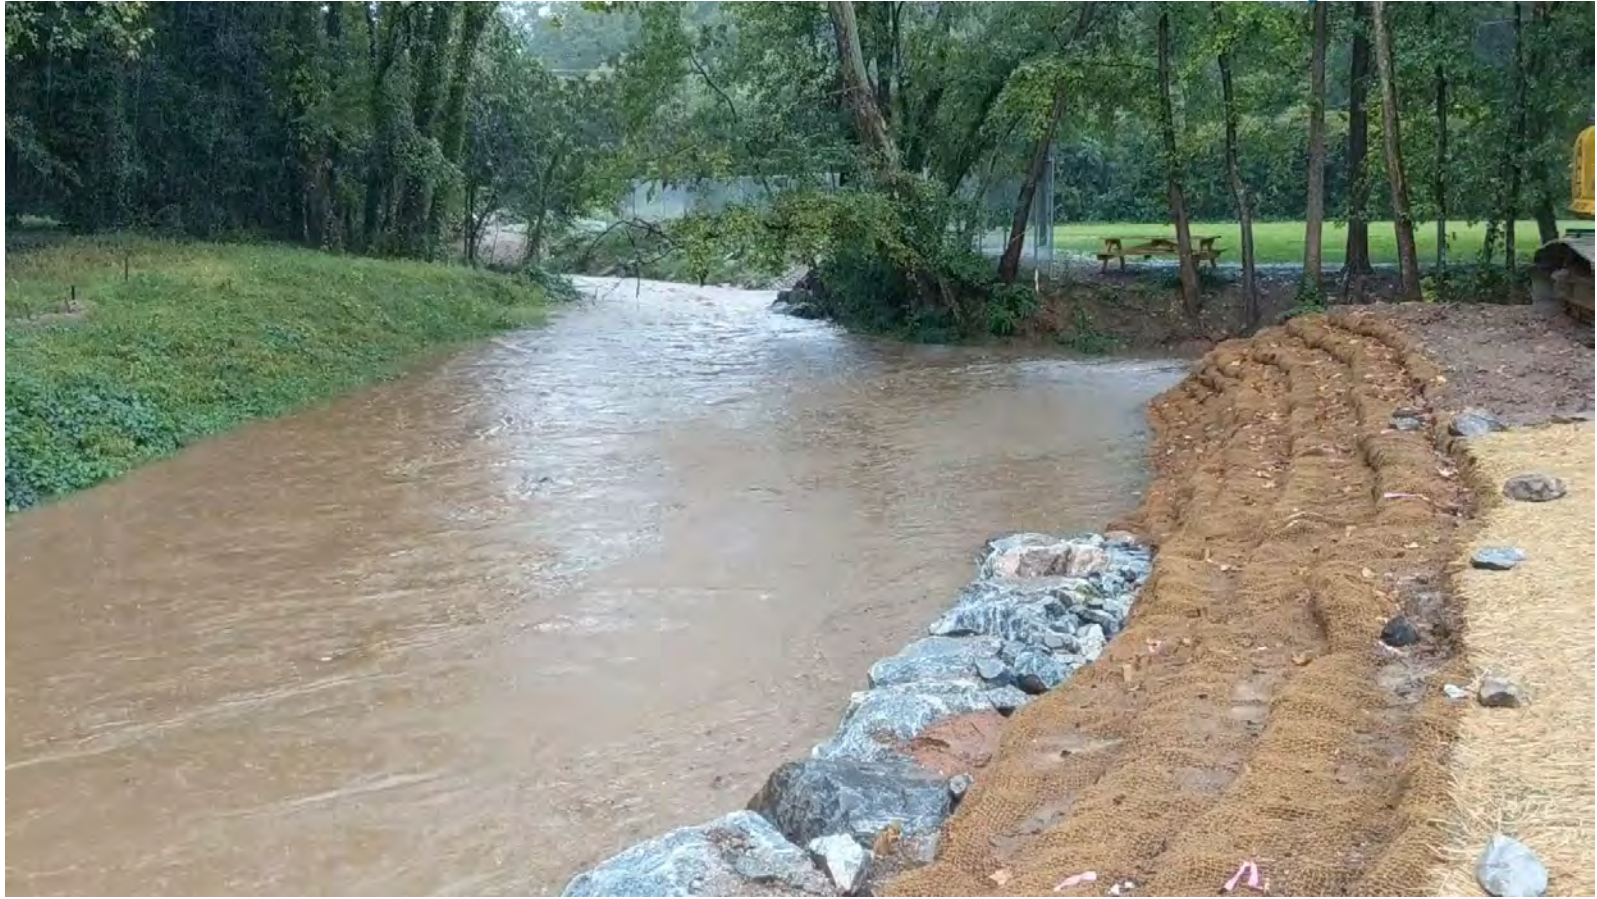
# Storm Event – How Did it Hold Up?

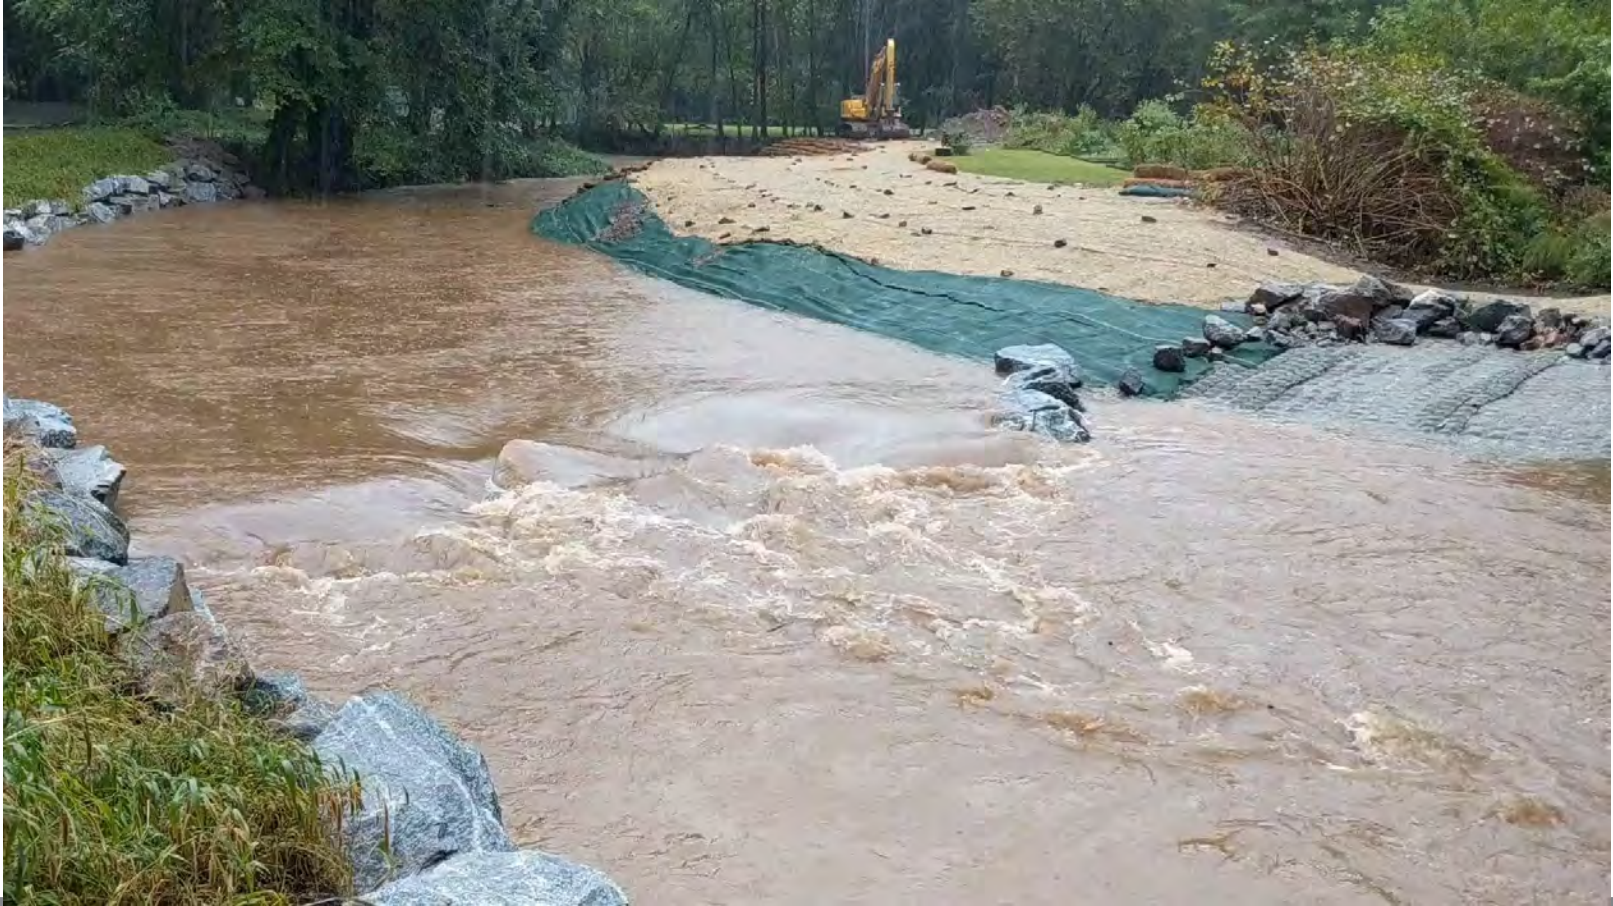
# Storm Event – How Did it Hold Up?

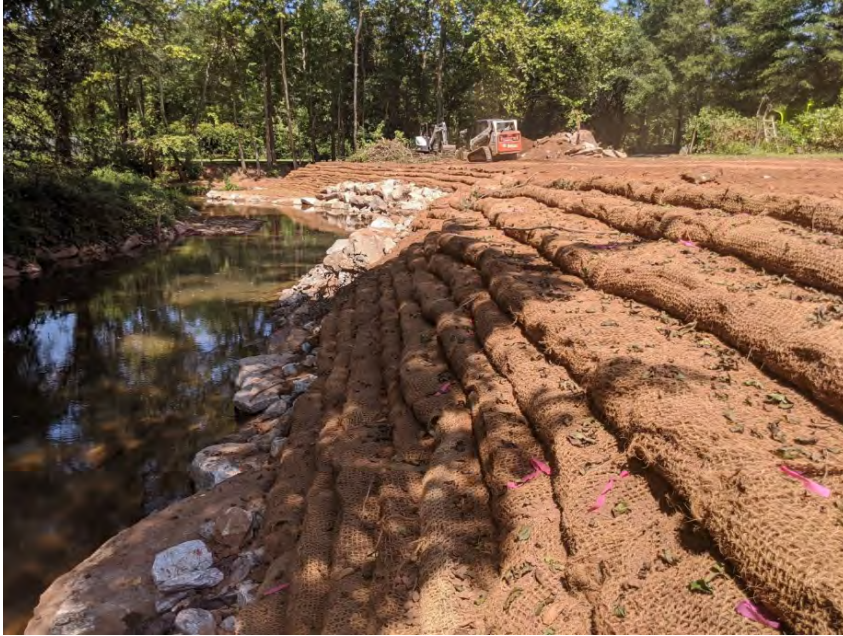
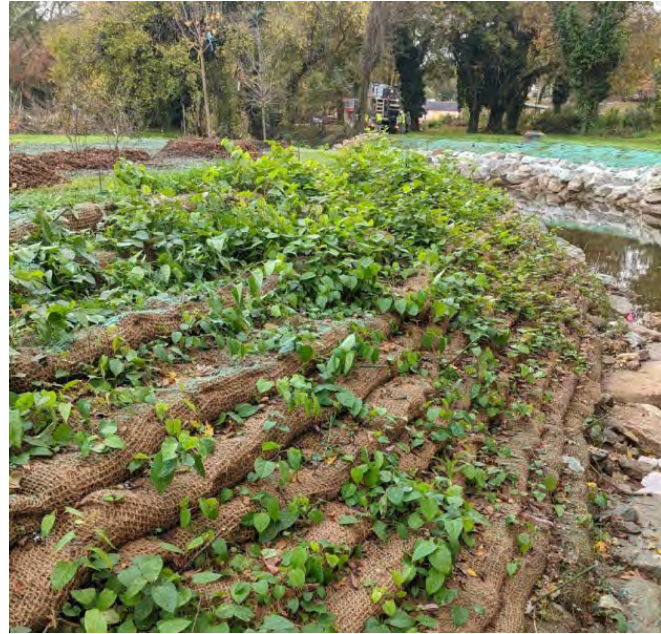
# Another Lesson: Invasive Species

## Japanese Knot weed

Aug '20

Oct '20

1. Continue invasive treatment at regular intervals
2. Evaluate water quality effects with continued Stream Monitoring
3. Follow up field inspections and repairs as needed
