Prioritization Matrix for Monitoring and Detection of Fecal Pollution in Urban Streams

Prioritizing Watersheds for Fecal Pollution Reduction in Mecklenburg County

Charlotte-Mecklenburg County Storm Water Services

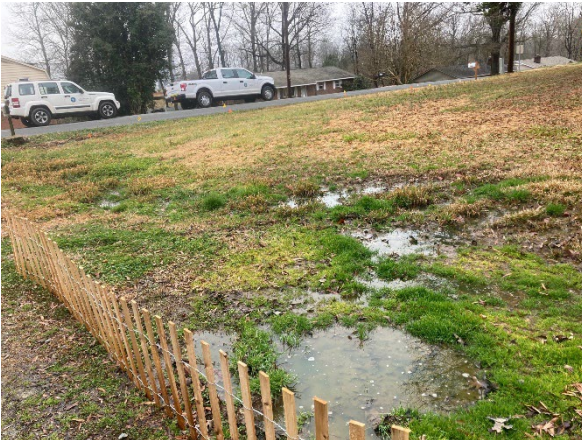
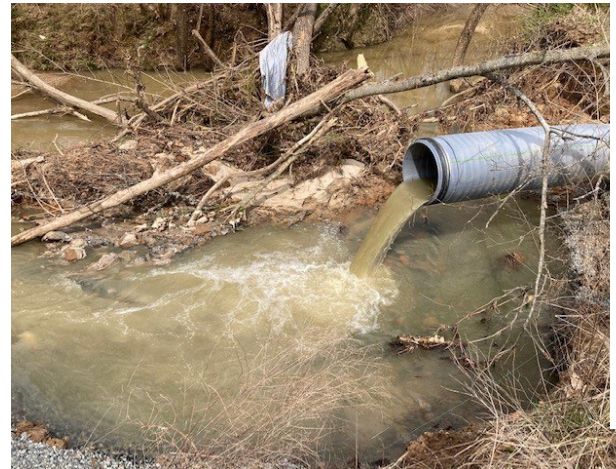
- ◁ Sanitary sewer overflows
 - Pipe failures, blockages
 - Lift stations, Private laterals, Multifamily systems
- ◁ Septic system failures
- ◁ Stormwater runoff
- ◁ Others

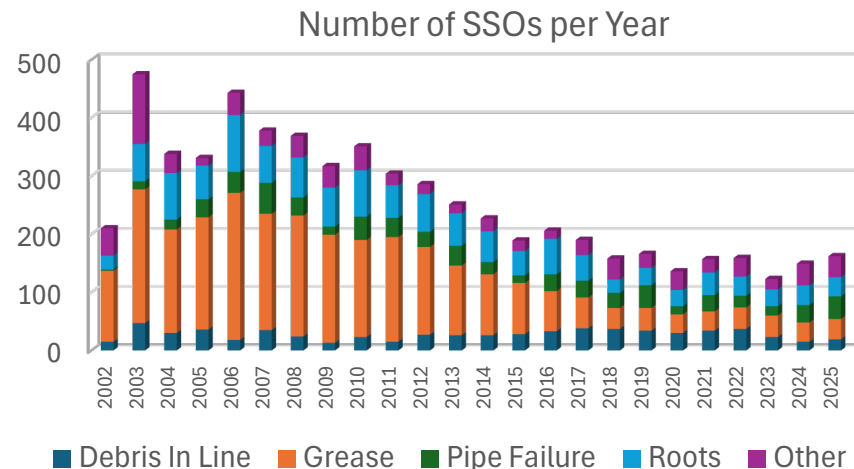
◁ Sanitary Sewer Features

- SSO counts/watershed
- Wastewater main line density
- Percent of vitrified clay pipe (VCP) and terracotta pipe
- Summarized into one sewer index

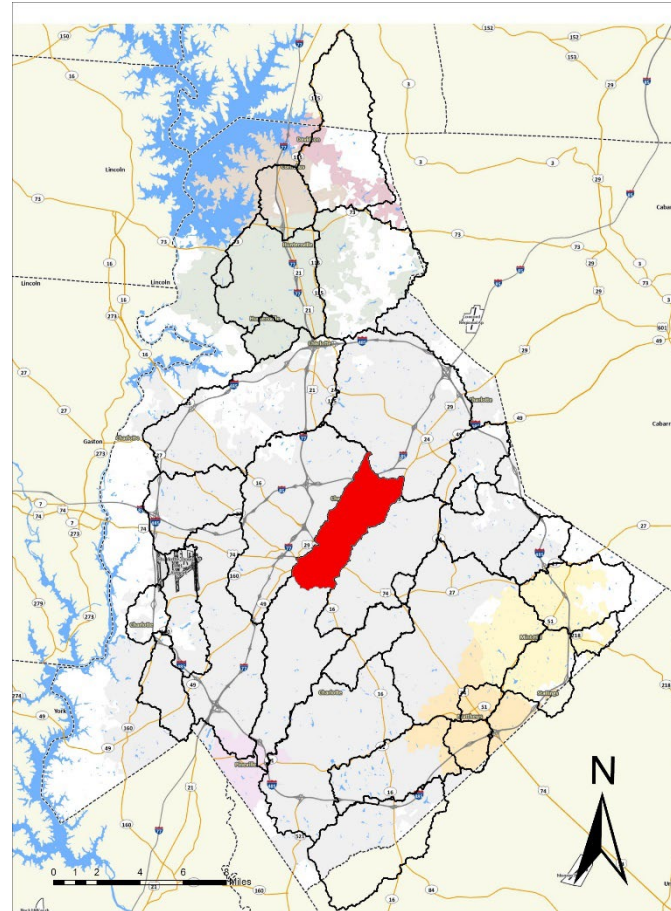
Upper Little Sugar Creek Watershed - High Priority

- ▶ **Upper Little Sugar Creek (ULSC) Watershed**
 - 712 Acre drainage
 - Fecal coliform TMDL, Trending up
 - 1552 Outfalls
- ▶ **Drains dense residential, commercial and industrial areas**
 - Uptown and Midtown Charlotte
 - High impervious cover
 - Piped tributaries
- ▶ **Aging sanitary sewer and stormwater infrastructure**
- ▶ **Creek runs along major Wastewater Treatment Plant trunkline**

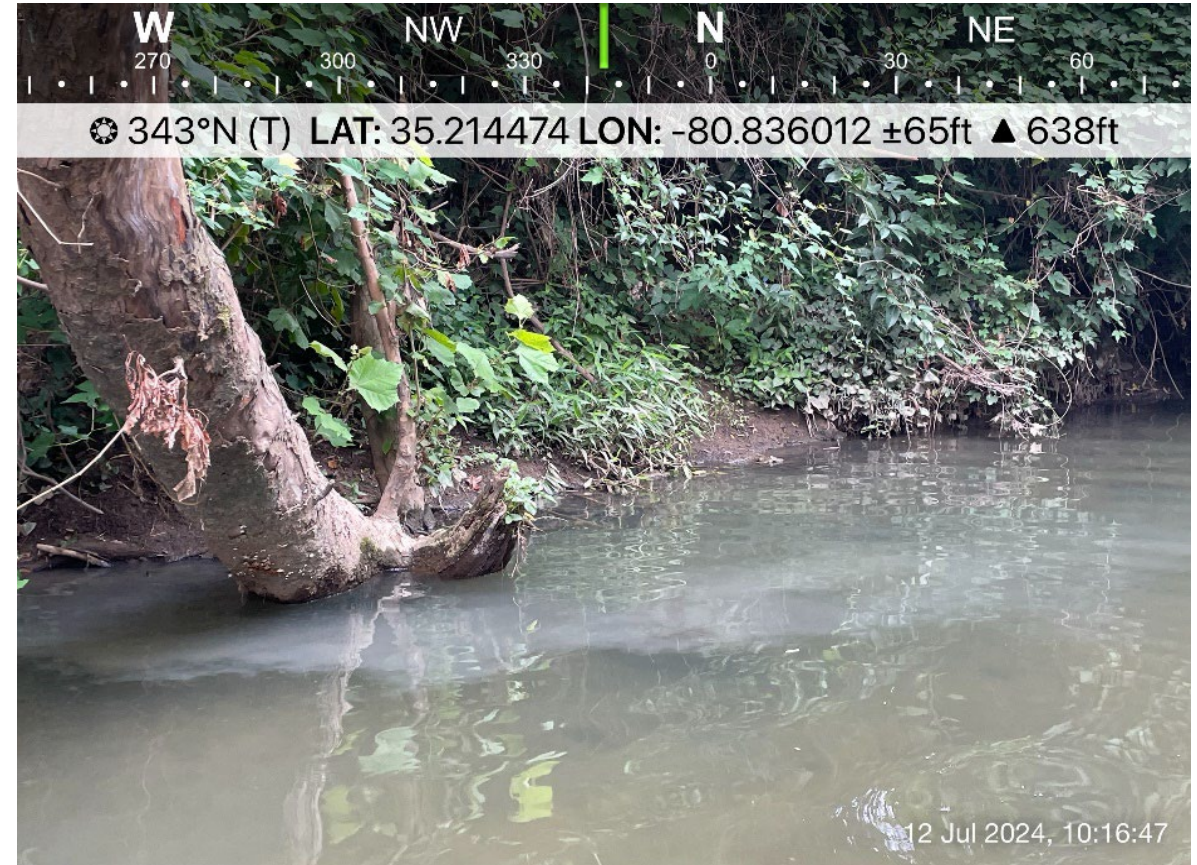
Spotlight: MC29A1 Trunkline Break

- ◀ First sign of a problem –
Results from April 2024 routine
monthly monitoring and
priority watershed monitoring
- ◀ Field investigations, sampling,
and dye-testing to delineate
issue
 - Mainstem of ULSC
 - Tributaries
 - Outfalls

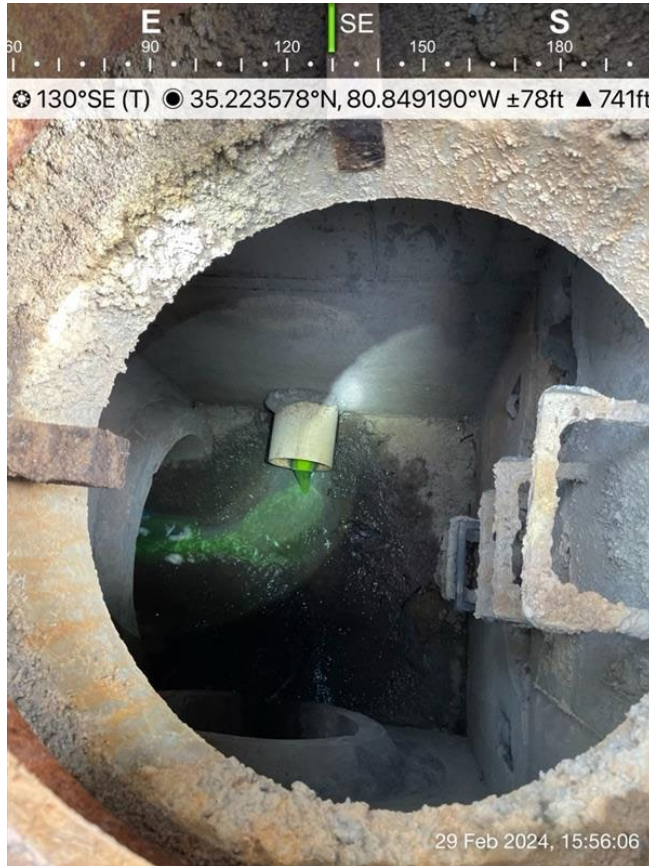
Spotlight: Uptown Illicit Connections

- ◁ Two unintentional connections
- ◁ High traffic retail spaces in uptown
- ◁ Sewage lines tapped into building roof drainage
 - Proposed code changes to mark roof drainage

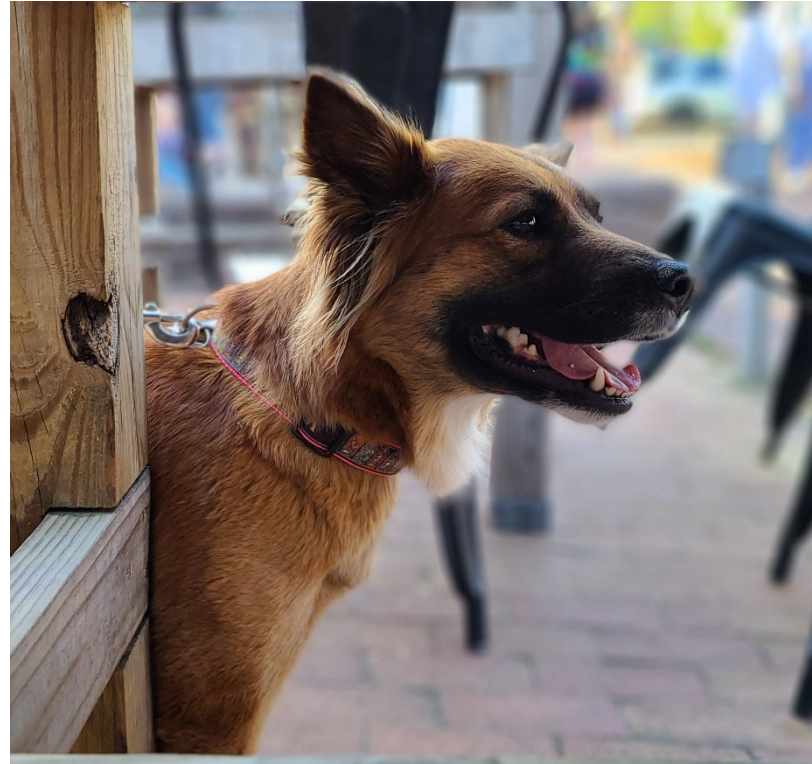
Sewage Detection

- Initial sample: WWTP influent
- 10-20 drops influent in mason jar on cotton swabs
- Cotton swabs in tins
- Indoor searching
- Outdoor searching
- Positive and Negative controls
- Bottle & Storm Drain searching
- Interferences

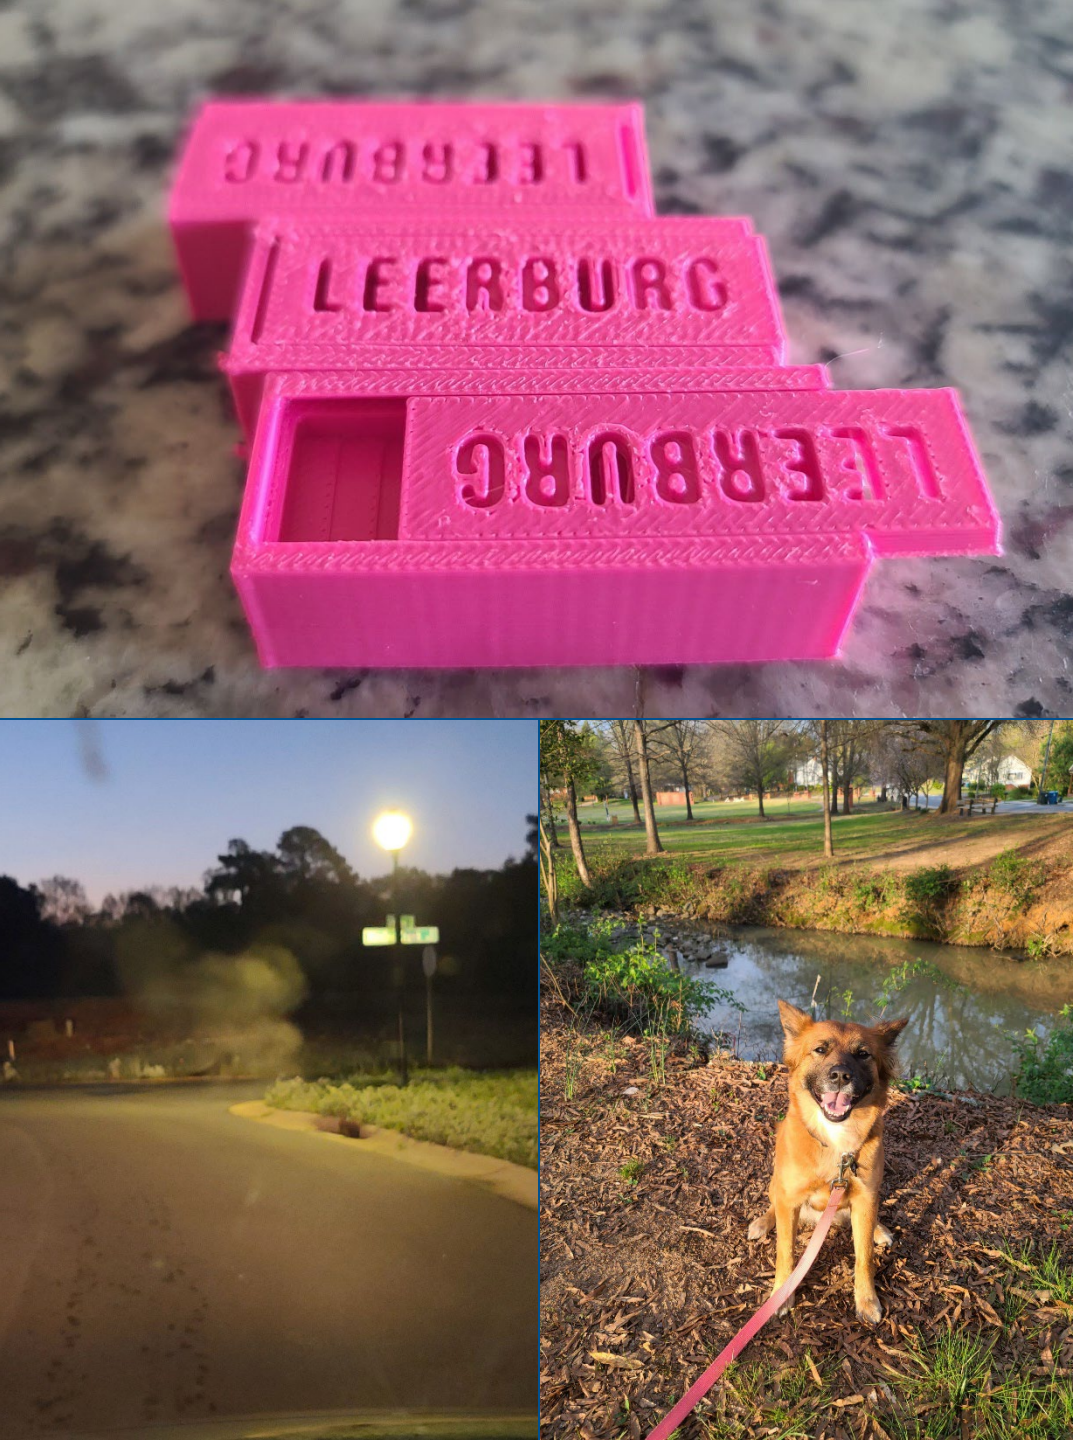
Investigation 1: Perth Ct FINS Site

- Wednesday: IDEP
- Thursday: Additional Samples
- Friday: Finding Sewage
- Results:
 - Apartment complex with sewage leaking directly into creek and under majority of buildings
 - Apartment complex with cracked pipe seeping into detention pond and surrounding area
