LILBURN CITY PARK GREEN INFRASTRUCTURE STORMWATER BMP DESIGN

Emma Highfield, EIT (GA) | October 5th, 2022

Geosyntec consultants

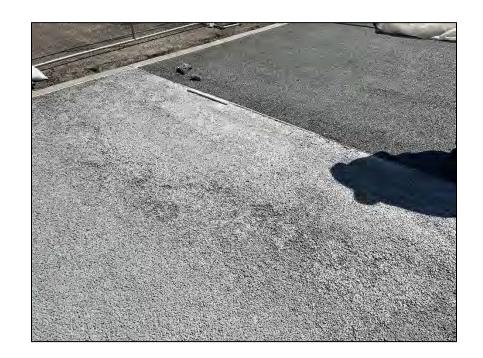
Quality Control

- High demand for concrete and limited supply of materials and drivers
- Delays between pervious concrete deliveries led to quality concerns regarding some of the pervious concrete panels
- Replaced panels identified with concerns
- Will monitor performance of other panels during hightraffic period of summer
