# City of Charleston Watershed Master Planning

## *Standardizing the Process*

SESWA Conference  
October 5, 2018

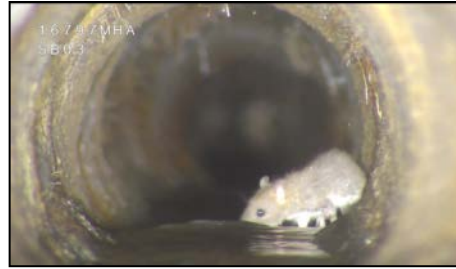
Condition Assessment Grading System

## – NASSCO® Standards as basis

- Standard enables consistent assessment and communication between field and office
- Scoring system

Grade	Description
5	Failed or failure is imminent - requires immediate attention
4	Severe defects - risk of future failure
3	Moderate defects - deterioration may continue
2	Minor to Moderate defects - low risk of failure
1	Minor defects - failure unlikely in the foreseeable future

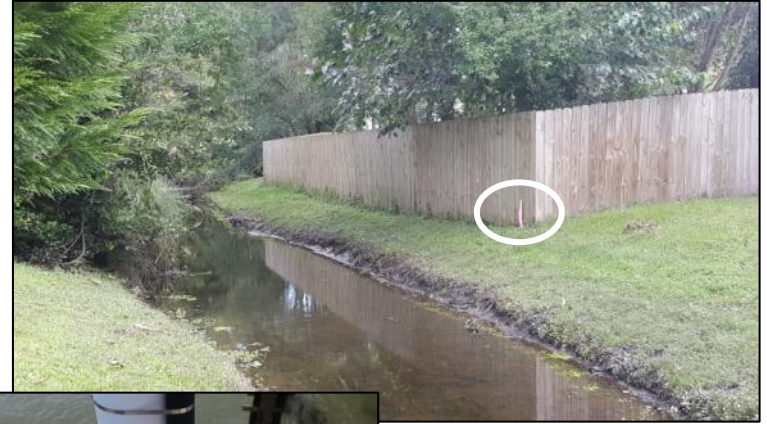
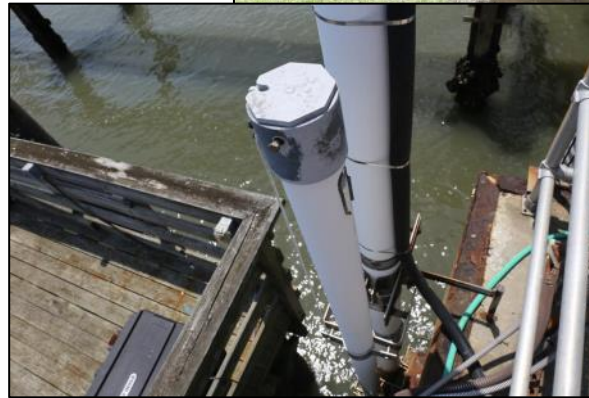
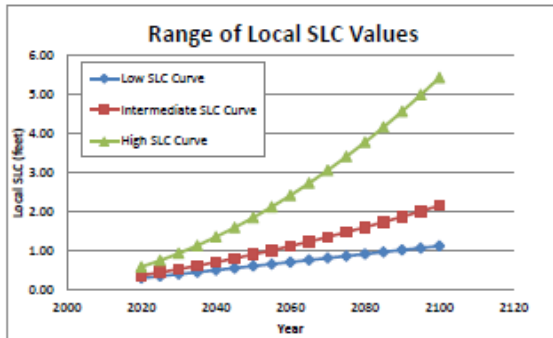
# PLANNING – Hydraulic and Hydrologic Modeling

- ICPR 4 – GIS Capabilities
- Field Validation from Gauge and Observed High Water Marks
- Incorporate Sea Level Change

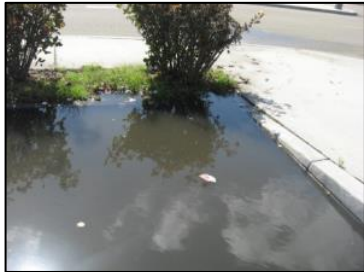
## MAINTENANCE ISSUES

- Accumulated sediment or debris in structures
- Standing water or sludge in structures
- Heavy overgrowth of vegetation

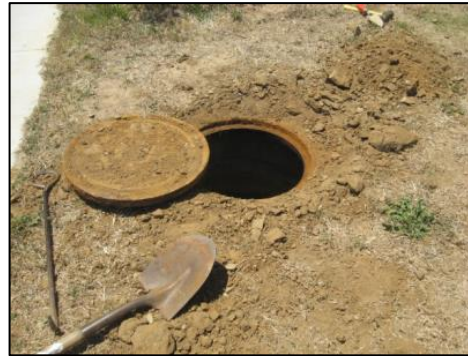
## ACCESS ISSUES

- Fencing or locked gate
- Manhole cover or inlet grate paved over or stuck
- Concrete box-top inlets or oversized manhole or inlet covers requiring heavy equipment to lift
- Owner denies entry
- Safety constraints, aggressive dogs

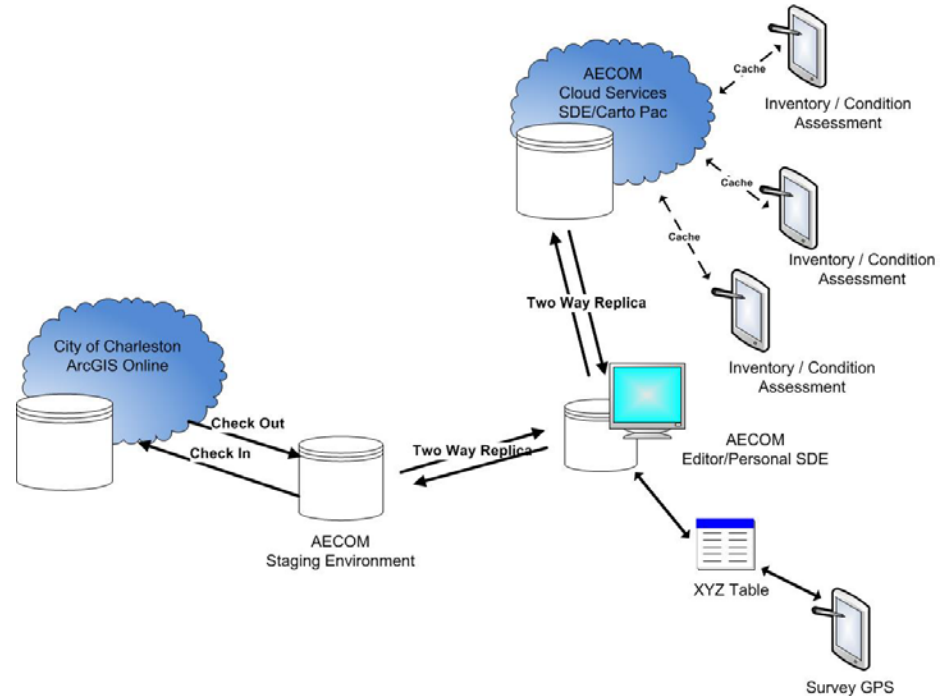
# ASSET INVENTORY – GIS Data Collection and Management

FEATURES (ASSETS)	FEATURE CLASS CATEGORY
Inlets Manholes/Junctions Outlets	Point Features
Discharge Points Fittings	
Pipes Culverts Channels	Linear Features
BMPs	Polygon Features
COMPONENTS	FEATURE CLASS CATEGORY
End Structures	Associated with Point and Linear Features

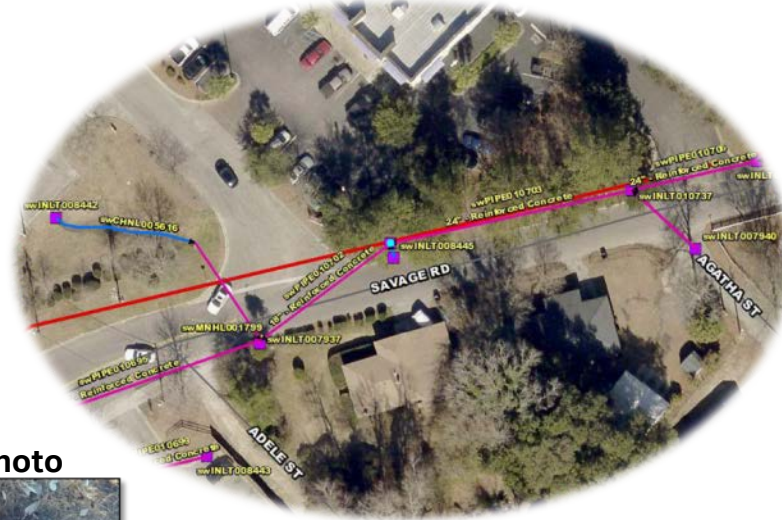
## INLETS

FIELD NAME	FIELD DESCRIPTION
ASSETID	swINLT007938
BASINID	1000
LegacyID	15030
GlobalID	{08FBBD4B-5FD9-42AA-BBE9-83C0B5F08334}
INLETYPE	Grate Inlet
HEIGHT	N/A
WIDTH	2 ft.
LENGTH	3 ft.
TOPELEV	14.90314
DEPTHORIM	N/A
RIMELEV	14.90314
INVERTDEPTH	2.34 ft.
INVERTELEV	12.56314
ACCESSMAT	Cast Iron
ACCESSTYPE	Rectangular Grate
ACCESSMARK	Generic no mark on cover
ACCESSDIAM	N/A
ACCESSLENGTH	3 ft.
ACCESSWIDTH	2 ft.
WALLMAT	Concrete
STENCIL	No
BMP	No
COMMENTS	#SEDIMENTLINER IN INLET
ACTIVEFLAG	True
LIFECYCLESTATUS	Active
LASTUPDATE	4/21/2017 8:49:53 AM
LASTEDITOR	LYNN SHELLEY
SOURCE	DGPS
SOURCEACC	N/A
SOURCEDATE	4/5/2018 9:02:56 AM
SOURCEDATUM	Unknown
DimUOMElev	Feet
DimUOMLength	Tenths of foot
DimUOMWidth	Tenths of foot
DimUOMDepth	Tenths of foot
DimUOMHeight	N/A
DimUOMDiameter	N/A
XCORD	2,300,541.777
YCORD	355,818.277
ZCORD	14.90314
NeedsMaintenance	No Maintenance Issues
Accessible	Accessible

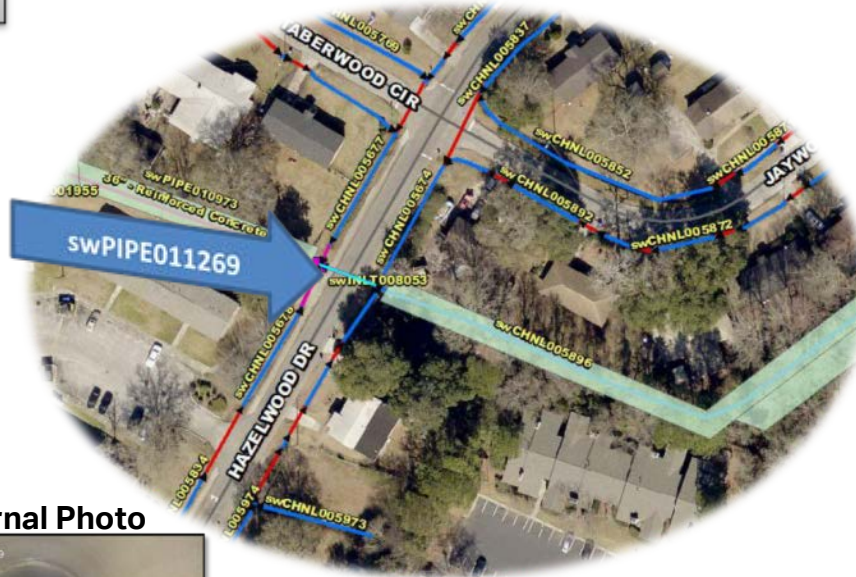
## PIPES

FIELD NAME	FIELD DESCRIPTION
ASSETID	swPIPE011269
BASINID	N/A
LegacyID	N/A
GlobalID	N/A
MATERIAL	Reinforced Concrete
DIAMETER	36"
HEIGHT	N/A
WIDTH	N/A
LENGTH	44.086366
MAINSHAPE	Circular
PIPETYPE	Gravity Main
LININGMAT	N/A
DNELEV_HW	N/A
DNDEPTH_TOP	N/A
DNELEV_TOP	8.55
DNELEV_INV	4.46
DNDEPTH_INV	4.09
UPELEV_HW	N/A
UPDEPTH_TOP	N/A
UPELEV_TOP	7.71
UPELEV_INV	4.51
UPDEPTH_INV	3.20
SLOPE	0.11
AVGCOVERDEPTH	N/A
FROM ASSET	N/A
TO ASSET	swINLT008053
STRUCT_TYP_UP	Projected from Fill
STRUCT_TYP_DN	N/A
STENCIL	No
COMMENTS	Data Source: 1984 Master Drainage and Floodplain Management Plan
ACTIVEFLAG	True
LIFECYCLESTATUS	Active
LASTUPDATE	4/21/2017 8:30:08AM
LASTEDITOR	LYNN SHELLEY
SOURCE	Other (See Comments)
SOURCEACC	Best Fit
SOURCEDATE	3/8/2018 12:37:05PM
SOURCE DATUM	Unknown
DimUOMlev	N/A
DimUOMLength	N/A
DimUOMWidth	N/A
DimUOMDepth	Tenths of Foot
DimUOMHeight	N/A
DimUOMSlope	Percent
DimUOMDiameter	Inch
NeedsMaintenance	No Maintenance Issues
Accessible	Accessible

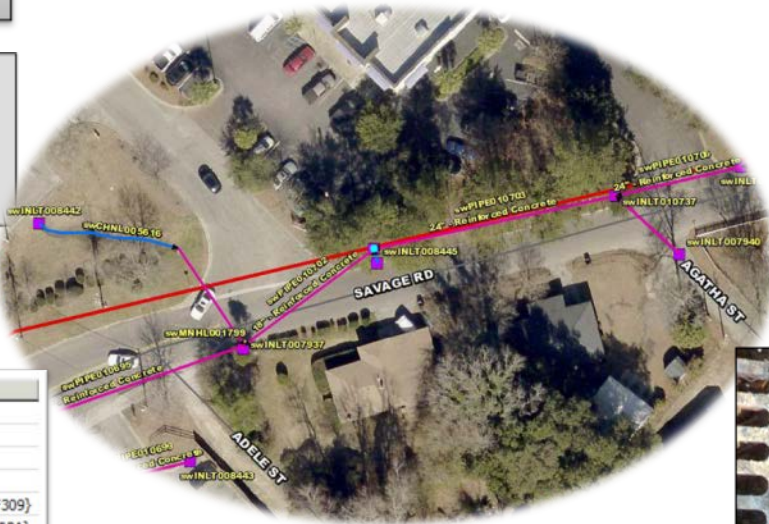
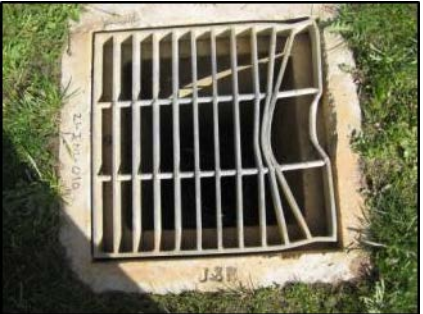
## INLETS

Field	Value
Asset ID	swINLT007938
Comments	#Sediment liner partially blocking flow.
Component	Not applicable
Component Condition	<null>
CP_FC_GUID	{EDA88C48-C88A-4FC7-9A92-5FE23AC9F309}
CP_INSP_GUID	{498AA188-1857-483D-ABD8-3950D538A93A}
Defect	Obstruction (> 25%)
Descriptor	Sediment
GlobalID	{391D8CC7-2746-4BA7-A5EF-1D779EB65E0D}
Inspection Date	4/5/2018 9:05:10 AM
Inspector	MR
Modifier	50% - 75%
OBJECTID	5753
Upstream or Downstream	NA

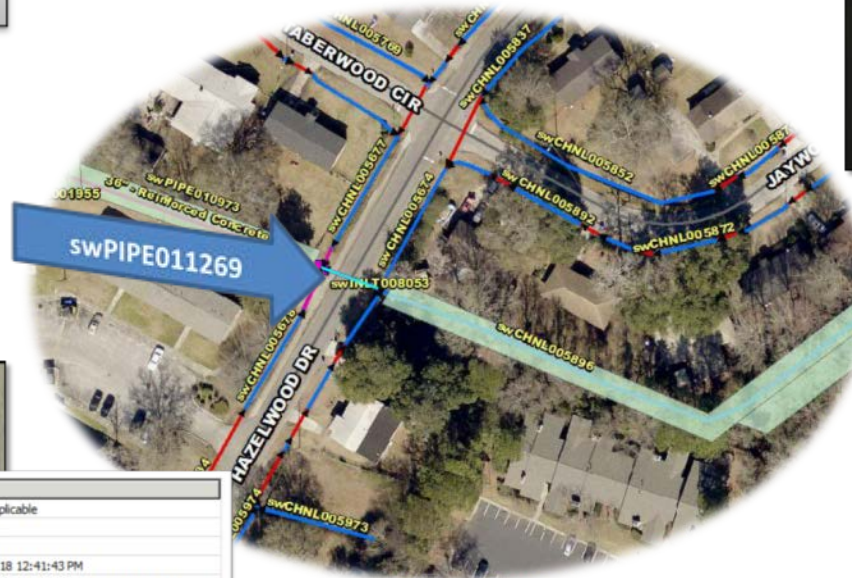
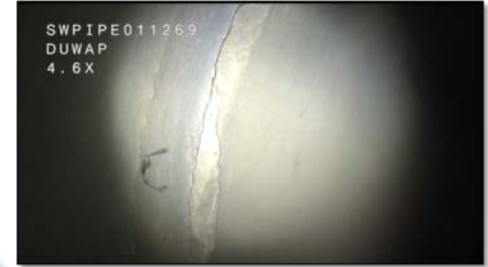
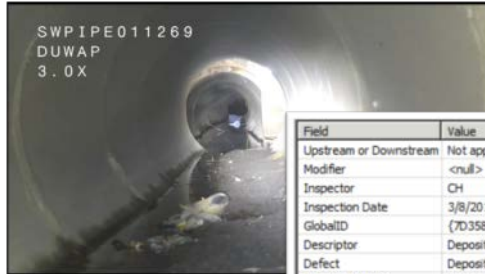
## PIPES

Field	Value
Upstream or Downstream	Not applicable
Modifier	<null>
Inspector	CH
Inspection Date	3/8/2018 12:41:43 PM
GlobalID	(7D35886C-F405-4966-9C6F-EB1E638138E7)
Descriptor	Deposit Sediment (no mod)
Defect	Deposits (LTEQ 25%)
CP_INSP_GUID	(27908B52-8CA9-464E-AE1B-56DDC0F6C350)
CP_FC_GUID	(F4074F1A-6996-40E2-A457-F297AE042528)
Component Condition	<null>
Component	Not applicable
Comments	<null>
Asset ID	swPIPE011269

Field	Value
Upstream or Downstream	Upstream
Modifier	Moderate
Inspector	CH
Inspection Date	3/8/2018 12:42:11 PM
GlobalID	(77D12DAE-9695-45F6-A1DA-EBC586FC0860)
Descriptor	<null>
Defect	Crack
CP_INSP_GUID	(1DC470A9-2F4B-427B-B1F5-163C88E42C32)
CP_FC_GUID	(F4074F1A-6996-40E2-A457-F297AE042528)
Component Condition	<null>
Component	Not applicable
Comments	<null>
Asset ID	swPIPE011269

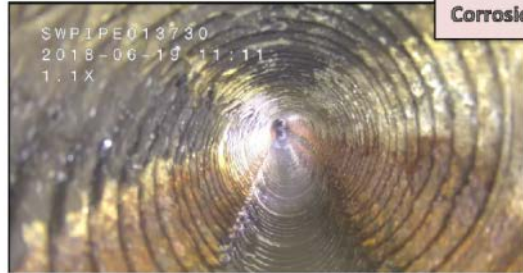
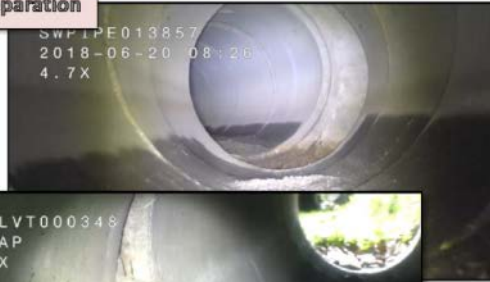
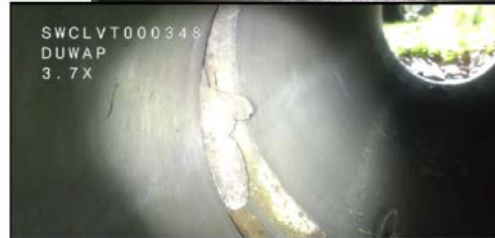
### STRUCTURAL DEFECTS Corrosion & Joint Separation

Defect Category	Defects	Descriptors	Modifiers	Condition Grade				
				No Modifier	Minor	Moderate	Severe	
Structural Defects	Crack		Minor, Moderate, Severe	2	3	4		
	Fracture		Minor, Moderate, Severe	3	4	5		
	Broken		Minor, Moderate, Severe	3	4	5		
	Hole		Minor, Moderate, Severe	3	4	5		
	Deformed (< 40%)			1				
	Collapse (> 40%)			5				
	Joint	Offset		Minor, Moderate, Severe	2	3	4	
		Separated		Minor, Moderate, Severe	3	4	5	
		Spalling		Minor, Moderate, Severe	2	3	4	5
	Surface Damage	Aggregate Visible			2			
		Rebar Exposed			4			
		Corrosion			5			
		Lining Issue			3			
	Back/Block/Rock	Other		Minor, Moderate, Severe	3	1	3	5
		Displaced			3			
Missing Mortar				4				
Decayed	Missing Mortar			2				
	Missing Mortar		Minor, Moderate, Severe	2	2	3	4	
Sag			< 30% (30-50%) (> 50%)	No Mod.	< 30%	30-50%	> 50%

Grade	Condition Description
5	Failed or failure is imminent - requires immediate attention
4	Severe defects - risk of future failure
3	Moderate defects - deterioration may continue
2	Minor to Moderate defects - low risk of failure
1	Minor defects - failure unlikely in the foreseeable future

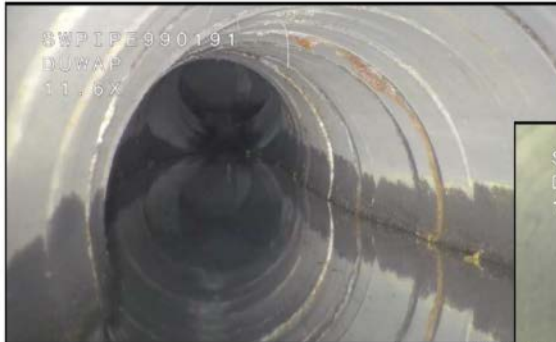
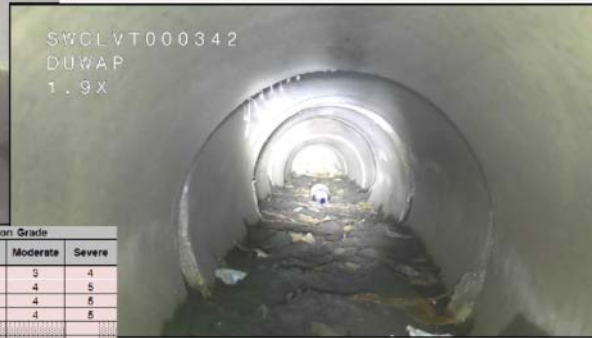
### STRUCTURAL DEFECTS Joint Offsets

Defect Category	Modifier	Description
Structural (except Sag)	Minor	Few defects visible
	Moderate	Multiple defects visible, deterioration may continue
	Severe	Risk of failure due to defects
Structural - Sag	< 30%	< 30% cross-sectional area affected
	30-50%	30-50% cross-sectional area affected

Defect Categories	Defects	Descriptors	Modifiers	Condition Grade				
				No Modifier	Minor	Moderate	Severe	
Structural Defects	Crack		Minor, Moderate, Severe	2	3	4	5	
	Fracture		Minor, Moderate, Severe	3	4	5		
	Broken		Minor, Moderate, Severe	3	4	5		
	Hole		Minor, Moderate, Severe	3	4	5		
	Deformed (< 40%)			4				
	Collapse (> 40%)			5				
	Joint	Offset		Minor, Moderate, Severe	2	3	4	5
		Separated		Minor, Moderate, Severe	3	4	5	
		Spalling			2			
		Aggregate Visible			3			
	Surface Damage	Rebar Exposed			4			
		Corrosion			5			
		Linting, Flaking, Other		Minor, Moderate, Severe	3	1	3	5
	Brick/Block/Block	Reinforcement Missing			3			
		Missing Mortar			4			
		Missing Mortar			2			
	Decayed			Minor, Moderate, Severe	No Mod.	2	3	4
					No Mod.	< 30%	30-50%	> 50%
Reg.					2	3	4

Grade	Condition Description
5	Failed or failure is imminent - requires immediate attention
4	Severe defects - risk of future failure
3	Moderate defects - deterioration may continue
2	Minor to Moderate defects - low risk of failure
1	Minor defects - failure unlikely in the foreseeable future

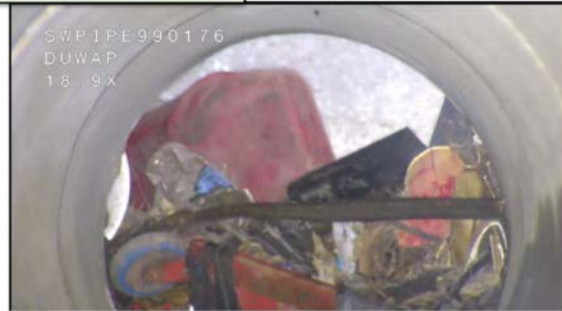
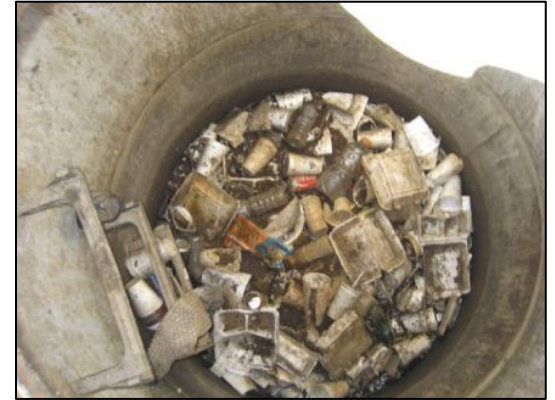
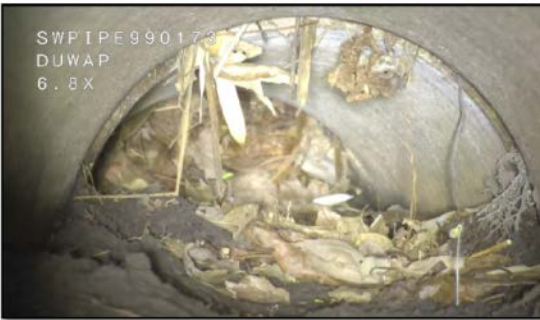
### OPERATIONAL & MAINTENANCE DEFECTS

Defect Categories	Defects	Descriptors	Modifiers	Condition Grade			
				No Modifier	Minor	Moderate	Severe
Operational & Maintenance (O&M) Defects	Deposits (< 25%)	Deposit Sediment		2			
		Deposit Gravel		2			
		Deposit Woody Debris		2			
		Deposit Concrete		2			
		Deposit Garbage		2			
		Deposit Other		2			
					No Mod.	< 50%	50-75%
Obstruction (> 25%)	Obstruction (> 25%)	Sediment (< 50%, 50-75%, > 75%)		3	4	5	
		Gravel/Rocks (< 50%, 50-75%, > 75%)		3	4	5	
		Woody Debris (< 50%, 50-75%, > 75%)		3	4	5	
		Construction Debris (< 50%, 50-75%, > 75%)		3	4	5	
		Garbage (< 50%, 50-75%, > 75%)		3	4	5	
		Burned (< 50%, 50-75%, > 75%)		5	3	4	5
		Object Intruding Through Wall (< 50%, 50-75%, > 75%)		3	4	5	
Roots	Roots	External Pipe/Utility (< 50%, 50-75%, > 75%)		3	4	5	
		Other (< 50%, 50-75%, > 75%)		3	4	5	
		Fine		2	3	4	5
Infiltration	Infiltration	Tap		3			
		Medium (< 50%)		4			
		Ball (> 50%)		5			
		Wrecker/Crusher Runner		2

Defect Category	Modifier	Description
O&M - Obstruction	< 50%	< 50% cross-sectional area affected
	50-75%	50-75% cross-sectional area affected
	> 75%	> 75% cross-sectional area affected

5	Failed or failure is imminent - requires immediate attention
4	Severe defects - risk of future failure
3	Moderate defects - deterioration may continue
2	Minor to Moderate defects - low risk of failure
1	Minor defects - failure unlikely in the foreseeable future

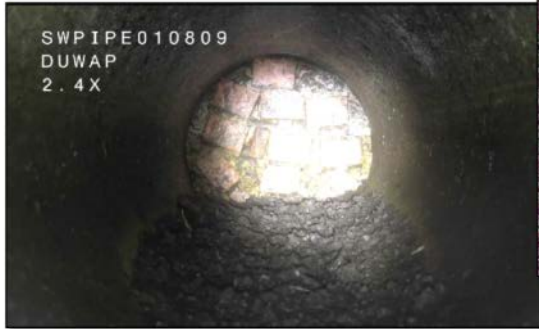
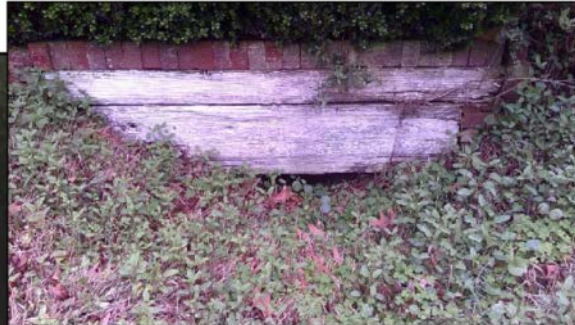
#### Obstructions

Grade	Condition Description
5	Failed or failure is imminent - requires immediate attention
4	Severe defects - risk of future failure
3	Moderate defects - deterioration may continue
2	Minor to Moderate defects - low risk of failure
1	Minor defects - failure unlikely in the foreseeable future

Defect Categories	Defects	Descriptors	Modifiers	Condition Grade					
				No Modifier	Minor	Moderate	Severe		
Operational & Maintenance (O&M) Defects	Deposits (≤ 25%)	Deposit Sediment		2					
		Deposit Gravel		2					
		Deposit Woody Debris		2					
		Deposit Concrete		2					
		Deposit Garbage		2					
	Deposit Other		2						
	Obstruction (> 25%)		Sediment (< 50%) (S1-75%) (> 75%)			3	4	5	
			Gravel/Rocks (< 25%) (21-75%) (> 75%)			3	4	5	
			Woody Debris (< 50%) (51-75%) (> 75%)			3	4	5	
			Construction Debris (< 50%) (51-75%) (> 75%)			3	4	5	
			Garbage (< 50%) (51-75%) (> 75%)			3	4	5	
			Dried			5			
			Object Intruding Through Wall (< 50%) (51-75%) (> 75%)			3	4	5	
			External Flow Cable (< 50%) (51-75%) (> 75%)			3	4	5	
			Other (< 50%) (51-75%) (> 75%)			3	4	5	
Fine					2				
Roots	Tap			3					
	Medium (≤ 50%)			4					
	Ball (> 50%)			5					
Infiltration	Washer/Drinker			2					
	Runner			4

Defect Category	Modifier	Description
O&M - Obstruction	< 50%	< 50% cross-sectional area affected
	50-75%	50-75% cross-sectional area affected
	> 75%	> 75% cross-sectional area affected
