Advancing Green Infrastructure in Coastal Georgia through Photo-Based O&M Tools

Robert A. Brown, Ph.D., P. E. Goodwyn Mills Cawood

SESWA's 17th Annual Regional Stormwater Seminar April 22, 2022 Atlanta, GA

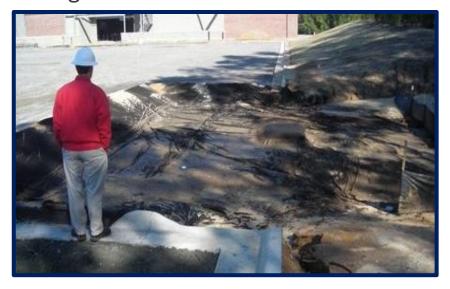
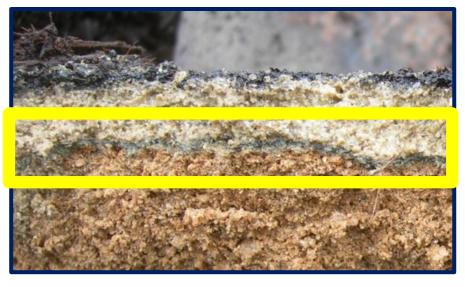
MONITOR ... MAINTAIN ... MONITOR

- Removed fines layer within the top 2-4 inches
 - -Infiltration rate increased by a factor of 10
 - -No media was replaced because system was already undersized
 - –Surface ponding volume doubled

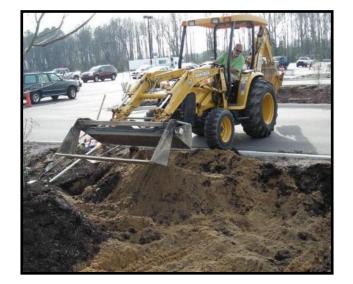
Monitoring Period	Pre-Repair	Post-Repair		
Dates	3/31/08–3/11/09	3/12/09–3/24/10		
Number of Events	64	76		
Events > 1 inch	11	14		
Events with Overflow (% surface storage vs. required):				
0.6-m Media Depth	38 (28% storage)	18 (53% storage)		
0.9-m Media Depth	35 (35% storage)	18 (66% storage)

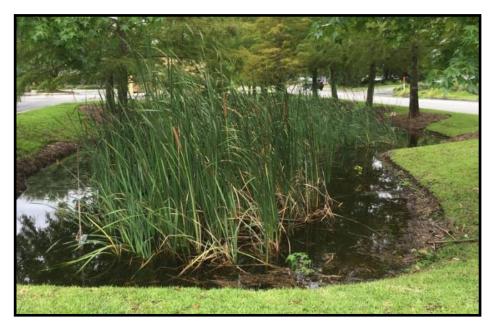
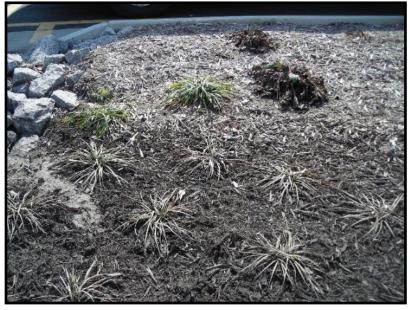
VEGETATION TYPE AND HEALTH OFFERS CLUES ON EXTENT OF SURFACE PONDING

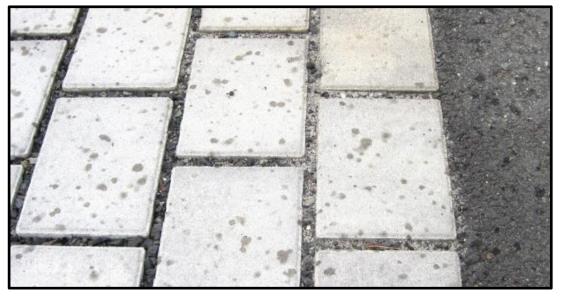
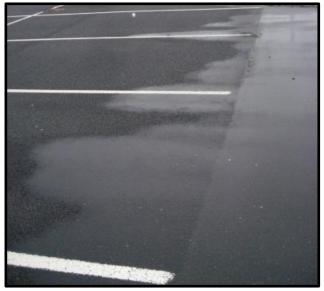
Sediment is not "snow" that spreads evenly over the surface.

THE RATIO OF DRAINAGE AREA TO UPGRADIENT FLOW WIDTH DRIVES SEDIMENT LOAD (& MAINTENANCE FREQUENCY)

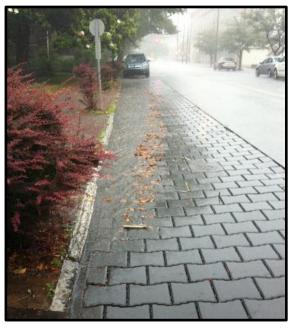
REMOVING PAVERS AT SELECTED LOCATIONS PROVIDES INFORMATION ON HOW THE SURFACE CLOGS.

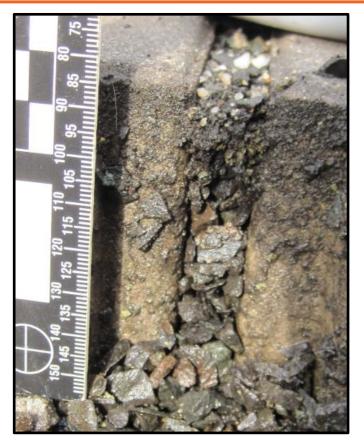
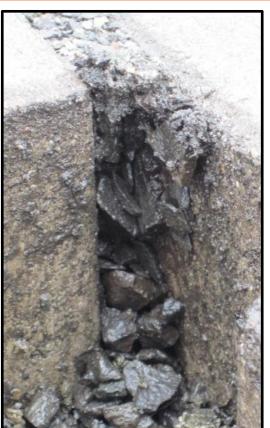
MOST OF THE FINES ARE TRAPPED IN THE TOP 20 MM (3/4").
